**Release Notification and Corrective Action**

Name of Company Devon Energy	Contact Robert Jordan
Address HWY 511 #1751 Navajo Dam	Telephone No. 505-320-1395
Facility Name NEBU 504	Facility Type CBM WELL

<h1 style="text-align: center;">Incident Report Form</h1>		<b>Division:</b> Western	
				<b>Reg./Area:</b> Permian Basin	
				<b>Field:</b> San Juan	
				<b>Group:</b> Northeast Blanco Unit CBM	
				<b>Location:</b>	
		<b>Devon Supervisor:</b> Robert Jordan

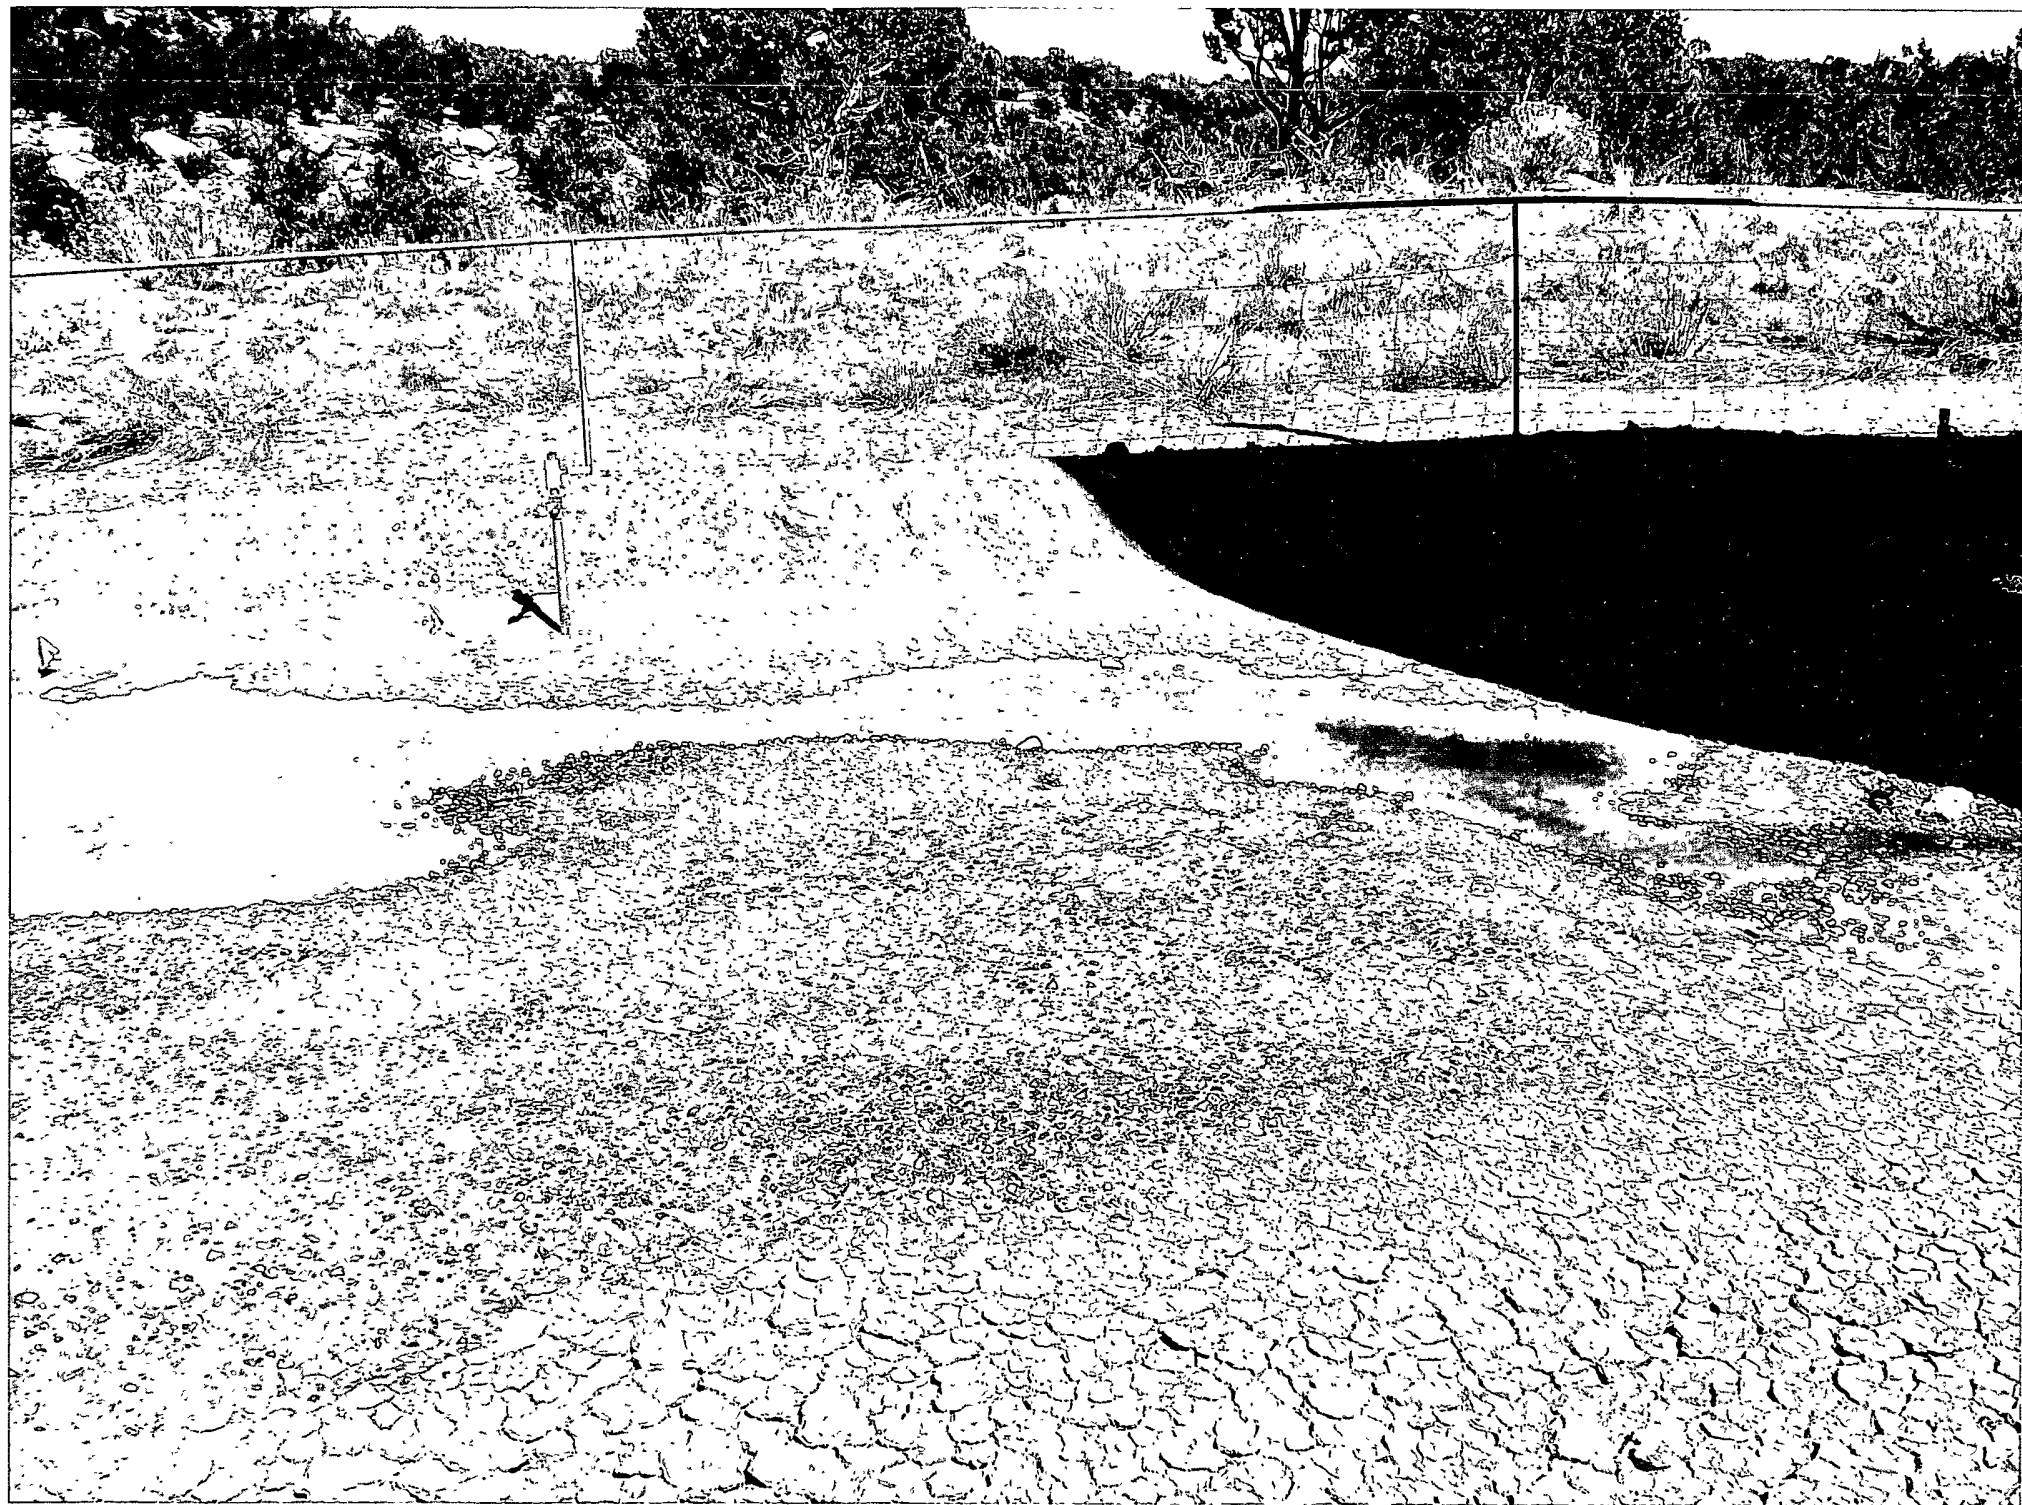
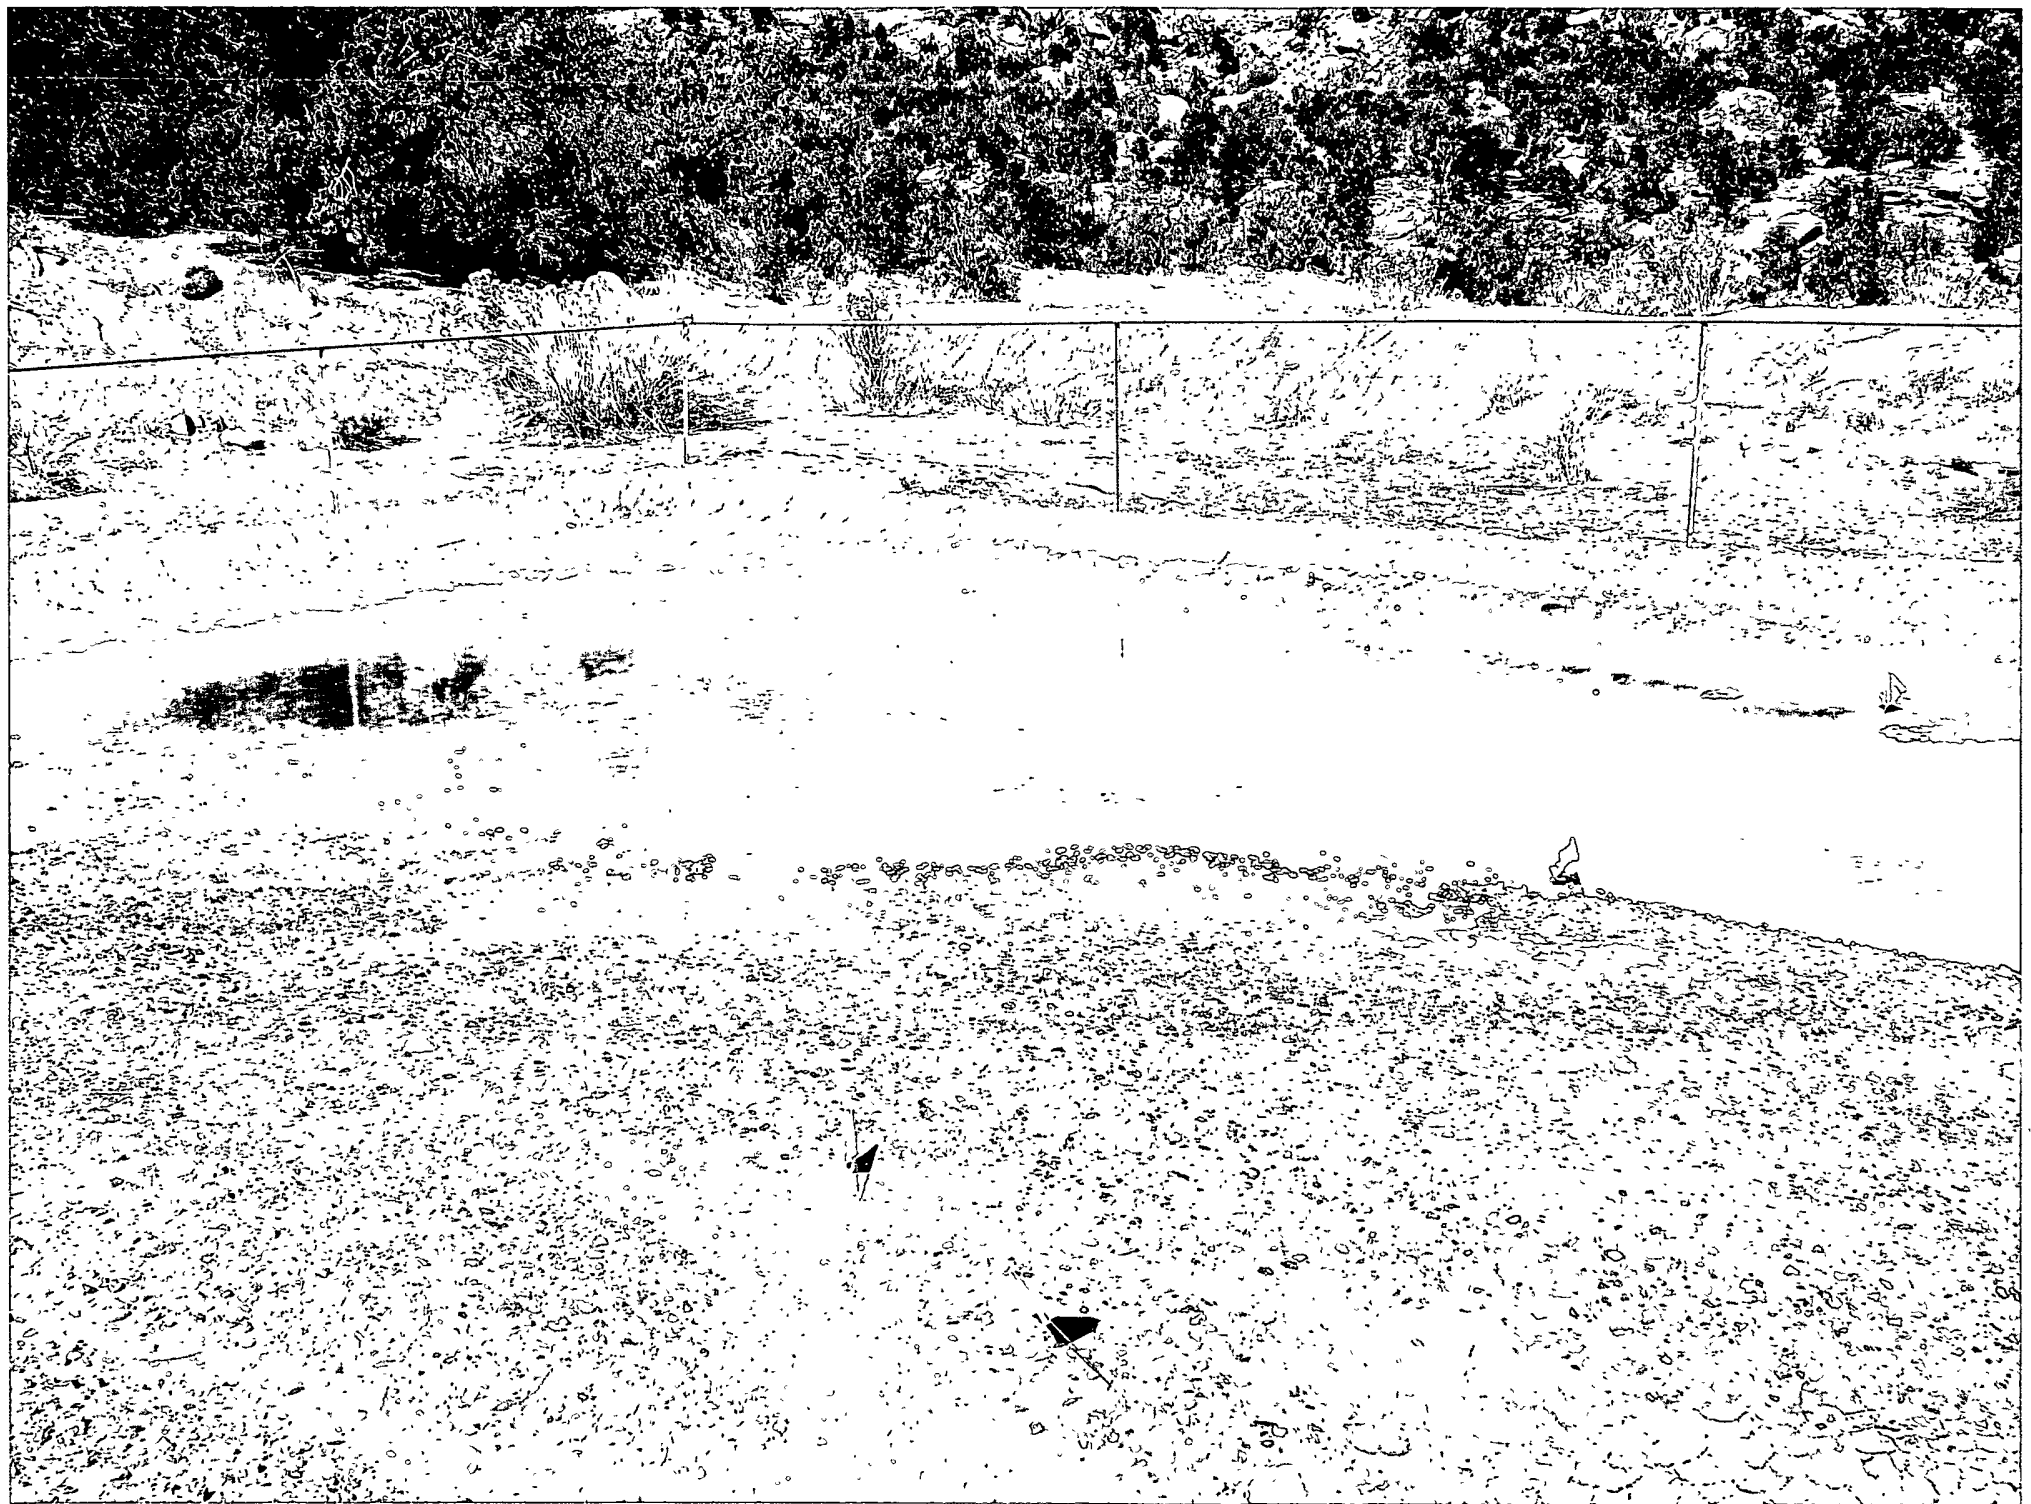
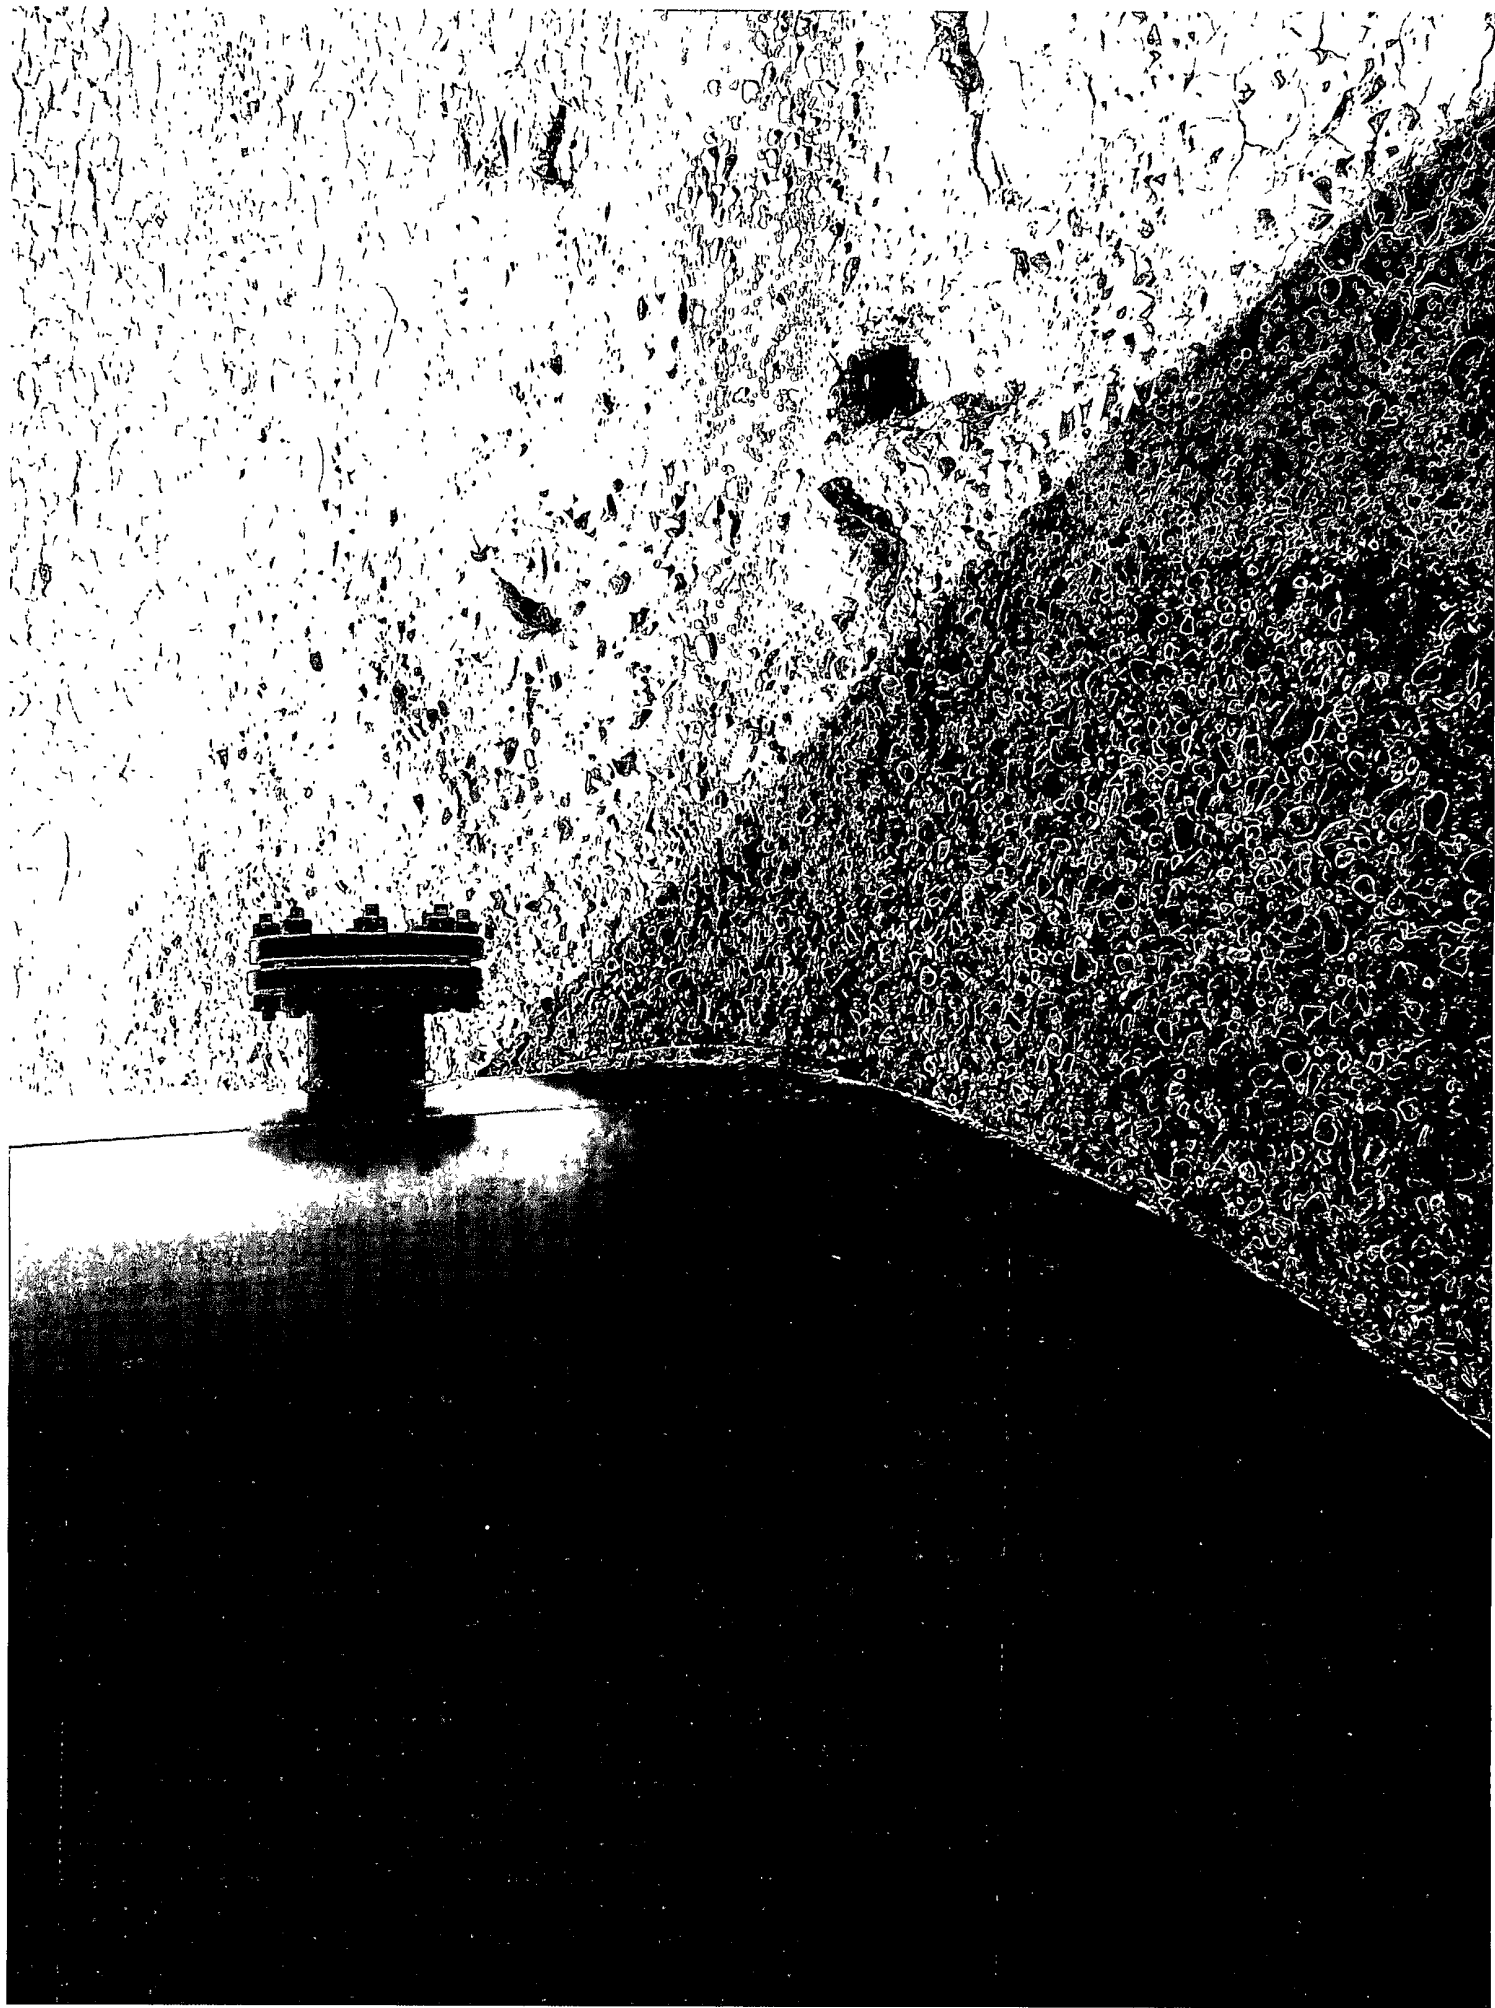
The sediment tank was corroded on the bottom and was seeping produced water in the containment. The tank has been removed and soil samples were taken by Envirotech Test results pending

A 20' x 20' x 4' area around the tanks and stayed with in the firewall. Wait on State to determine remedial action.

Time of air release		Start		End		Gas Released				
Describe Area, Property, and Wildlife impacted				On location Type C soil						
Immediate Concern										
Describe Immediate Actions taken				Tank was drained and removed from operation, soil				Qty of Release		
<input checked="" type="checkbox"/> Reportable to Regulator		<input type="checkbox"/> Reserve Pits		Equipment: Storage Tank		Units.
