Pit, Closed-Loop System, Below-Grade Tank, or

# Burlington Resources Oil Gas Company, LP San Juan Basin Closure Report

Lease Name: SAN JUAN 30-6 UNIT 43N

API No.: 30-039-30958

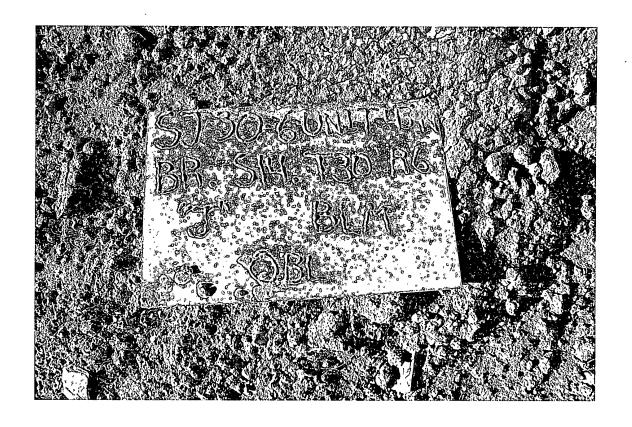
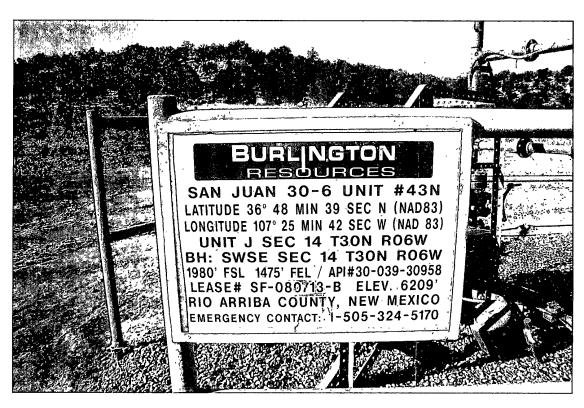
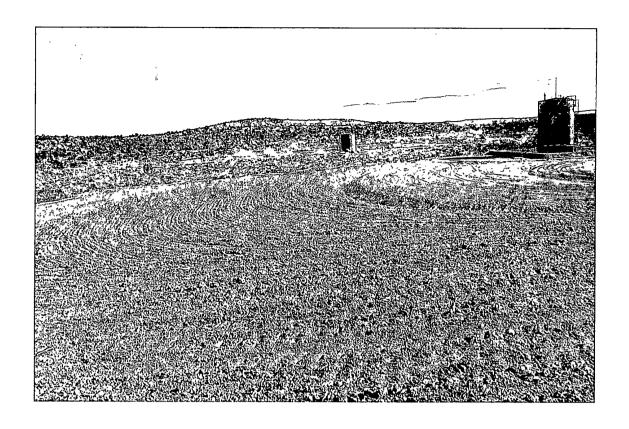
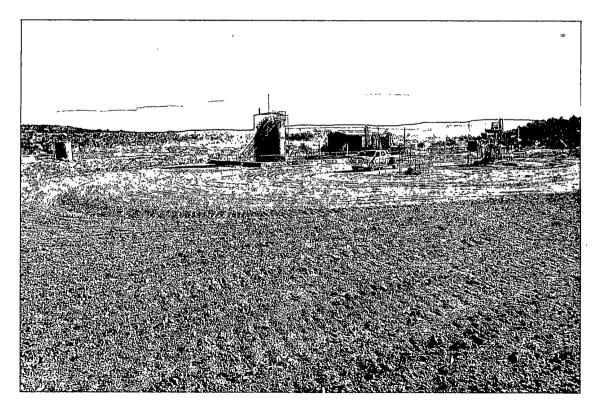
Reclamation Form:	•
Date: 11-30-201	7.
Well Name: <u>\$3</u> 30	D-6 H3N
Footages: 1980 FSL	. 1475 FEL Unit Letter: 3
Section: 14 , T-30	-N, R- <u>6</u> -W, County: <u>RA</u> State: <u>MM</u>
Reclamation Contractor:	Riffer
Reclamation Date:	9-29-2011
Road Completion Date:	11-4-2011
Seeding Date:	11-4-2011
MARKER PLACED :  LATATUDE:  LONGITUDE:	(When Required): Picture of Marker set needed 9-30-2011 (DATE)
MARKER PLACED :  LATATUDE:  LONGITUDE:  Pit Manifold removed	9-30-2011 (DATE)
MARKER PLACED :  LATATUDE:  LONGITUDE:  Pit Manifold removed  Construction Inspector:	9-30-2011 (DATE)  19-2011 (DATE)  Norman Faver Date: 11-30-2011
MARKER PLACED :  LATATUDE:  LONGITUDE:  Pit Manifold removed  Construction Inspector:	9-30-2011 (DATE)
