**Pit, Closed-Loop System, Below-Grade Tank, or  
Proposed Alternative Method Permit or Closure Plan Application**

**Burlington Resources Oil Gas Company, LP**  
**San Juan Basin**  
**Closure Report**

**Lease Name: SANDIA FEDERAL 1F**

**API No.: 30-045-35016**

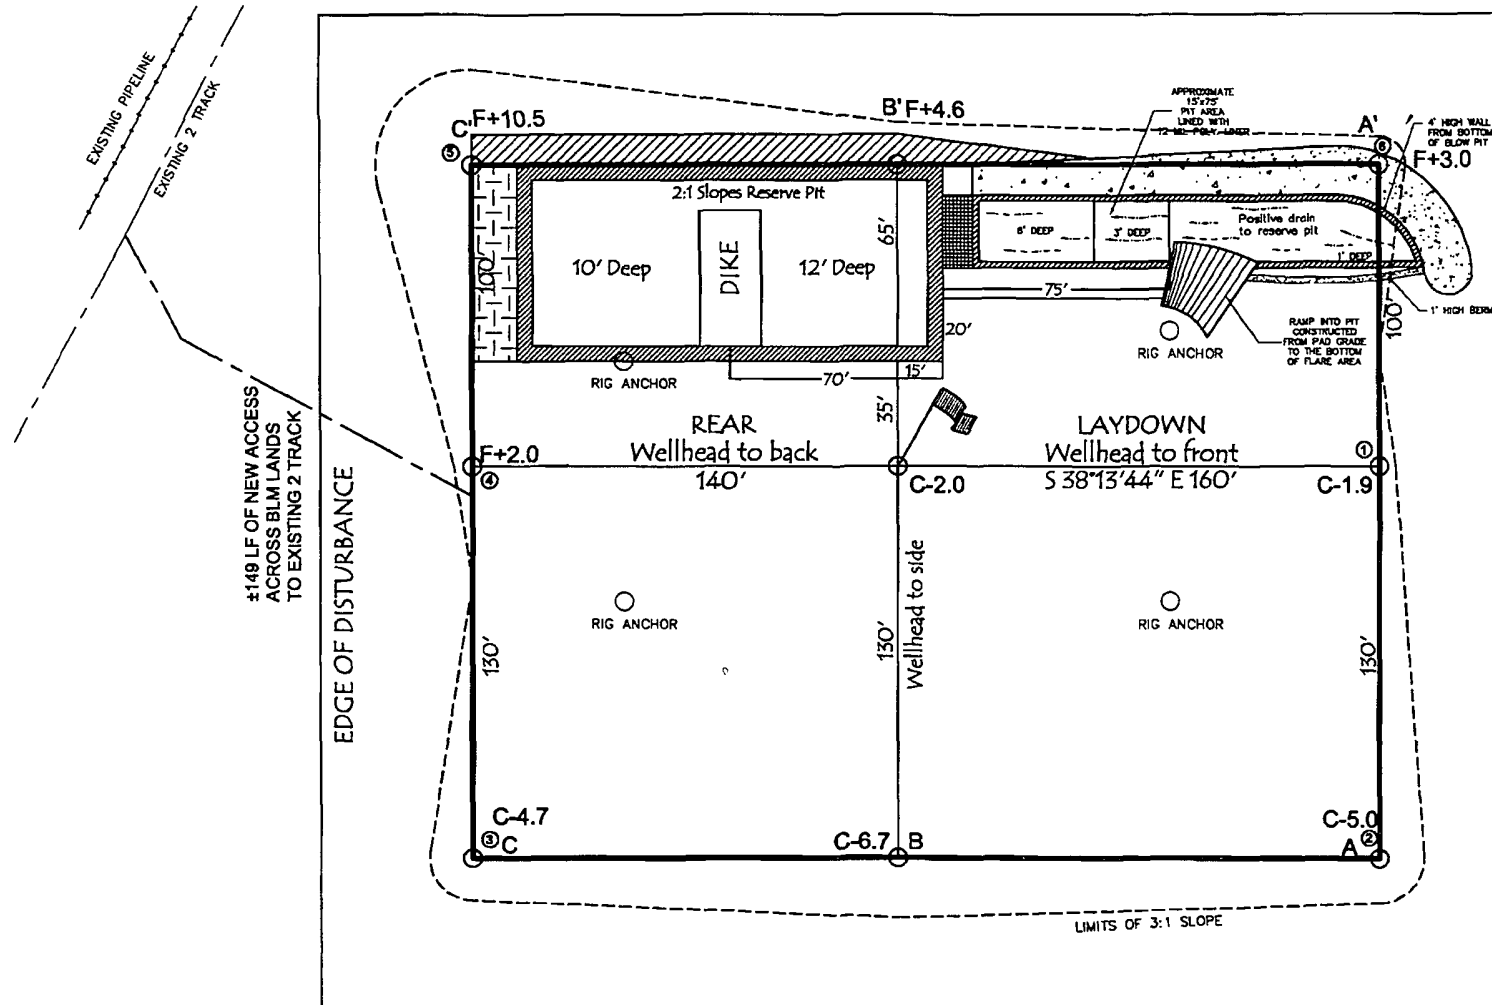
**WELL FLAG**  
 LATITUDE: 36.78469°N  
 LONGITUDE: 108.01176°W  
**CENTER OF PIT**  
 LATITUDE: 36.78495°N  
 LONGITUDE: 108.01177°W  
 ELEVATION: 5816.3'  
 DATUM: NAD 83 & NAVD88

**BURLINGTON RESOURCES OIL & GAS COMPANY LP**  
 SANDIA FEDERAL #1 F  
 2095' FNL & 1990' FEL  
 LOCATED IN THE SW/4 NE/4 OF SECTION 29,  
 T30N, R11W, N.M.P.M.,  
 SAN JUAN COUNTY, NEW MEXICO  
 GROUND ELEVATION: 5830', NAVD 88  
 FINISHED PAD ELEVATION: 5828.3', NAVD 88

SLOPES TO BE CONSTRUCTED TO MATCH THE ORIGINAL CONTOURS AS CLOSE AS POSSIBLE.

330' x 400' = 3.03 ACRES OF DISTURBANCE  
 SCALE: 1" = 60'  
 JOB No.: COPC189  
 DATE: 06/02/08
