**Pit, Closed-Loop System, Below-Grade Tank, or  
Proposed Alternative Method Permit or Closure Plan Application**

Operator: **Burlington Resources Oil & Gas Company, LP** OGRID#: **14538**

Facility or well name: **ATLANTIC 5C**

**OCD Approval:** ☐ Permit Application (including closure plan) ☒ Closure Plan (only) ☐ OCD Conditions (see attachment)

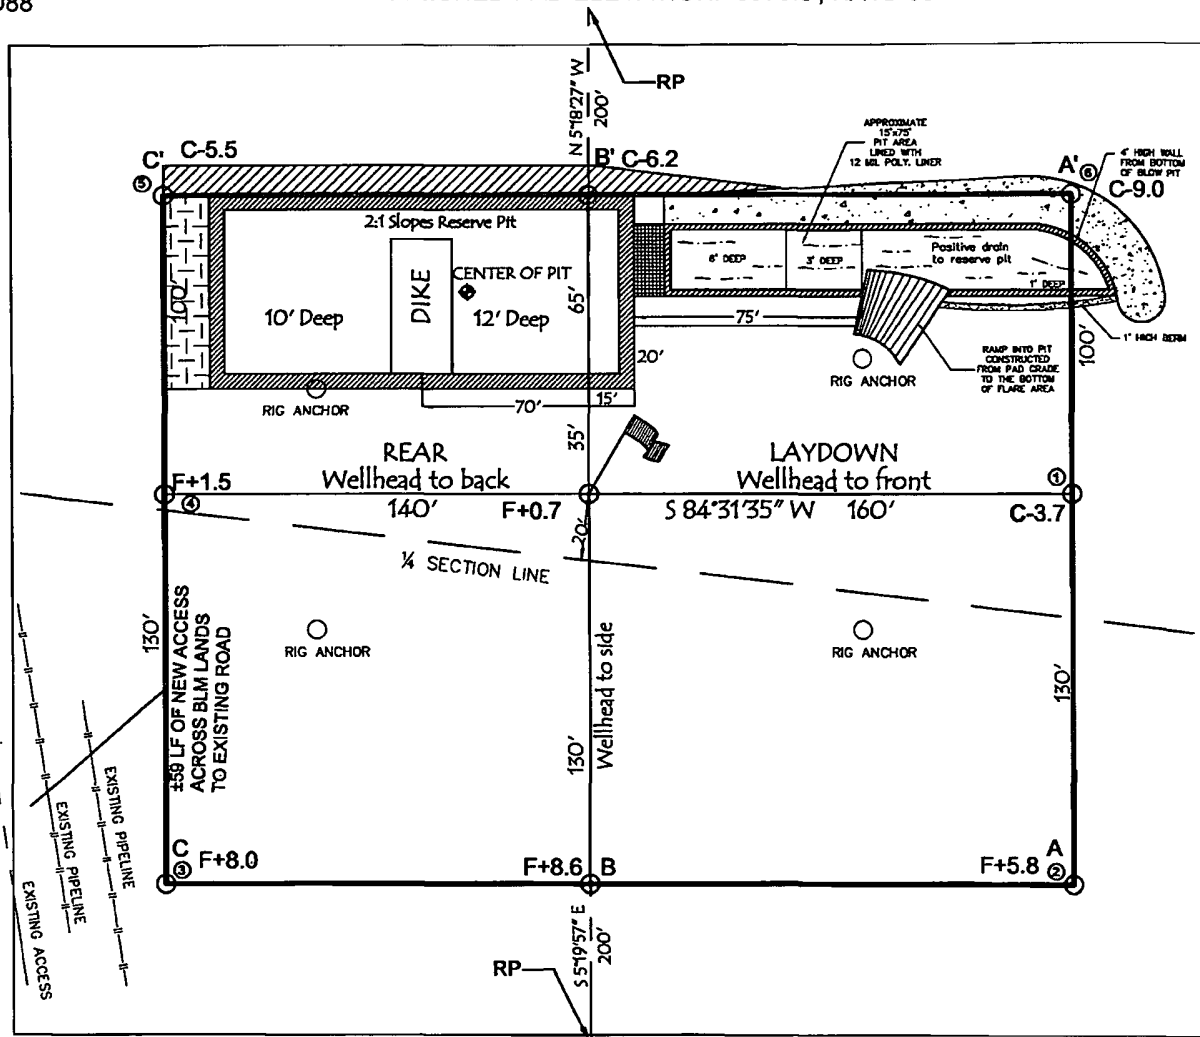
SLOPES TO BE CONSTRUCTED TO MATCH THE ORIGINAL CONTOURS AS CLOSE AS POSSIBLE.

**TOTAL PERMITTED AREA**  
 330' x 400' = 3.03 ACRES  
**SCALE:** 1" = 60'  
**JOB No.:** COPC340  
**DATE:** 08/30/09  
**DRAWN BY:** TWT
