Pit, Closed-Loop System, Below-Grade Tank, or Proposed Alternative Method Permit or Closure Plan Application

Burlington Resources Oil Gas Company, LP San Juan Basin Closure Report

Lease Name: SAN JUAN 28-6 UNIT 13P

API No.: 30-039-30583

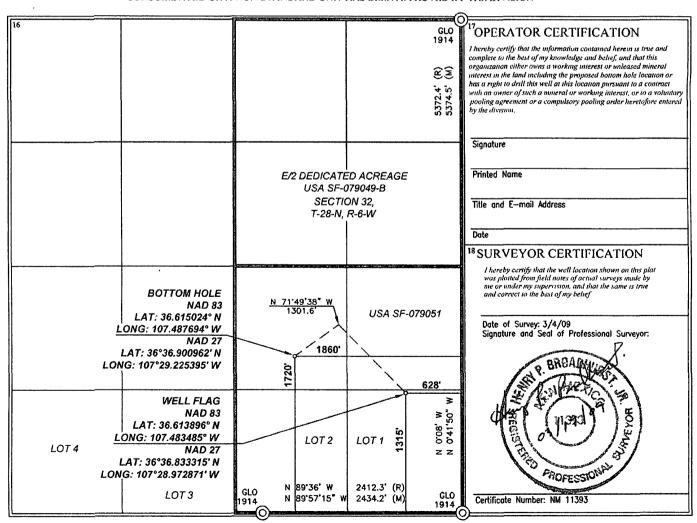
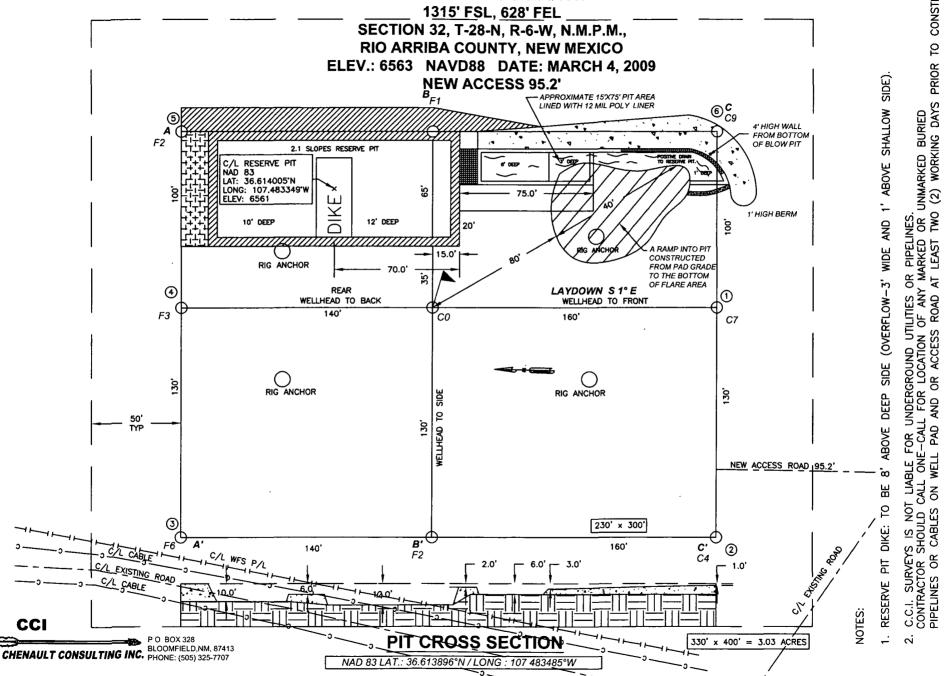
WELL LOCATION AND ACREAGE DEDICATION PLAT

SAN JUAN 28-6 UNIT #130P

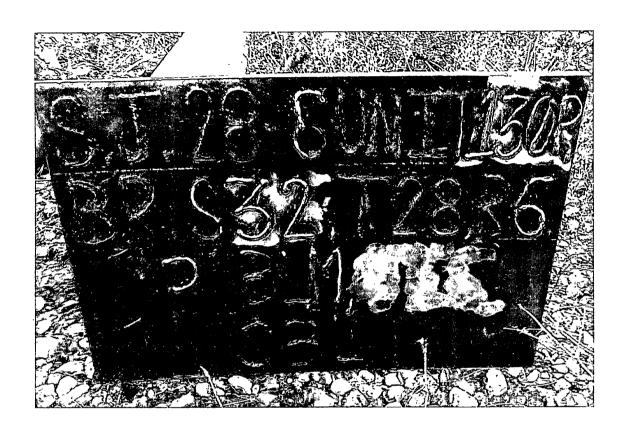
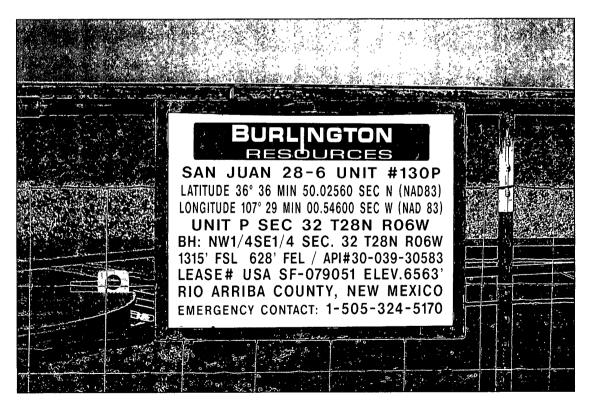
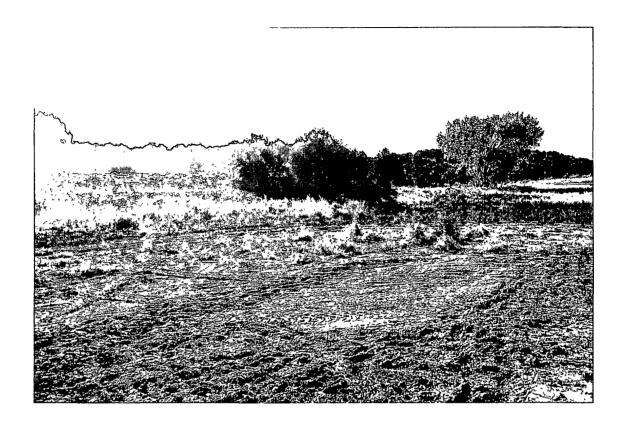
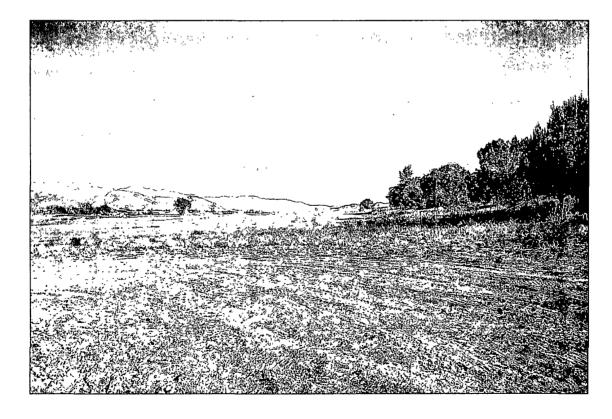
The pit area was re-contoured to match fit, shape, line, form and texture of the surrounding area. Re-shaping included drainage control, to prevent ponding and erosion. Natural drainages were unimpeded and water bars and/or silt traps were placed in areas where needed to prevent erosion on a large scale. Final recontour has a uniform appearance with smooth surface, fitting the natural landscape.

Provision 15 was accomplished by installing a steel marker in the temporary pit, no less than four inches in diameter, cemented in a hole three feet deep in the center of the onsite burial. The marker is flush with the ground to allow access of the active well pad and for safety concerns. The top of the marker contains a welded steel 12" square plate that indicates the onsite burial of the temporary pit. The plate contains the following: Operator Name, Lease Name, Well Name and number, Unit Number, Section, Township, Range and an indicator that the marker is an onsite burial location.
