Pit, Closed-Loop System, Below-Grade Tank, or
Proposed Alternative Method Permit or Closure Plan Application

XTO Energy Inc. San Juan Basin Below Grade Tank Closure Report

Lease Name: RP Hargrave K #1E

API No.: 30-045-25635

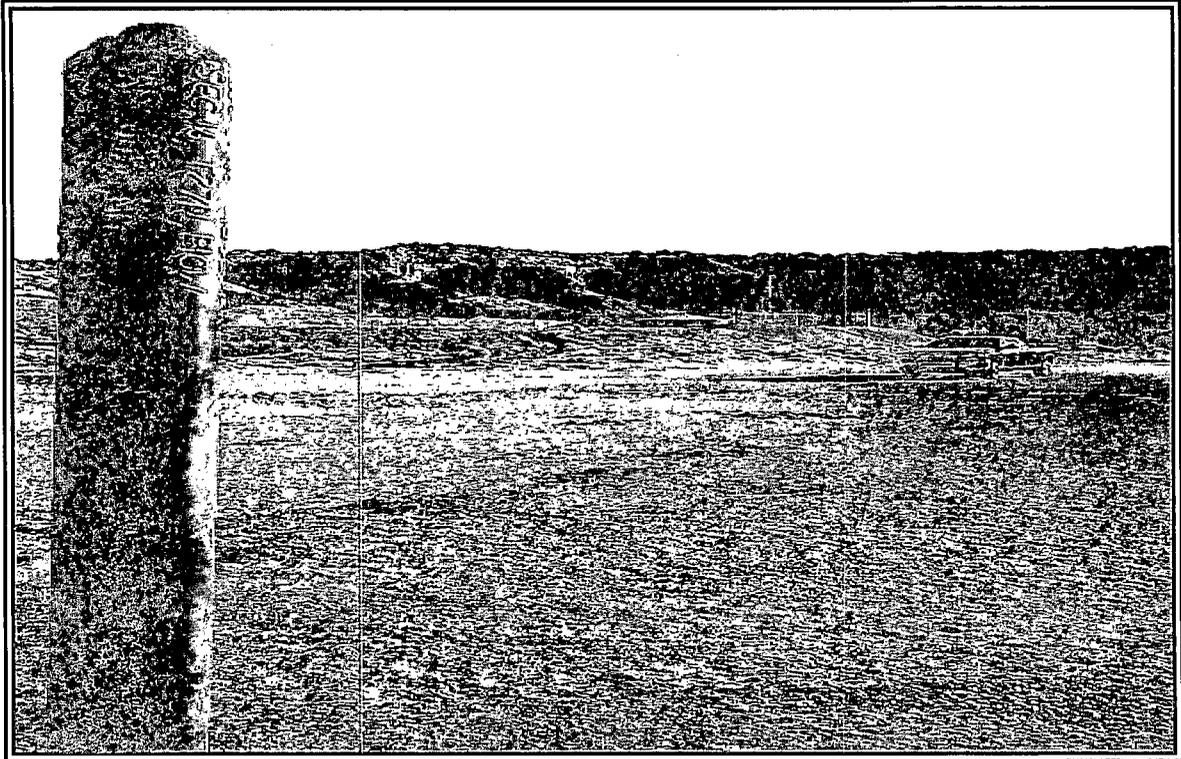
Photo 3: RP Hargrave K #1E after Reclamation.
