_		Pit, Closed-Loop System, Below-Grade Tank, or
3112	<u>Prop</u>	osed Alternative Method Permit or Closure Plan Application
<b>'</b> 2`	Type of action:	Permit of a pit, closed-loop system, below-grade tank, or proposed alternative method
		$\overline{X}$ Closure of a pit, closed-loop system, below-grade tank, or proposed alternative method
		Modification to an existing permit

# ConocoPhillips Company San Juan Basin Closure Report

Lease Name: SAN JUAN 29-5 UNIT 90N

API No.: 30-039-30672

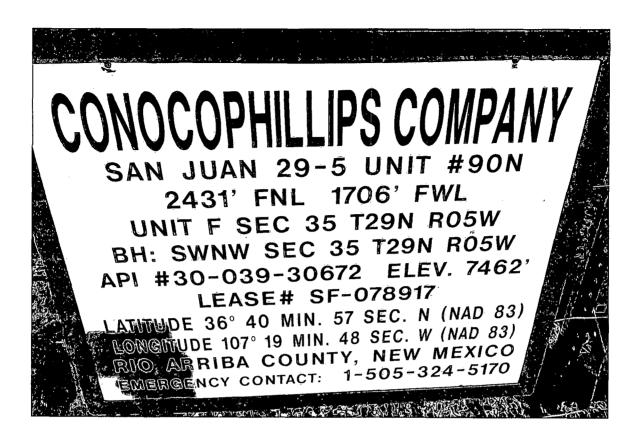
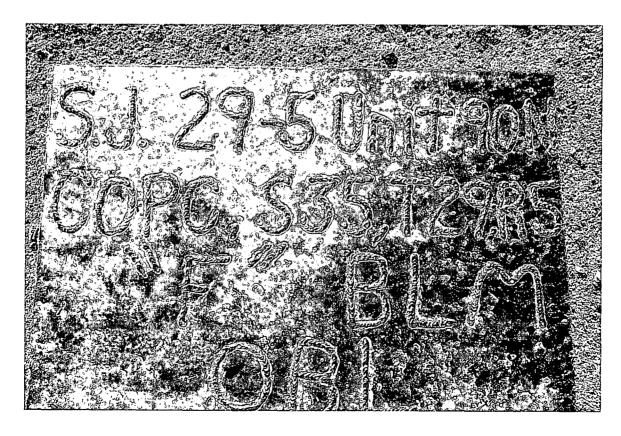
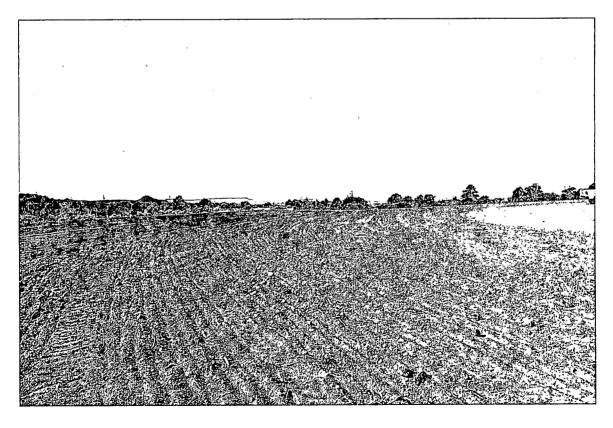
Reclamation Form:
Date: 8/15/12 cor
Well Name: 6ds 5529-5#90N
Footages: 243/FNL 1706 FWL Unit Letter: F
Section: 35, T-29-N, R-5-W, County: Lindship State: 1/1
Reclamation Contractor: Ace Selvices
Reclamation Start Date: 6/28/12
Reclamation Complete Date: $\frac{7/9/i2}{}$
Road Completion Date: $\frac{7/12}{12}$
Seeding Date: 7/13/12
**PIT MARKER STATUS (When Required): Picture of Marker set needed
MARKER PLACED: $\frac{8}{14}/12$ (DATE)
LATATUDE: 36.68250°
LONGITUDE: 107. 32986
Pit Manifold removed $\frac{6/28//2}{}$ (DATE)
Construction Inspector: 912 Date: 8/15/12
Inspector Signature: Sture McClasson
Office Use Only: SubtaskDSMFolderPictures
Davis and C(14/2042

The pit area was re-contoured to match fit, shape, line, form and texture of the surrounding area. Reshaping included drainage control, to prevent ponding and erosion. Natural drainages were unimpeded and water bars and/or silt traps were placed in areas where needed to prevent erosion on a large scale. Final recontour has a uniform appearance with smooth surface, fitting the natural landscape.

Provision 15 was accomplished by installing a steel marker in the temporary pit, no less than four inches in diameter, cemented in a hole three feet deep in the center of the onsite burial. The marker is flush with the ground to allow access of the active well pad and for safety concerns. The top of the marker contains a welded steel 12" square plate that indicates the onsite burial of the temporary pit. The plate contains the following: Operator Name, Lease Name, Well Name and number, Unit Number, Section, Township, Range and an indicator that the marker is an onsite burial location.
