Pit, Closed-Loop System, Below-Grade Tank, or Proposed Alternative Method Permit or Closure Plan Application

Operator: Burlington Resources Oil & Gas Company, LP OGRID#: 14538
Address: P.O. Box 4289, Farmington, NM 87499
Facility or well name: SAN JUAN 32-9 UNIT 24B
API Number: 30-045-35208 OCD Permit Number:
U/L or Qtr/Qtr: P(SE/SE) Section: 5 Township: 31N Range: 9W County: SAN JUAN
Center of Proposed Design: Latitude: <u>36.92219</u> °N Longitude: <u>107.76863</u> °W NAD: 1927 X 1983
Surface Owner: Federal State X Private Tribal Trust or Indian Allotment
RCVD AUG 9 12 RCVD AUG 9 1
Closed-loop System: Subsection H of 19.15.17.11 NMAC Type of Operation: P&A Drilling a new well Workover or Drilling (Applies to activities which require prior approval of a permit or notice of intent) Drying Pad Above Ground Steel Tanks Haul-off Bins Other Lined Unlined Liner type: Thickness mil LLDPE HDPE PVD Other Liner Seams: Welded Factory Other
Below-grade tank: Subsection I of 19.15.17.11 NMAC Volume: bbl Type of fluid: Tank Construction material: Secondary containment with leak detection Visible sidewalls, liner, 6-inch lift and automatic overflow shut-off Visible sidewalls and liner Visible s

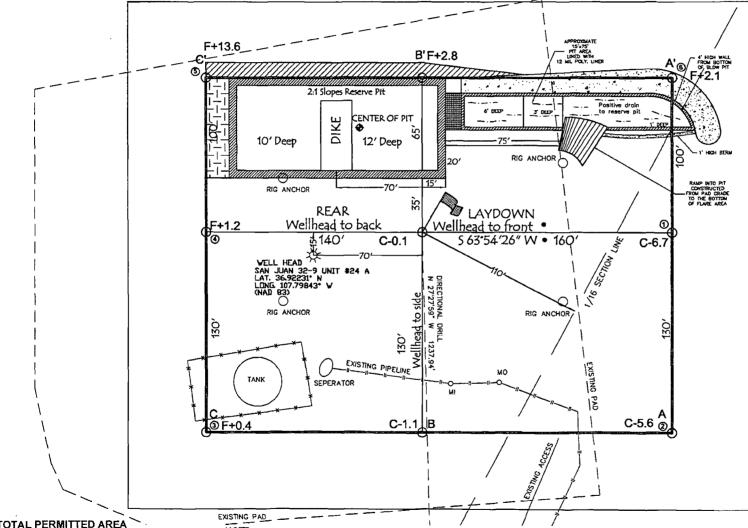
CENTER OF PIT

LATITUDE: 36.92209° N ONGITUDE: 107.79834° W ELEVATION: 6624.8

TOTAL PERMITTED AREA 330' x 400' = 3.03 ACRES

RESERVE PIT DIKE: TO BE 8' ABOVE DEEP SIDE (OVERFLOW - 3' WIDE AND 1' ABOVE SHALLOW SIDE). RUSSELL SURVEYING, INC. IS NOT LIABLE FOR UNDERGROUND UTILITIES OR PIPELINES. CONTRACTOR SHOULD CALL ONE-CALL FOR LOCATION OF ANY MARKED OR UNMARKED, BURIED PIPELINES OR CABLES ON WELL PAD, IN CONSTRUCTION ZONE AND/OR ACCESS ROAD AT LEAST TWO (2) WORKING DAYS PRIOR TO CONSTRUCTION.

MATCH THE ORIGINAL CONTOURS AS CLOSE AS POSSIBLE.
