Burlington Resources Oil Gas Company, LP San Juan Basin Closure Report

Lease Name: SAN JUAN 29-7 UNIT 138N

API No.: 30-045-30961

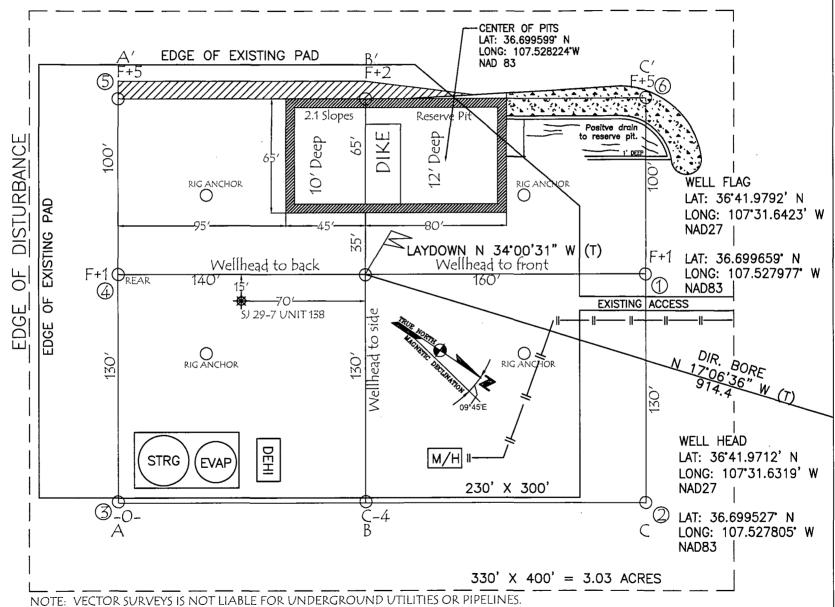
BURLINGTON RESOURCES OIL & GAS COMPANY LP SAN JUAN 29-7 UNIT 138M, 1580' FNL & 980' FWL

SECTION 25, T-29-N, R-7-W, NMPM, RIO ARRIBA COUNTY, NM GROUND ELEVATION: 6735', DATE: APRIL 3, 2008/Rvsd: OCTOBER 18,2011

NOTE: VECTOR SURVEYS IS NOT LIABLE FOR UNDERGROUND UTILITIES OR PIPELINES.
CONTRACTOR SHOULD CALL ONE-CALL FOR LOCATION OF ANY MARKED OR UNMARKED BURIED
PIPLINES OR CABLES ON WELL PAD AND OR ACCESS ROAD AT LEAST TWO (2) WORKING DAYS PRIOR TO CONSTRUCTION.
RESERVE PIT DIKE: TO BE 8' ABOVE DEEP SIDE (OVERFLOW – 3' WIDE AND 1' ABOVE SHALLOW SIDE).

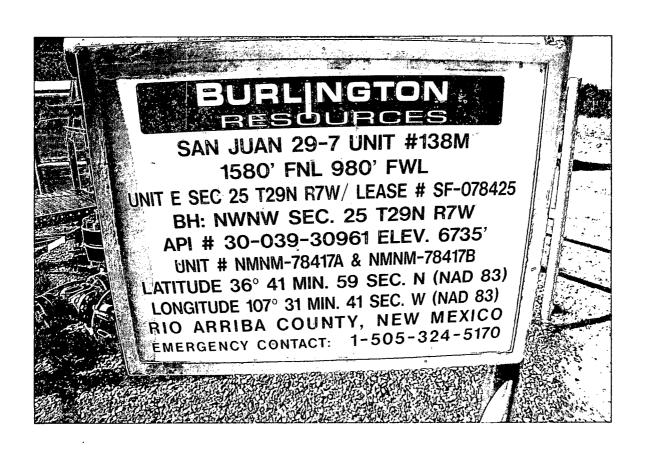
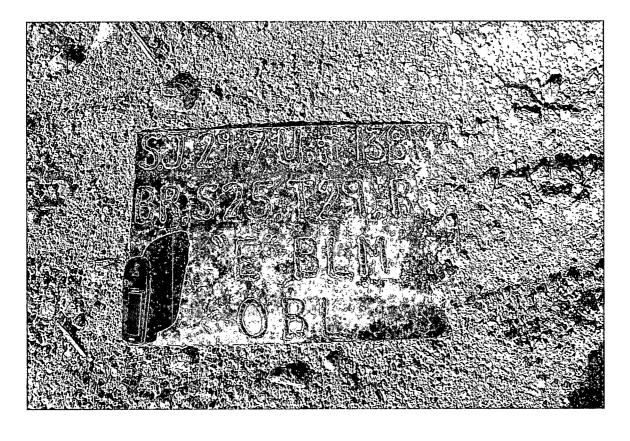
Reclamation Form:	
Date: 8-30-12	
Vell Name: <u>\$3 29-7 138M</u>	
footages: <u>/580 FNL, 980 Fいん</u> Unit Letter: <u>E</u>	
Section: <u>25</u> , T- <u>29</u> -N, R- <u>フ</u> -W, County: <u>パ. 冶.</u> State: <u>火</u>	<u>~۱</u>
Reclamation Contractor: R; Her	
Reclamation Start Date: <u> </u>	
Reclamation Complete Date: 8-8-/2	
Road Completion Date: 8-13-12	······································
Seeding Date: 8-24-12	
**PIT MARKER STATUS (When Required): Picture of Marker set needed	
MARKER PLACED: <u>8/23/12</u> (DA	TE)
LATATUDE:	
LONGITUDE:	_
it Manifold removed <u>8-3-/2</u> (DA	ATE)
onstruction Inspector: Norman Faver Date: 8-30-	-/2
espector Signature:	
fice Use Only: SubtaskPictures	
vised 6/44/2042

The pit area was re-contoured to match fit, shape, line, form and texture of the surrounding area. Reshaping included drainage control, to prevent ponding and erosion. Natural drainages were unimpeded and water bars and/or silt traps were placed in areas where needed to prevent erosion on a large scale. Final recontour has a uniform appearance with smooth surface, fitting the natural landscape.

Provision 15 was accomplished by installing a steel marker in the temporary pit, no less than four inches in diameter, cemented in a hole three feet deep in the center of the onsite burial. The marker is flush with the ground to allow access of the active well pad and for safety concerns. The top of the marker contains a welded steel 12" square plate that indicates the onsite burial of the temporary pit. The plate contains the following: Operator Name, Lease Name, Well Name and number, Unit Number, Section, Township, Range and an indicator that the marker is an onsite burial location.
