Pit, Closed-Loop System, Below-Grade Tank, or
Proposed Alternative Method Permit or Closure Plan Application

1
Operator: ConocoPhillips Company OGRID#: 217817
Address: P.O. Box 4289, Farmington, NM 87499
Facility or well name: San Juan 28-7 Unit Com 298
API Number: 30-039-31093 OCD Permit Number: _____
U/L or Qtr/Qtr: C(NE/NW) Section: 27 Township 27N Range: 7W County: Rio Arriba
Center of Proposed Design: Latitude: 36.5487154 °N Longitude: 107.5653912 °W NAD: 1927 1983
Surface Owner: Federal State Private Tribal Trust or Indian Allotment

**ConocoPhillips Company
San Juan Basin
Closure Report**

**Lease Name: SJ 28-7 UNIT COM 298
API No.: 30-039-31093**

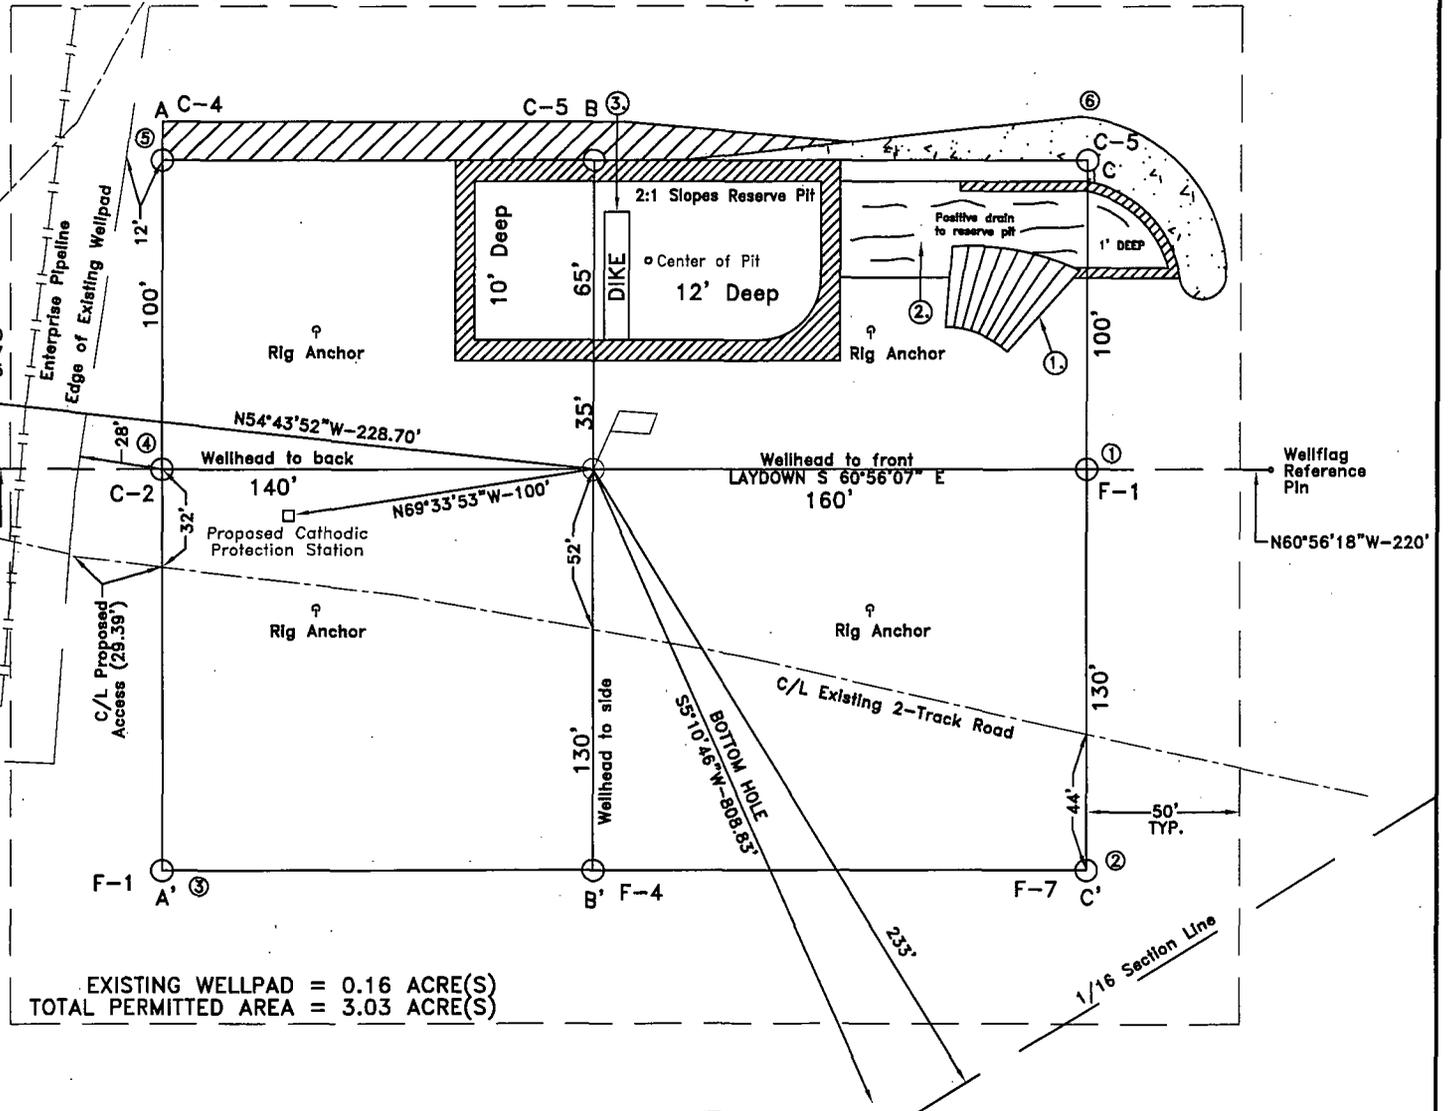
PAD CONSTRUCTION SPECS:

1. RAMP INTO PIT CONSTRUCTED FROM PAD GRADE INTO FLARE AREA AT 5% SLOPE.
2. APPROXIMATE 13'x75' PIT AREA LINED WITH 12 MIL POLYLINER.
3. RESERVE PIT DIKE TO BE 6' ABOVE DEEP SIDE (OVERFLOW- 3' WIDE AND 1' ABOVE SHALLOW SIDE).
