**Pit, Closed-Loop System, Below-Grade Tank, or
Proposed Alternative Method Permit or Closure Plan Application**

1
Operator: BP AMERICA PRODUCTION COMPANY OGRID #: 778
Address: 200 Energy Court, Farmington, NM 87401
Facility or well name: GALLEGOS CANYON UNIT 108
API Number: 3004508271 OCD Permit Number: _____
U/L or Qtr/Qtr J Section 13.0 Township 29.0N Range 13W County: San Juan County
Center of Proposed Design: Latitude 36.7235 Longitude -108.15721 NAD: ☐ 1927 ☒ 1983
Surface Owner: ☐ Federal ☐ State ☒ Private ☐ Tribal Trust or Indian Allotment

BELOW-GRADE TANK CLOSURE PLAN

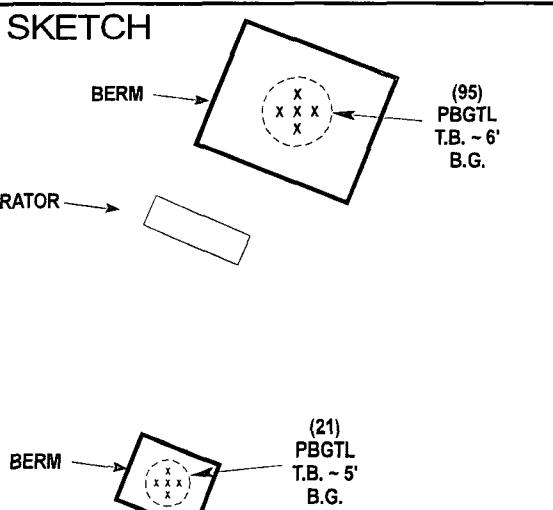
SITE SKETCH <div style="display: flex; align-items: center;">

<div style="margin-left: 20px;"> PLOT PLAN circle: attached TO W.H. N </div> </div>		
NOTES: BGT = BELOW-GRADE TANK; E.D. = EXCAVATION DEPRESSION; B.G. = BELOW GRADE; B = BELOW; T.H. = TEST HOLE; ~ = APPROX.; W.H. = WELL HEAD; T.B. = TANK BOTTOM; PBGT = PREVIOUS BELOW-GRADE TANK LOCATION; SPD = SAMPLE POINT DESIGNATION; R.W. = RETAINING WALL; NA = NOT APPLICABLE OR NOT AVAILABLE; SW - SINGLE WALL; DW - DOUBLE WALL; SB - SINGLE BOTTOM; DB - DOUBLE BOTTOM.		MISCELL. NOTES WO: N15336873 PO #: _____ PK: ZEVH01BGT2 PJ #: Z2-006Q0 Permit date(s): 06/14/10 OCD Appr. date(s): 05/10/11 Tank ID: _____ OVM = Organic Vapor Meter ppm = parts per million A BGT Sidewalls Visible: Y / (N) B BGT Sidewalls Visible: Y / (N) BGT Sidewalls Visible: Y / N Magnetic declination: 10° E
TRAVEL NOTES: CALLOUT: _____ ONSITE: 10/14/13
