Pit, Closed-Loop System, Below-Grade Tank, or Proposed Alternative Method Permit or Closure Plan Application

BELOW-GRADE TANK CLOSURE PLAN

Gallegos Canyon Unit 33  
API No. 3004507268  
Unit Letter M, Section 21, T28N, R12W

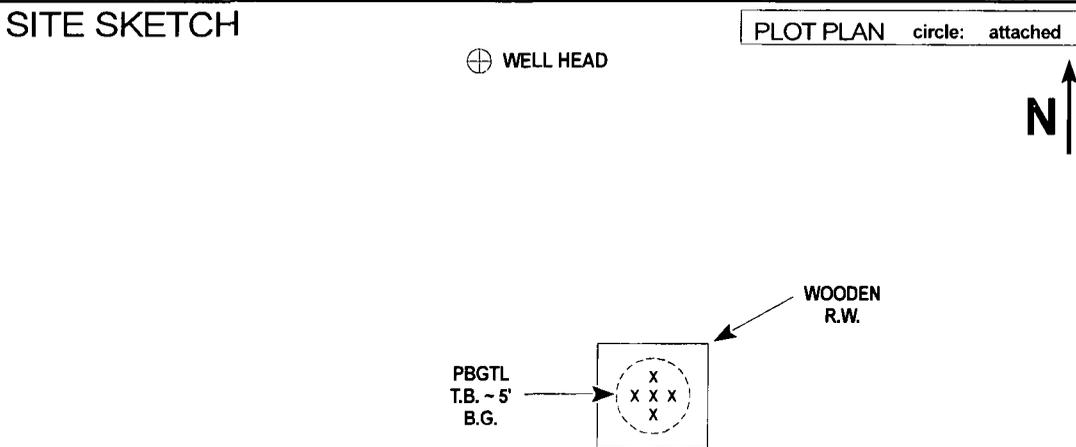
ADDITIONAL COMMENTS: **BGT IN 10'X10'X5' DEEP WOOD LINED CELLAR. TANK FIBERGLASS - NO LINING RUNNING TO IT (ABANDON)**  
**NO APPARENT EVIDENCE OF A RELEASE FROM THE BGT OBSERVED.**

DEPTH TO GROUNDWATER: **<50'** NEAREST WATER SOURCE: **>1,000'** NEAREST SURFACE WATER: **<1,000'** NMOCD TPH CLOSURE STD: **100** ppm
