Pit, Closed-Loop System, Below-Grade Tank, or
Proposed Alternative Method Permit or Closure Plan Application

BP AMERICA PRODUCTION COMPANY
SAN JUAN BASIN, NORTHWEST NEW MEXICO

BELOW-GRADE TANK CLOSURE PLAN

Fields LS 10

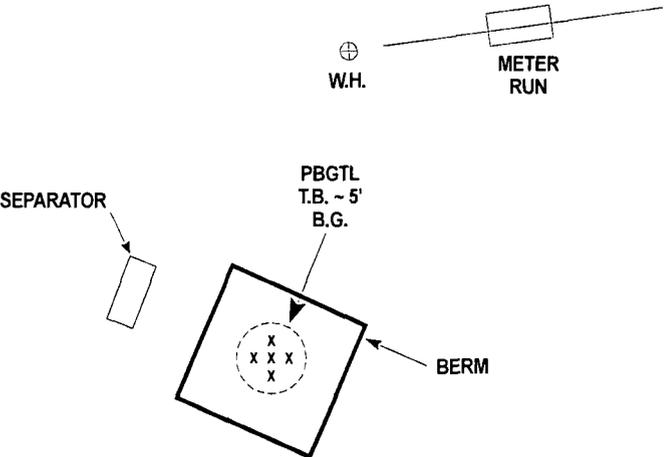
SOIL DESCRIPTION: SOIL TYPE: SAND / SILTY SAND / SILT / SILTY CLAY / CLAY / GRAVEL / OTHER **BEDROCK (SANDSTONE) @ 5.5'**
 SOIL COLOR: _____ PLASTICITY (CLAYS): NON PLASTIC / SLIGHTLY PLASTIC / COHESIVE / MEDIUM PLASTIC / HIGHLY PLASTIC
 COHESION (ALL OTHERS): NON COHESIVE / SLIGHTLY COHESIVE / COHESIVE / HIGHLY COHESIVE DENSITY (COHESIVE CLAYS & SILTS): SOFT / FIRM / STIFF / VERY STIFF / HARD
 CONSISTENCY (NON COHESIVE SOILS): LOOSE / FIRM / DENSE / VERY DENSE HC ODOR DETECTED: YES / NO EXPLANATION - _____
 MOISTURE: DRY / SLIGHTLY MOIST / MOIST / WET / SATURATED / SUPER SATURATED ANY AREAS DISPLAYING WETNESS: YES / NO EXPLANATION - _____
 SAMPLE TYPE: GRAB / COMPOSITE # OF PTS. **5** DISCOLORATION/STAINING OBSERVED: YES / NO EXPLANATION - _____

SITE OBSERVATIONS: LOST INTEGRITY OF EQUIPMENT: YES / NO EXPLANATION - _____
 APPARENT EVIDENCE OF A RELEASE OBSERVED AND/OR OCCURRED: YES / NO EXPLANATION: _____
 EQUIPMENT SET OVER RECLAIMED AREA: YES / NO EXPLANATION - _____
 OTHER: _____

SOIL IMPACT DIMENSION ESTIMATION: **NA** ft. X **NA** ft. X **NA** ft. EXCAVATION ESTIMATION (Cubic Yards): **NA**
 DEPTH TO GROUNDWATER: **>100'** NEAREST WATER SOURCE: **>1,000'** NEAREST SURFACE WATER: **<1,000'** NMOCD TPH CLOSURE STD: **1,000** ppm

SITE SKETCH BGT Located: off on site PLOT PLAN circle: **attached** OVM CALIB. READ. = **100.4** ppm RF=1.00
 OVM CALIB. GAS = **100** ppm
 TIME: **12:40** am/pm DATE: **01/28/14**
