Pit, Below-Grade Tank, or
Proposed Alternative Method Permit or Closure Plan Application

1.
Operator: BP America Production Company OGRID #: 778 OIL CONS. DIV DIST. 3
Address: 200 Energy Court, Farmington, NM 87401 MAY 27 2014
Facility or well name: Gallegos Canyon Unit 86E
API Number: 3004524958 OCD Permit Number:
U/L or Qtr/Qtr P Section 35 Township 29N Range 13W County: San Juan
Center of Proposed Design: Latitude 36.67848 Longitude -108.16984 NAD: ☐ 1927 ☒ 1983
Surface Owner: ☒ Federal ☐ State ☐ Private ☐ Tribal Trust or Indian Allotment

BELOW-GRADE TANK CLOSURE PLAN

Gallegos Canyon Unit 86E

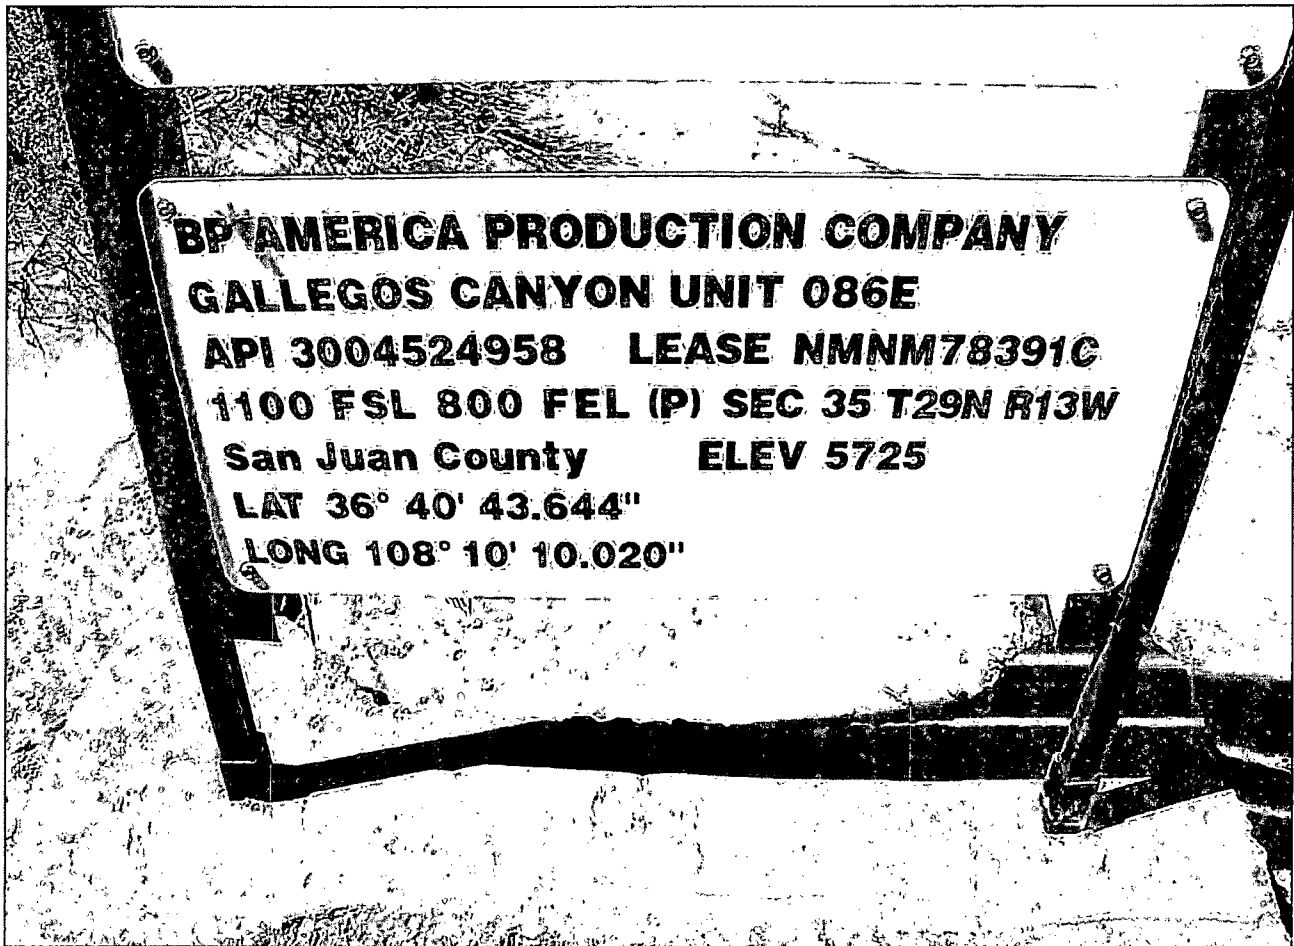
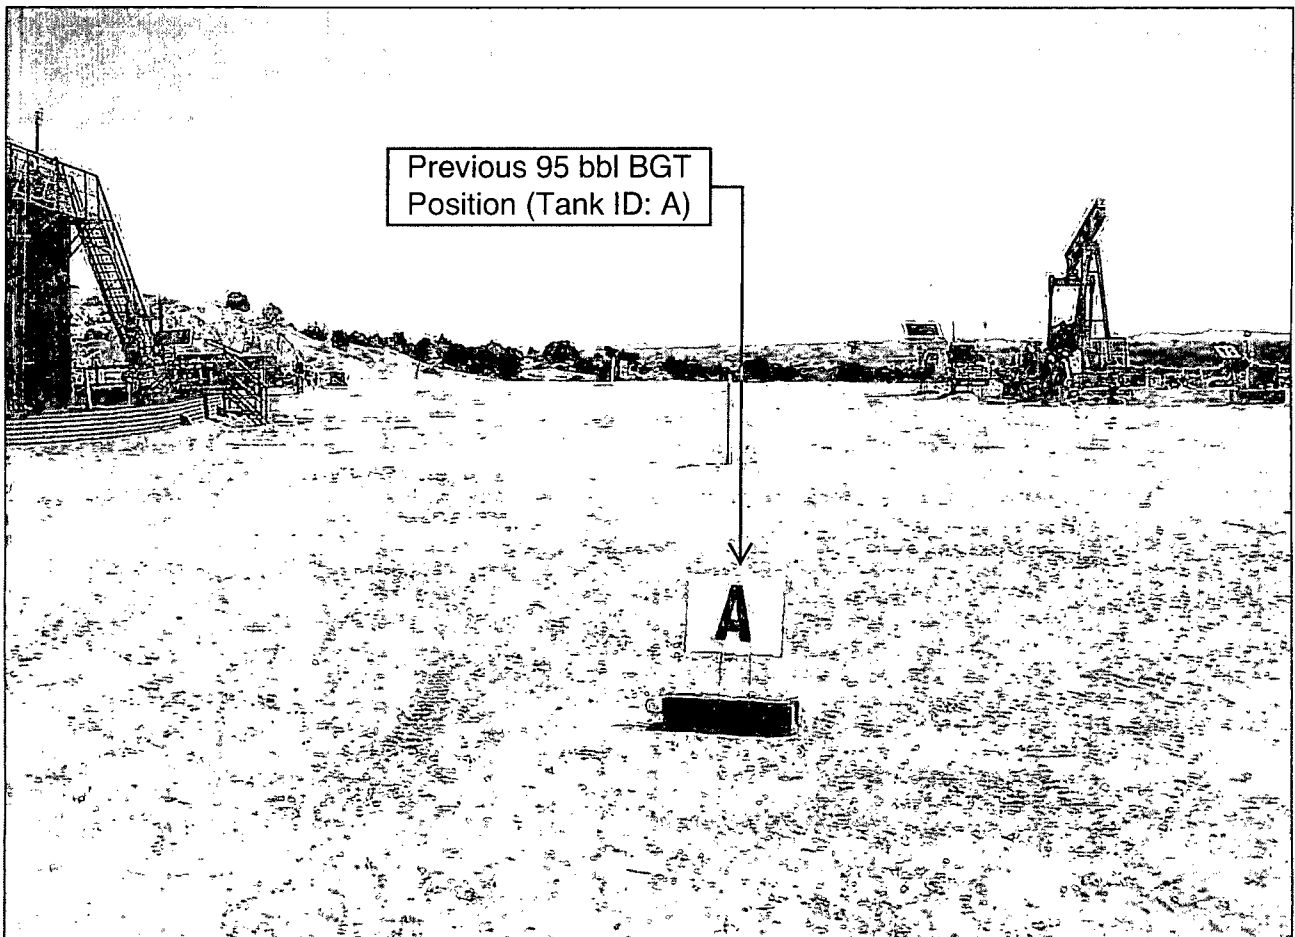
- ☐ Proof of Closure Notice (surface owner and division)
- ☐ Proof of Deed Notice (required for on-site closure for private land only)
- ☐ Plot Plan (for on-site closures and temporary pits)
- ☒ Confirmation Sampling Analytical Results (if applicable)
- ☒ Waste Material Sampling Analytical Results (required for on-site closure)
- ☒ Disposal Facility Name and Permit Number
- ☒ Soil Backfilling and Cover Installation
- ☐ Re-vegetation Application Rates and Seeding Technique
- ☒ Site Reclamation (Photo Documentation)

10. BP shall reclaim the BGT location and all areas associated with the BGT including associated access roads to a safe and stable condition that blends with the surrounding undisturbed area. BP shall substantially restore the impacted surface area to the condition that existed prior to oil and gas operations by placement of the soil cover as provided in Subsection H of 19.15.17.13 NMAC, re-contour the location and associated areas to a contour that approximates the original contour and blends with the surrounding topography and re-vegetate according to Subsection I of 19.15.17.13 NMAC.
The area over the BGT is still within the active well area. This area will be reclaimed when the well is plugged and abandoned as part of final reclamation.
