# NEW MEXICO ENERGY, MINERALS and NATURAL RESOURCES DEPARTMENT

## MECHANICAL INTEGRITY TEST REPORT

Date of Test 8-15-14 Operator Enurwest LP. API # 30-0 45-33583

Property Name Rio Bravo Well # 5 Location: Unit 7 Sec 27 Twn 31 Rge 13

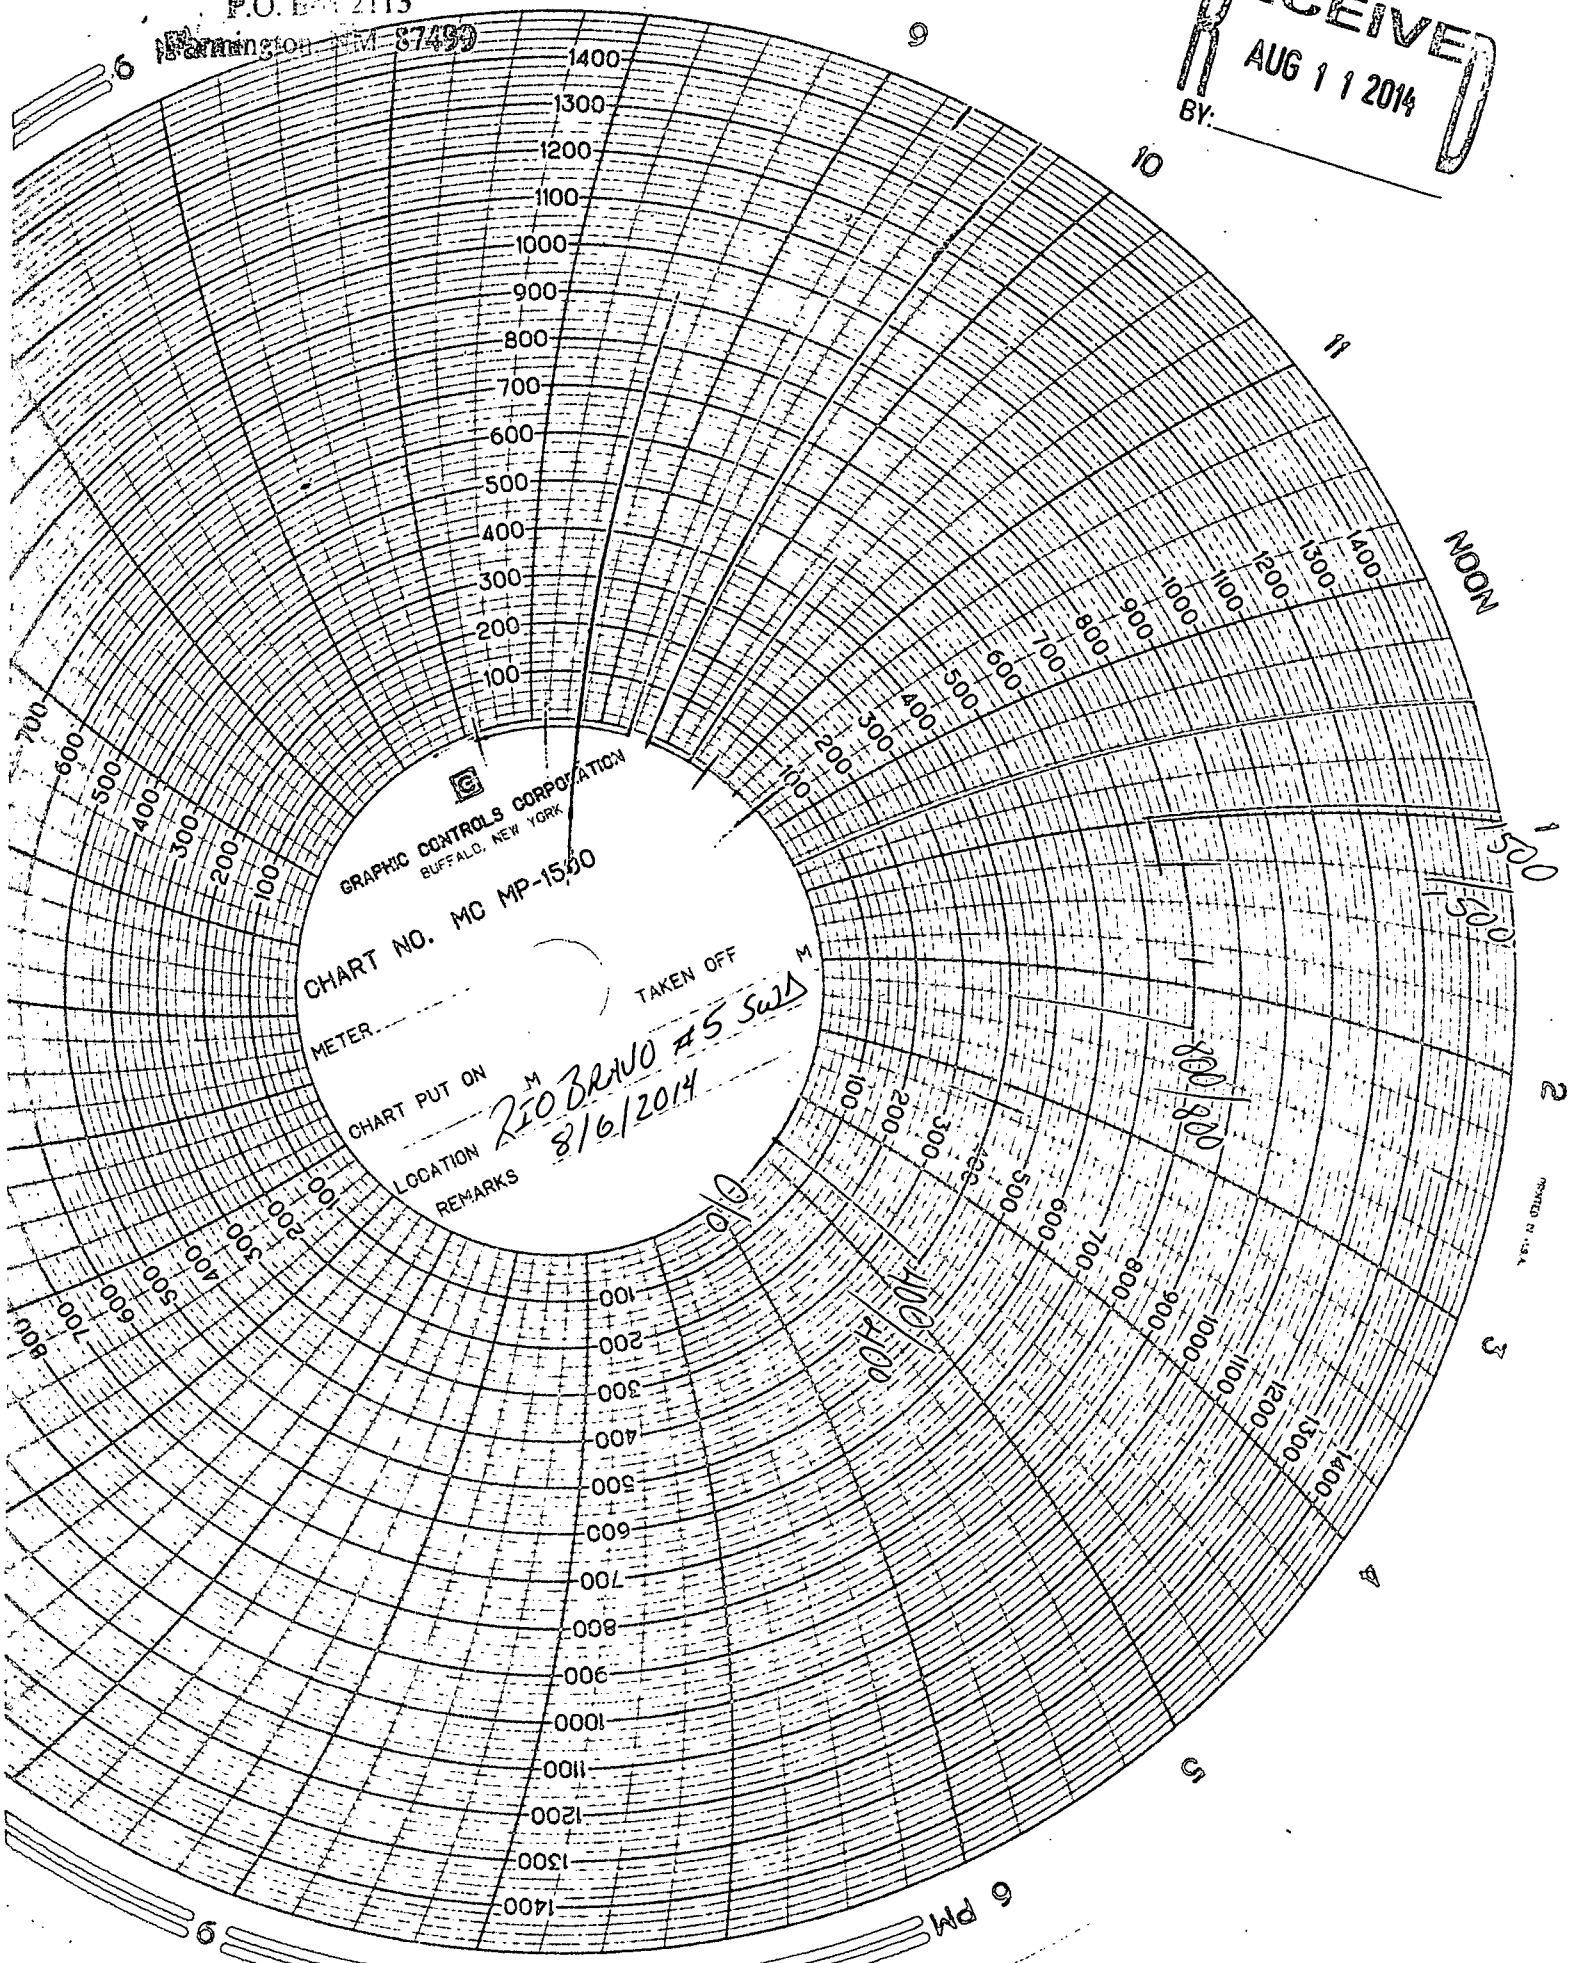
CHART NO. MC MP-1500

Pressured annulus up to 450 psi. for 30 mins. Test passed/failed passed OIL CONS. DIV. AUG 15 '14

RIO BRUNO #5 SW21  
8/6/2014
