Pit, Below-Grade Tank, or  
Proposed Alternative Method Permit or Closure Plan Application

1.  
Operator: BP America Production Company OGRID #: 778  
Address: 200 Energy Court, Farmington, NM 87401  
Facility or well name: Gallegos Canyon Unit 153E  
API Number: 3004524292 OCD Permit Number:  
U/L or Qtr/Qtr C Section 28 Township 29N Range 12W County: San Juan  
Center of Proposed Design: Latitude 36.70205 Longitude -108.10827 NAD: ☐ 1927 ☒ 1983  
Surface Owner: ☐ Federal ☐ State ☒ Private ☐ Tribal Trust or Indian Allotment

19.  
**Closure Report (required within 60 days of closure completion):** 19.15.17.13 NMAC

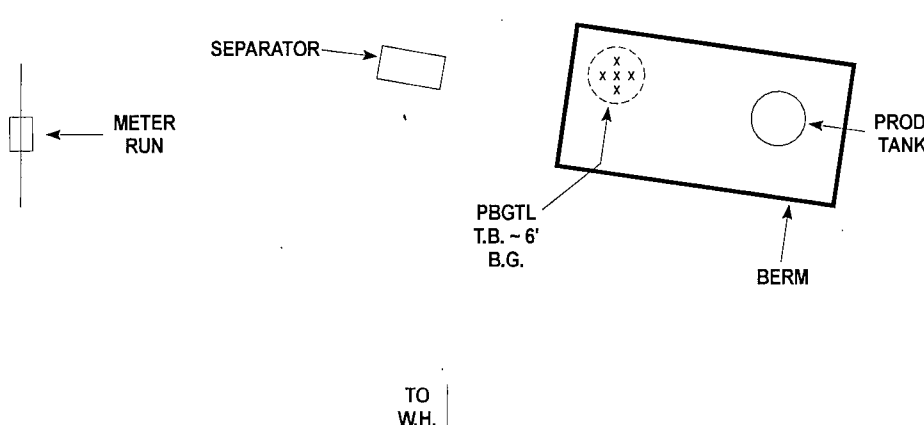
| <b>SOIL DESCRIPTION:</b> | SOIL TYPE: <b>SAND</b> / SILTY SAND / SILT / SILTY CLAY / CLAY / GRAVEL / OTHER<br>SOIL COLOR: <b>MODERATE BROWN</b><br>COHESION (ALL OTHERS): <b>NON COHESIVE</b> / SLIGHTLY COHESIVE / COHESIVE / HIGHLY COHESIVE<br>CONSISTENCY (NON COHESIVE SOILS): <b>LOOSE / FIRM</b> / DENSE / VERY DENSE<br>MOISTURE: DRY / <b>SLIGHTLY MOIST</b> / MOIST / WET / SATURATED / SUPER SATURATED<br>SAMPLE TYPE: GRAB <b>COMPOSITE</b> # OF PTS. <b>5</b><br>DISCOLORATION/STAINING OBSERVED: YES <b>NO</b> EXPLANATION - |

| <b>SITE OBSERVATIONS:</b> | LOST INTEGRITY OF EQUIPMENT: YES <b>NO</b> EXPLANATION -<br>APPARENT EVIDENCE OF A RELEASE OBSERVED AND/OR OCCURRED: YES <b>NO</b> EXPLANATION:<br>EQUIPMENT SET OVER RECLAIMED AREA: <b>YES</b> NO EXPLANATION - <b>LOW PROFILE ABOVE-GRADE TANK TO BE PARTIALLY SET ATOP BGT POSITION.</b><br>OTHER: |

| <b>SITE SKETCH</b> | BGT Located: off <input checked="" type="checkbox"/> on site PLOT PLAN circle: <b>attached</b><br> |
