1.
Operator: BP America Production Company _____ OGRID #: 778 _____
Address: 200 Energy Court, Farmington, NM 87401 _____
Facility or well name: Gallegos Canyon Unit 96E _____
API Number: 3004525213 _____ OCD Permit Number: _____
U/L or Qtr/Qtr B _____ Section 18 _____ Township 29N _____ Range 12W _____ County: San Juan _____
Center of Proposed Design: Latitude 36.73107 _____ Longitude -108.13593 _____ NAD: 1927 1983
Surface Owner: Federal State Private Tribal Trust or Indian Allotment

BELOW-GRADE TANK CLOSURE PLAN

Gallegos Canyon Unit 96E

API No. 3004525213

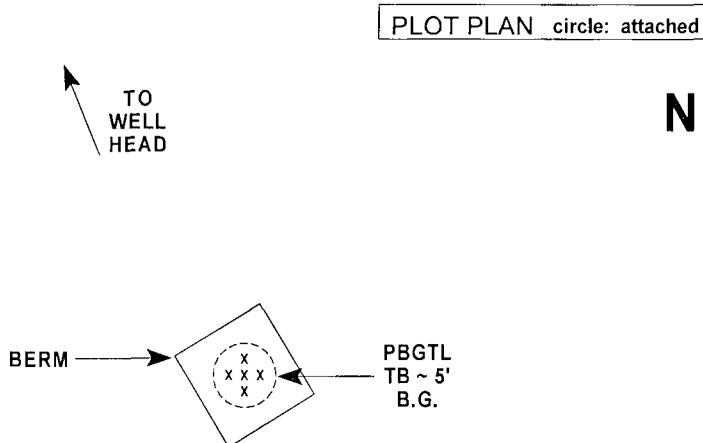
SITE SKETCH

SOIL DESCRIPTION: SOIL TYPE: **SAND** / SILTY SAND / SILT / SILTY CLAY / CLAY / GRAVEL / **OTHER** **BEDROCK**
 SOIL COLOR: _____
 COHESION (ALL OTHERS): **NON COHESIVE** / SLIGHTLY COHESIVE / COHESIVE / HIGHLY COHESIVE
 CONSISTENCY (NON COHESIVE SOILS): **LOOSE / FIRM** / DENSE / VERY DENSE
 MOISTURE: DRY / **SLIGHTLY MOIST** / MOIST / WET / SATURATED / SUPER SATURATED
 SAMPLE TYPE: GRAB / **COMPOSITE** - # OF PTS. **5**
 DISCOLORATION/STAINING OBSERVED: **YES** / NO EXPLANATION - **LIGHT GRAY @ BEDROCK SURFACE.**

ANY AREAS DISPLAYING WETNESS: YES / **NO** EXPLANATION - _____
 APPARENT EVIDENCE OF A RELEASE OBSERVED AND/OR OCCURRED: **Y** / N EXPLANATION: **ASSUMED DISCOLORATION OBSERVED FROM BGT.**
 ADDITIONAL COMMENTS: _____

EXCAVATION DIMENSIONS (if applicable): **NA** ft. X **NA** ft. X **NA** ft. cubic yards excavated (if applicable): **NA**
 DEPTH TO GROUNDWATER: **<100'** NEAREST WATER SOURCE: **>1,000'** NEAREST SURFACE WATER: **>1,000'** NMOCD TPH CLOSURE STD: **1,000** PPM
