Operator: BP America Production Company OGRID #: 778  
Address: 200 Energy Court, Farmington, NM 87401  
Facility or well name: Gallegos Canyon Unit 247E  
API Number: 3004526335 OCD Permit Number:  
U/L or Qtr/Qtr P Section 5 Township 27N Range 12W County: San Juan  
Center of Proposed Design: Latitude 36.59958 Longitude -108.12948 NAD: ☐ 1927 ☒ 1983 Surface  
Owner: ☐ Federal ☐ State ☐ Private ☒ Tribal Trust or Indian Allotment

BELOW-GRADE TANK CLOSURE PLAN

Gallegos Canyon Unit 247E  
API No. 3004526335  
Unit Letter P, Section 5, T27N, R12W

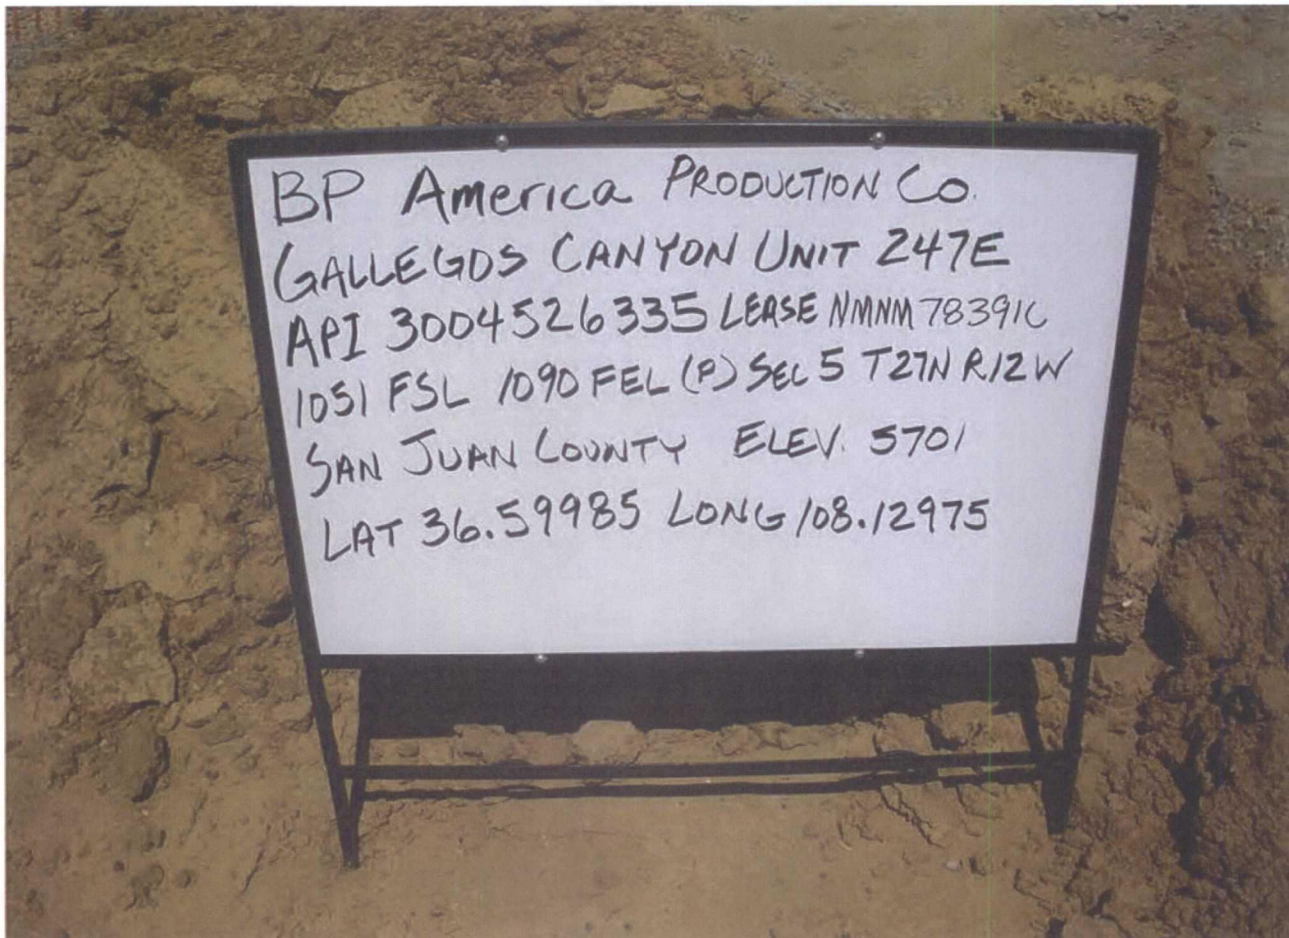
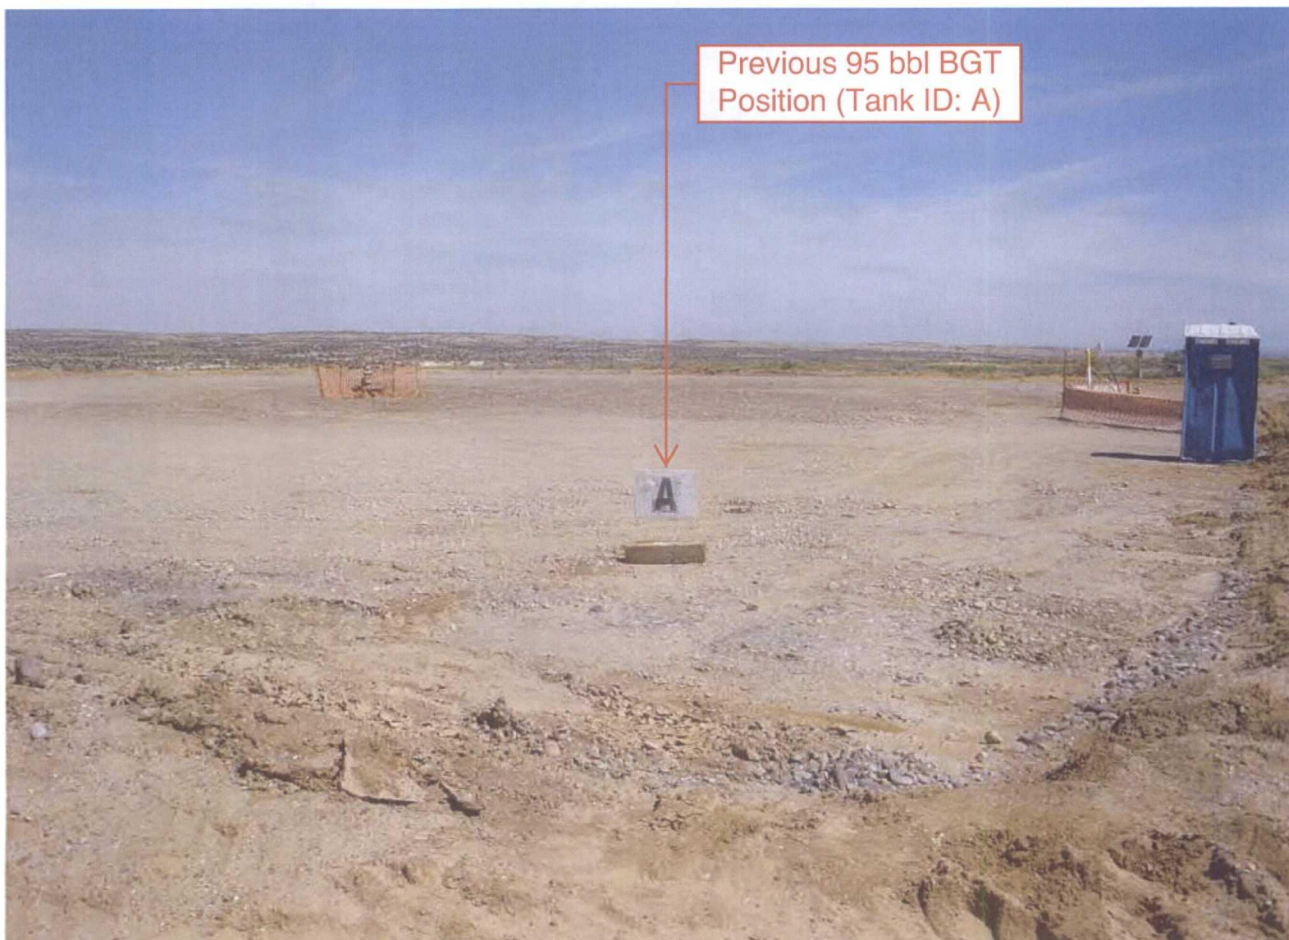
- ☒ Proof of Closure Notice (surface owner and division)  
☐ Proof of Deed Notice (required for on-site closure for private land only)  
☐ Plot Plan (for on-site closures and temporary pits)  
☒ Confirmation Sampling Analytical Results (if applicable)  
☐ Waste Material Sampling Analytical Results (required for on-site closure)  
☒ Disposal Facility Name and Permit Number  
☒ Soil Backfilling and Cover Installation  
☐ Re-vegetation Application Rates and Seeding Technique  
☒ Site Reclamation (Photo Documentation)

10. BP shall reclaim the BGT location and all areas associated with the BGT including associated access roads to a safe and stable condition that blends with the surrounding undisturbed area. BP shall substantially restore the impacted surface area to the condition that existed prior to oil and gas operations by placement of the soil cover as provided in Subsection H of 19.15.17.13 NMAC, re-contour the location and associated areas to a contour that approximates the original contour and blends with the surrounding topography and re-vegetate according to Subsection I of 19.15.17.13 NMAC.
