Proposed Alternative Method Permit or Closure Plan Application

BP AMERICA PRODUCTION COMPANY  
SAN JUAN BASIN, NORTHWEST NEW MEXICO

BELOW-GRADE TANK CLOSURE PLAN

Sellers LS 1

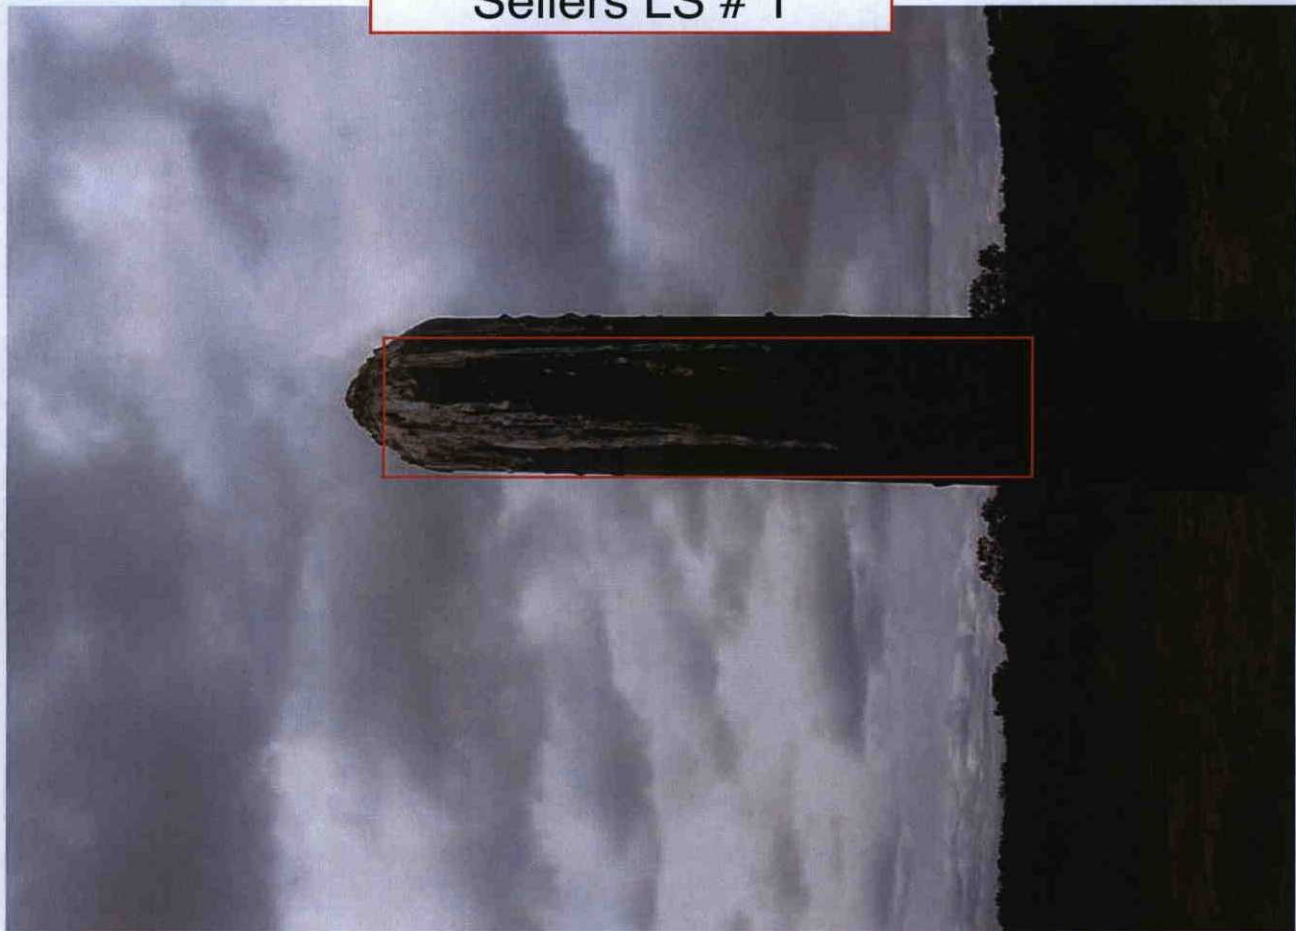
Sellers LS # 1

Plugged &  
Abandoned Marker

**The area of the BGT was backfilled with clean soil and has been reclaimed. The well has been plugged and abandoned and NMOCD has released the site.**

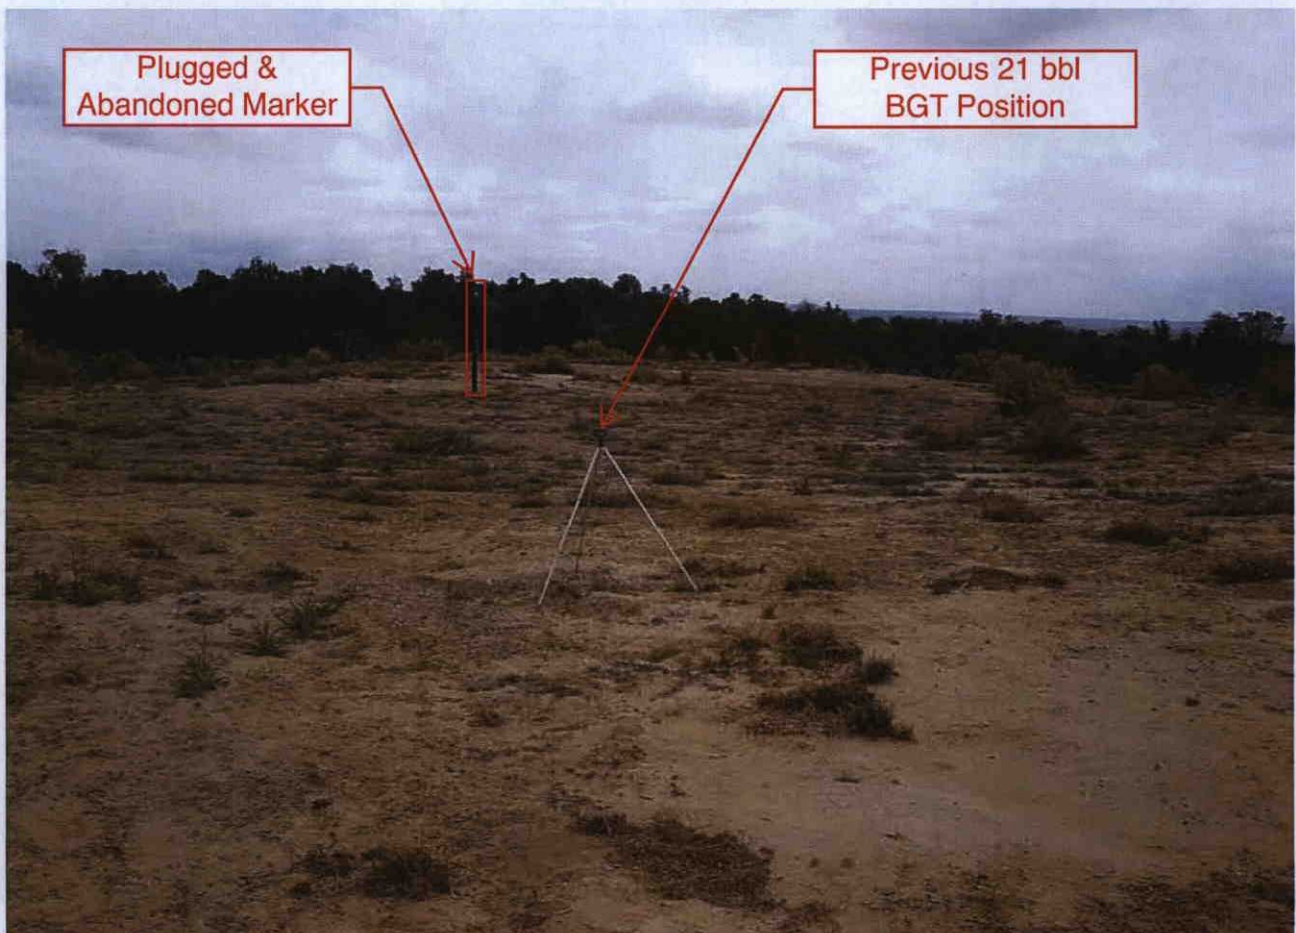
Previous 21 bbl  
BGT Position
