12831 Pit, Below-Grade Tank, or
Proposed Alternative Method Permit or Closure Plan Application

BELOW-GRADE TANK CLOSURE PLAN

Mudge C 1E

API No. 3004524719

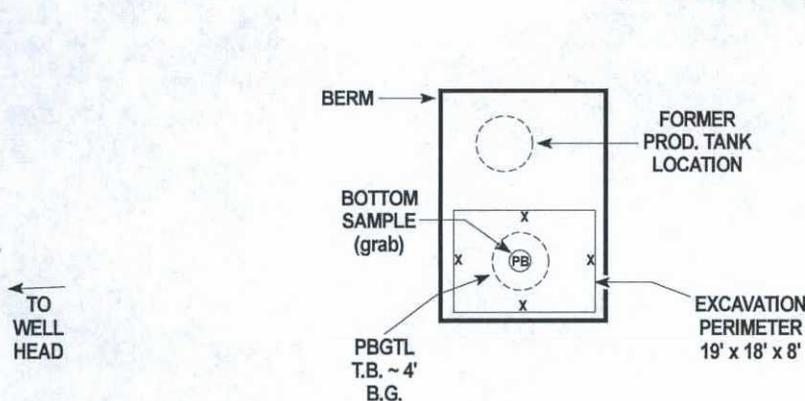
PLOT PLAN
circle: **Attached**

DISCOLORATION/STAINING OBSERVED: YES NO EXPLANATION - **MEDIUM GRAY TO BLACK**
