Release Notification and Corrective Action

**Rosa Unit #379 Produced Water Release Report**  
Unit Letter K, Section 8, Township 31N, Range 5W  
Rio Arriba County, NM

July 11, 2016

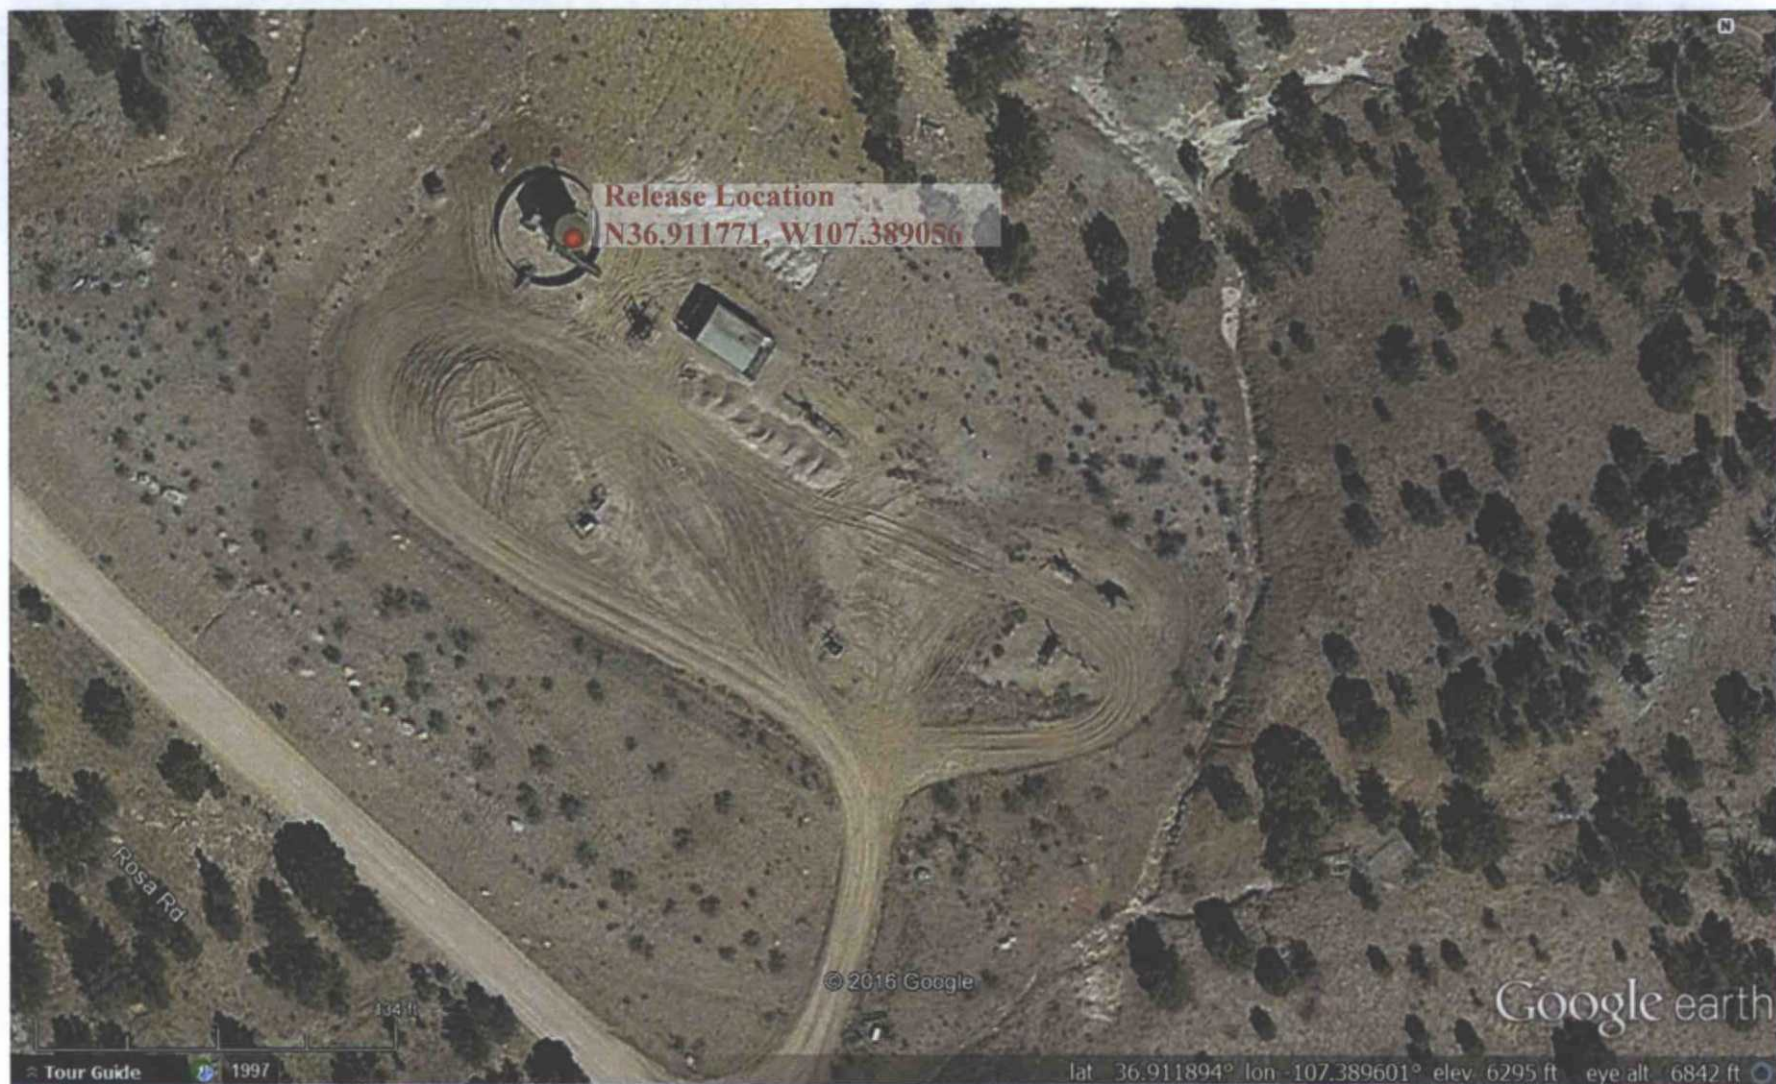
**Figure 2. Aerial Photograph  
December 2015 and February 2016  
Rosa Unit #379 Produced Water Release  
Section 8, Township 31N, Range 5W  
N36.9113846, W107.3889694  
Rio Arriba County, NM**

A topographic map of the location is included as Figure 1 and an aerial site map is included as Figure 2.

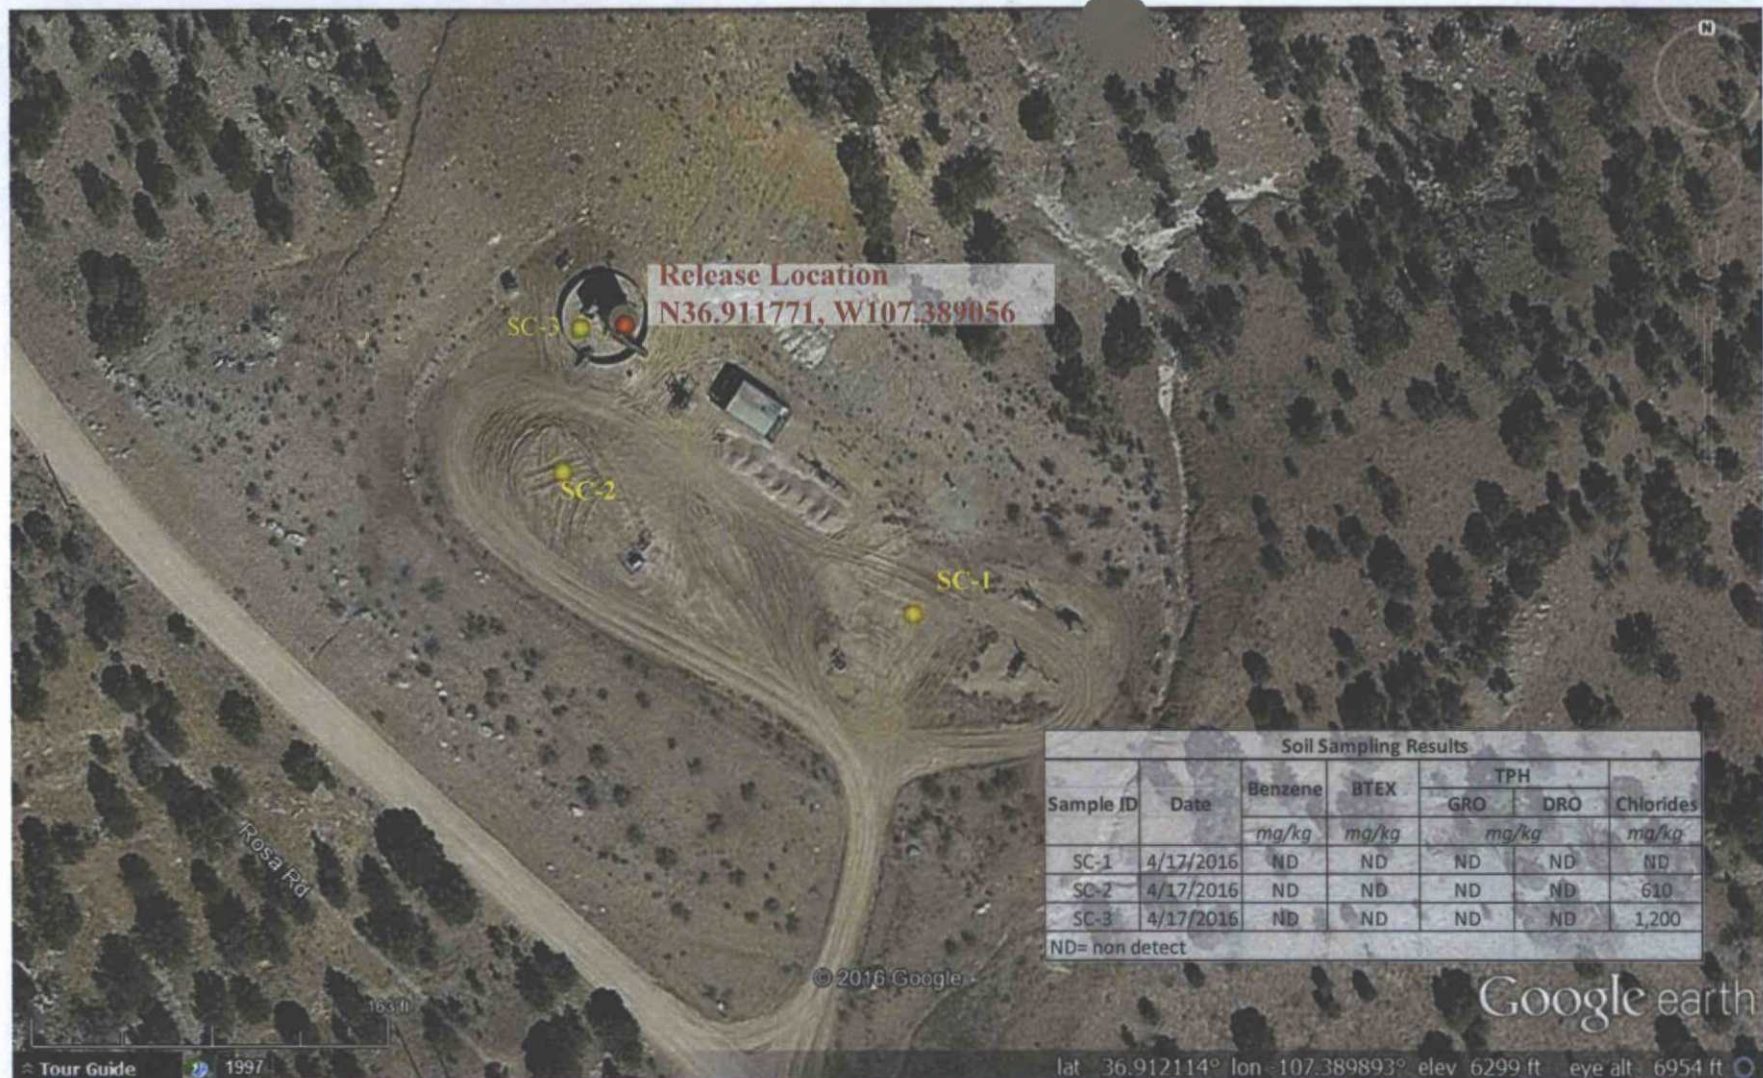
Figure 3. Soil Analytical Map

Laboratory analytical results for soil confirmation samples (SC-1 through SC-3) reported benzene and BTEX concentrations below NMOCD action levels of 10 mg/kg and 50 mg/kg, respectively. All soil confirmation samples reported TPH concentrations below NMOCD action level of 100 mg/kg. Action levels are based on a NMOCD site ranking of 30. Chloride concentrations were reported at less than 30 mg/kg (SC-1), 610 mg/kg (SC-2), and 1,200 mg/kg (SC-3).

**Figure 3. Soil Analytical Map**  
**December 2015 and February 2016**  
**Rosa Unit #379 Produced Water Release**  
 Section 8, Township 31N, Range 5W  
 N36.9113846, W107.3889694  
 Rio Arriba County, NM
