Pit, Below-Grade Tank, or  
Proposed Alternative Method Permit or Closure Plan Application

BP AMERICA PRODUCTION COMPANY  
SAN JUAN BASIN, NORTHWEST NEW MEXICO

BELOW-GRADE TANK CLOSURE PLAN

FLORANCE GAS COM B 001  
API No. 3004508586  
Unit Letter H, Section 09, T29N, R12W

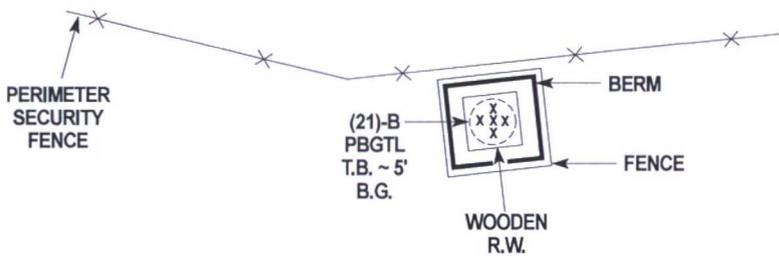
SITE SKETCH	BGT Located: off <input checked="" type="checkbox"/> on site	PLOT PLAN circle: <input checked="" type="checkbox"/> attached	OVM CALIB. READ. = <b>52.5</b> ppm RF=0.52
			OVM CALIB. GAS = <b>100</b> ppm
			TIME: <b>9:50</b> am/pm DATE: <b>05/02/16</b>

SITE OBSERVATIONS:	LOST INTEGRITY OF EQUIPMENT: YES <input type="checkbox"/> NO <input checked="" type="checkbox"/> EXPLANATION - _____
APPARENT EVIDENCE OF A RELEASE OBSERVED AND/OR OCCURRED: YES <input type="checkbox"/> NO <input checked="" type="checkbox"/> EXPLANATION: _____	
EQUIPMENT SET OVER RECLAIMED AREA: YES <input type="checkbox"/> NO <input checked="" type="checkbox"/> EXPLANATION - _____	
OTHER: <b>BGT ACTUAL CONSTRUCTION WERE SW/DB.</b>

SOIL IMPACT DIMENSION ESTIMATION: <b>NA</b> ft. X <b>NA</b> ft. X <b>NA</b> ft.	EXCAVATION ESTIMATION (Cubic Yards): <b>NA</b>
DEPTH TO GROUNDWATER: <b>&gt;100'</b>	NEAREST WATER SOURCE: <b>&gt;1,000'</b> NEAREST SURFACE WATER: <b>&lt;1,000'</b> NMOCD TPH CLOSURE STD: <b>1,000</b> ppm
