Pit, Below-Grade Tank, or
Proposed Alternative Method Permit or Closure Plan Application

BELOW-GRADE TANK CLOSURE PLAN

GALLEGOS CANYON UNIT 347

API No. 3004526134

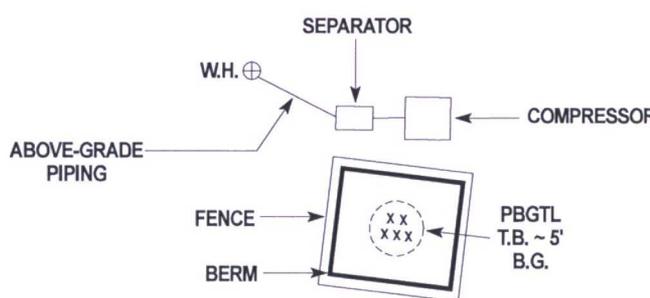
SITE SKETCH	BGT Located: off / <input checked="" type="checkbox"/> on site	PLOT PLAN circle: attached
		OVM CALIB. READ. = NA ppm RF = 0.52
		OVM CALIB. GAS = NA ppm
		TIME: NA am/pm DATE: NA

SITE OBSERVATIONS:	LOST INTEGRITY OF EQUIPMENT: YES / <input checked="" type="checkbox"/> NO EXPLANATION -
APPARENT EVIDENCE OF A RELEASE OBSERVED AND/OR OCCURRED: YES / <input checked="" type="checkbox"/> NO EXPLANATION -	
EQUIPMENT SET OVER RECLAIMED AREA: YES / <input checked="" type="checkbox"/> NO EXPLANATION -	
OTHER: BEDROCK ENCOUNTERED @ 5.5 FT. BELOW GRADE. SANDSTONE - OLIVE GRAY IN COLOR. OCD & BLM REPS ON-SITE TO WITNESS

SAMPLE COLLECTION.	SOIL IMPACT DIMENSION ESTIMATION: NA ft. X NA ft. X NA ft. EXCAVATION ESTIMATION (Cubic Yards): NA
	DEPTH TO GROUNDWATER: >100' NEAREST WATER SOURCE: >1,000' NEAREST SURFACE WATER: <1,000' NMOCD TPH CLOSURE STD: 1,000 ppm

Describe Cause of Problem and Remedial Action Taken.* Sampling of the soil beneath the BGT was done during removal. Soil analysis resulted for BTEX and TPH below BGT closure standards. Chloride concentrations were elevated, but at a depth of 5 feet below ground surface with an estimated depth to groundwater of >100' the levels pose no significant threat to surface or groundwater. Field reports and laboratory results are attached.
