Pit, Below-Grade Tank, or
Proposed Alternative Method Permit or Closure Plan Application

BP AMERICA PRODUCTION COMPANY
SAN JUAN BASIN, NORTHWEST NEW MEXICO

BELOW-GRADE TANK CLOSURE PLAN

Florance Z 040A
API No. 3004522145
Unit Letter I, Section 21, T30N, R08W

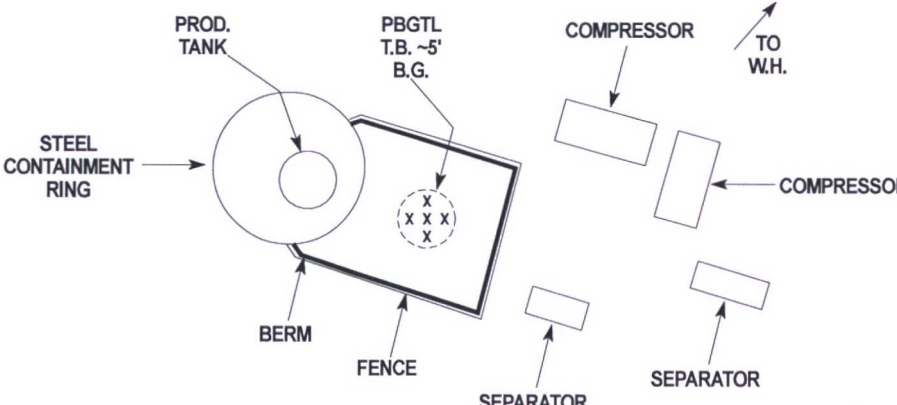
SITE SKETCH	BGT Located: off <u>on</u> site PLOT PLAN circle: <u>attached</u>

SITE OBSERVATIONS:	LOST INTEGRITY OF EQUIPMENT: YES <u>NO</u> EXPLANATION - APPARENT EVIDENCE OF A RELEASE OBSERVED AND/OR OCCURRED: YES <u>NO</u> EXPLANATION: EQUIPMENT SET OVER RECLAIMED AREA: <u>YES</u> / NO EXPLANATION - 105 BBL SHALLOW LOW PROFILE ABOVE-GRADE TANK TO BE SET ATOP BGT LOCATION. OTHER: WELL PAD SHARED WITH BP'S FLORANCE Z # 3S GAS WELL. NMOCD REP. PRESENT TO WITNESS CONFIRMATION SAMPLING.
---------------------------	--

SOIL IMPACT DIMENSION ESTIMATION: NA ft. X NA ft. X NA ft.	EXCAVATION ESTIMATION (Cubic Yards): NA DEPTH TO GROUNDWATER: >100' NEAREST WATER SOURCE: >1,000' NEAREST SURFACE WATER: <1,000' NMOCD TPH CLOSURE STD: 1,000 ppm
---	--
