**Barnes LS 007M**

MV/DK  
API #: 300453249100  
Unit E - Sec. 23 - T32N - R11W  
San Juan, NM

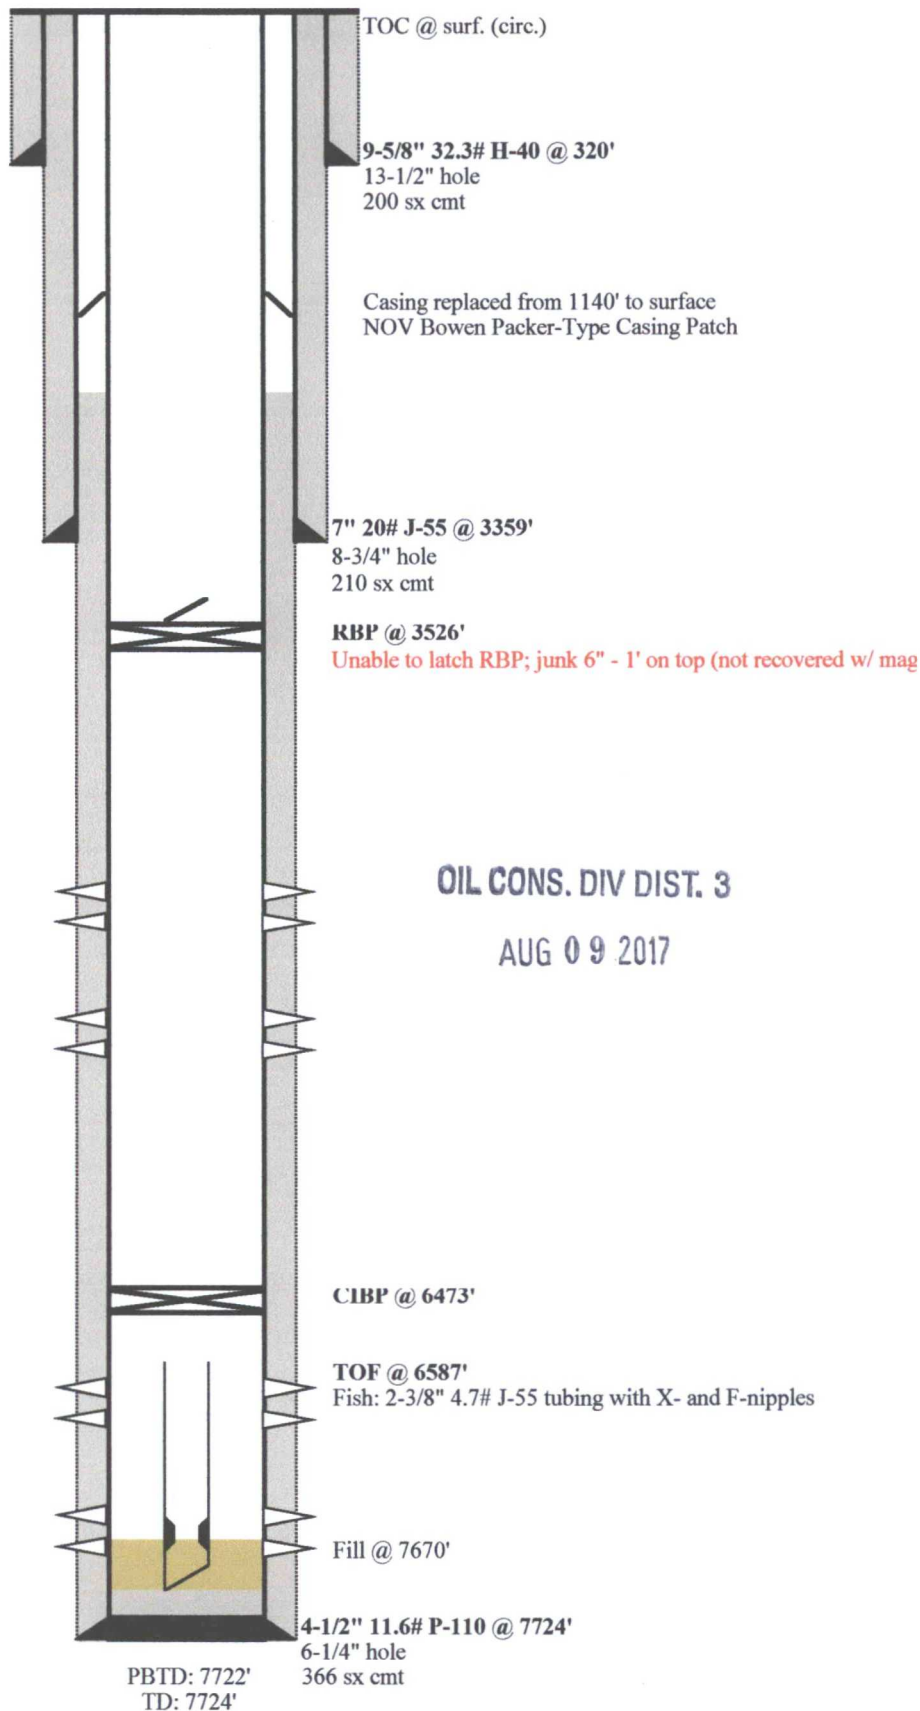
**Mesa Verde Perforations**

5005' - 5225' 4 jspf  
Frac'd w/ 11k# 40/70, 144k# 16/30, 70Q foam

5285' - 5358' 3 jspf  
5369' - 5472' 4 jspf  
Frac'd w/ 8k# 40/70, 140k# 16/30, 70Q foam

**Dakota Perforations**

7573' - 7486' 3 jspf  
7709' - 7585' 4 jspf  
Frac'd w/ 96k# carbolite & 65Q foam (SO)

GL: 6324'  
KB: 12'
