Pit, Below-Grade Tank, or  
Proposed Alternative Method Permit or Closure Plan Application

**BELOW-GRADE TANK CLOSURE PLAN**

**FLORANCE U 006**

**API No. 3004509284**

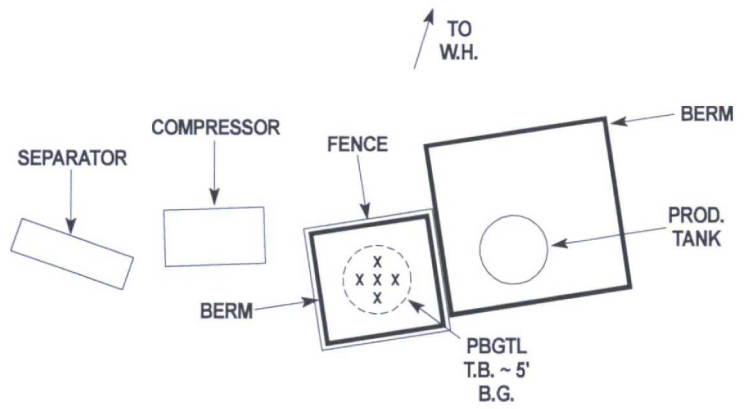
<b>SITE SKETCH</b>	BGT Located: off <b>on</b> site PLOT PLAN circle: <b>attached</b>

<b>SOIL DESCRIPTION:</b>	SOIL TYPE: <b>SAND / SILTY SAND</b> SILT / SILTY CLAY / CLAY / GRAVEL / OTHER SOIL COLOR: <b>DARK YELLOWISH ORANGE</b> COHESION (ALL OTHERS): <b>NON COHESIVE / SLIGHTLY COHESIVE</b> COHESIVE / HIGHLY COHESIVE CONSISTENCY (NON COHESIVE SOILS): <b>LOOSE / FIRM</b> DENSE / VERY DENSE MOISTURE: DRY / <b>SLIGHTLY MOIST</b> MOIST / WET / SATURATED / SUPER SATURATED SAMPLE TYPE: GRAB / <b>COMPOSITE</b> # OF PTS. <b>5</b> DISCOLORATION/STAINING OBSERVED: <b>YES</b> NO EXPLANATION - <b>RUST STAINS FROM BGT IN SMALL ISOLATED PATCHES BENEATH BGT BOTTOM.</b>
--------------------------	--

<b>SITE OBSERVATIONS:</b>	LOST INTEGRITY OF EQUIPMENT: YES <b>NO</b> EXPLANATION - APPARENT EVIDENCE OF A RELEASE OBSERVED AND/OR OCCURRED: YES <b>NO</b> EXPLANATION: EQUIPMENT SET OVER RECLAIMED AREA: <b>YES</b> NO EXPLANATION - <b>105 BBL SHALLOW LOW PROFILE ABOVE-GRADE TANK TO BE SET ATOP BGT LOCATION.</b> OTHER: <b>NMOCD &amp; BLM REPS. PRESENT TO WITNESS CONFIRMATION SAMPLING.</b>
---------------------------	---

SOIL IMPACT DIMENSION ESTIMATION: <b>NA</b> ft. X <b>NA</b> ft. X <b>NA</b> ft. EXCAVATION ESTIMATION (Cubic Yards): <b>NA</b> DEPTH TO GROUNDWATER: <b>&gt;100'</b> NEAREST WATER SOURCE: <b>&gt;1,000'</b> NEAREST SURFACE WATER: <b>&lt;1,000'</b> NMOCD TPH CLOSURE STD: <b>1,000</b> ppm
--

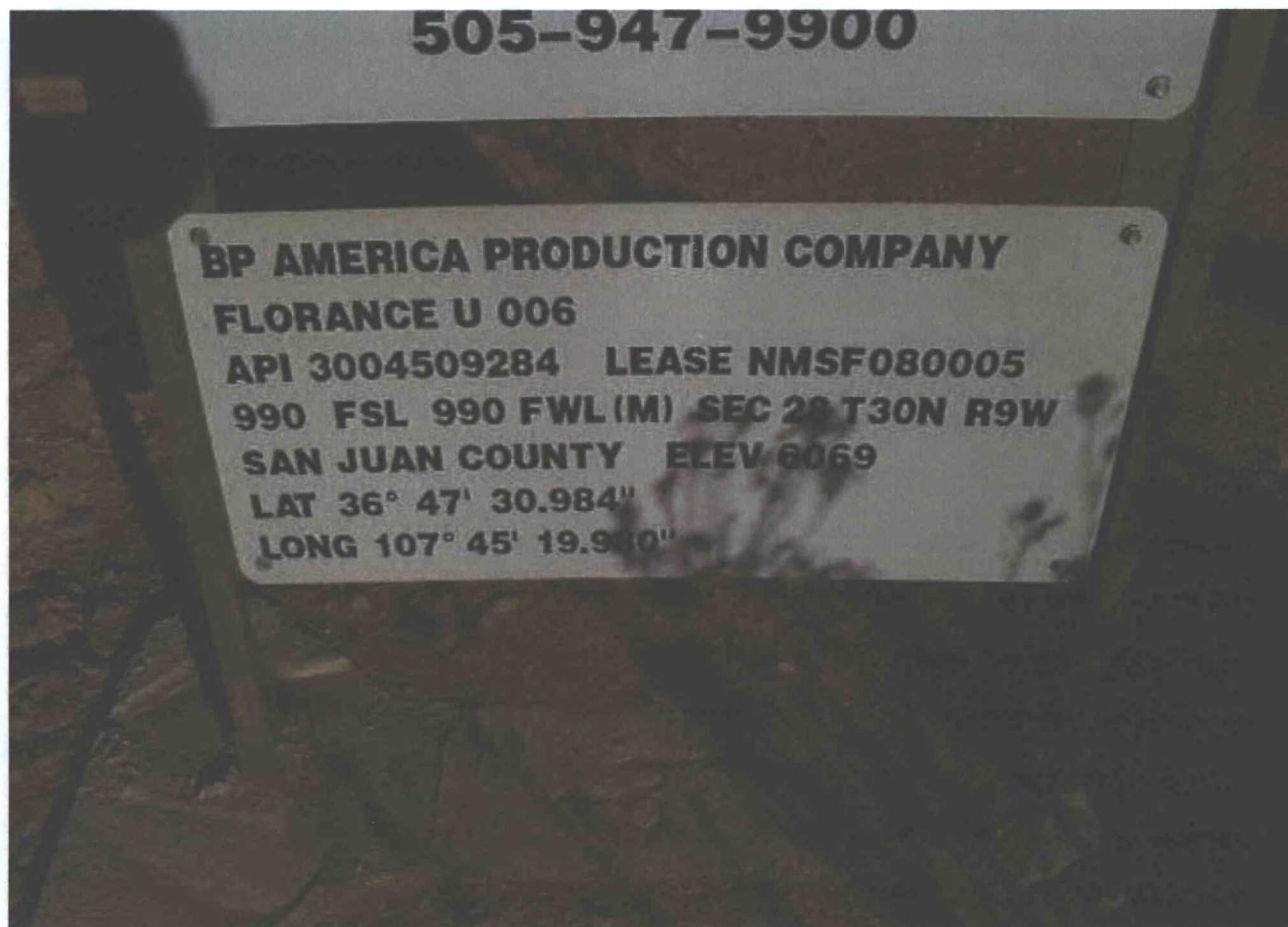
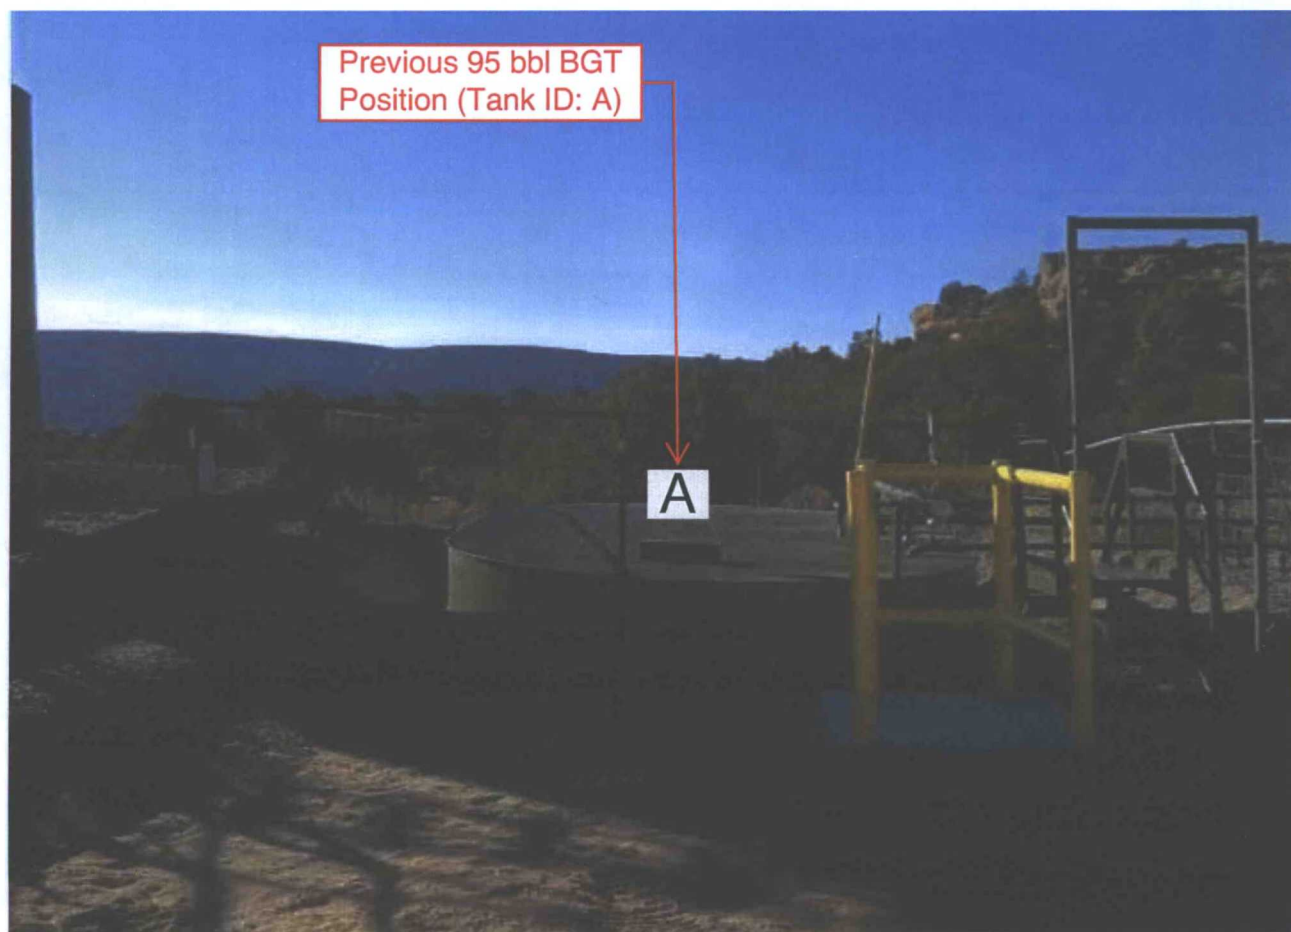
- d. details on back-filling, capping, covering, and where applicable re-vegetation application rates and seeding techniques and
  - e. site reclamation, photo documentation.**BP did not meet the 60 closure completion requirement due to an error in internal tracking. Closure report on C-144 form is included including photos of reclamation completion.**
