15992  
Pit, Below-Grade Tank, or  
Proposed Alternative Method Permit or Closure Plan Application

**BP AMERICA PRODUCTION COMPANY**  
**SAN JUAN BASIN, NORTHWEST NEW MEXICO**

**BELOW-GRADE TANK CLOSURE PLAN**

**Fields A 004A**

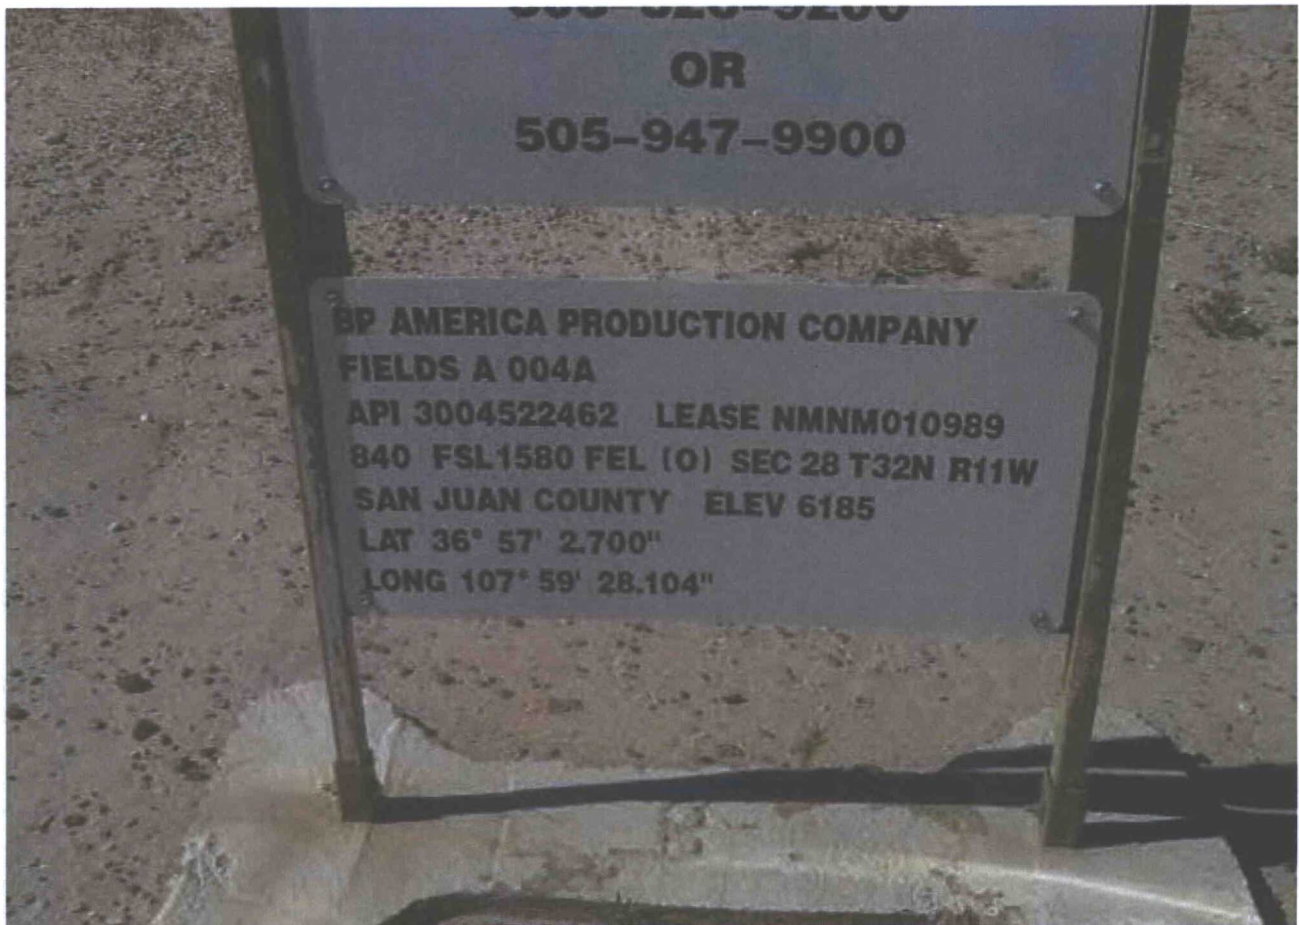
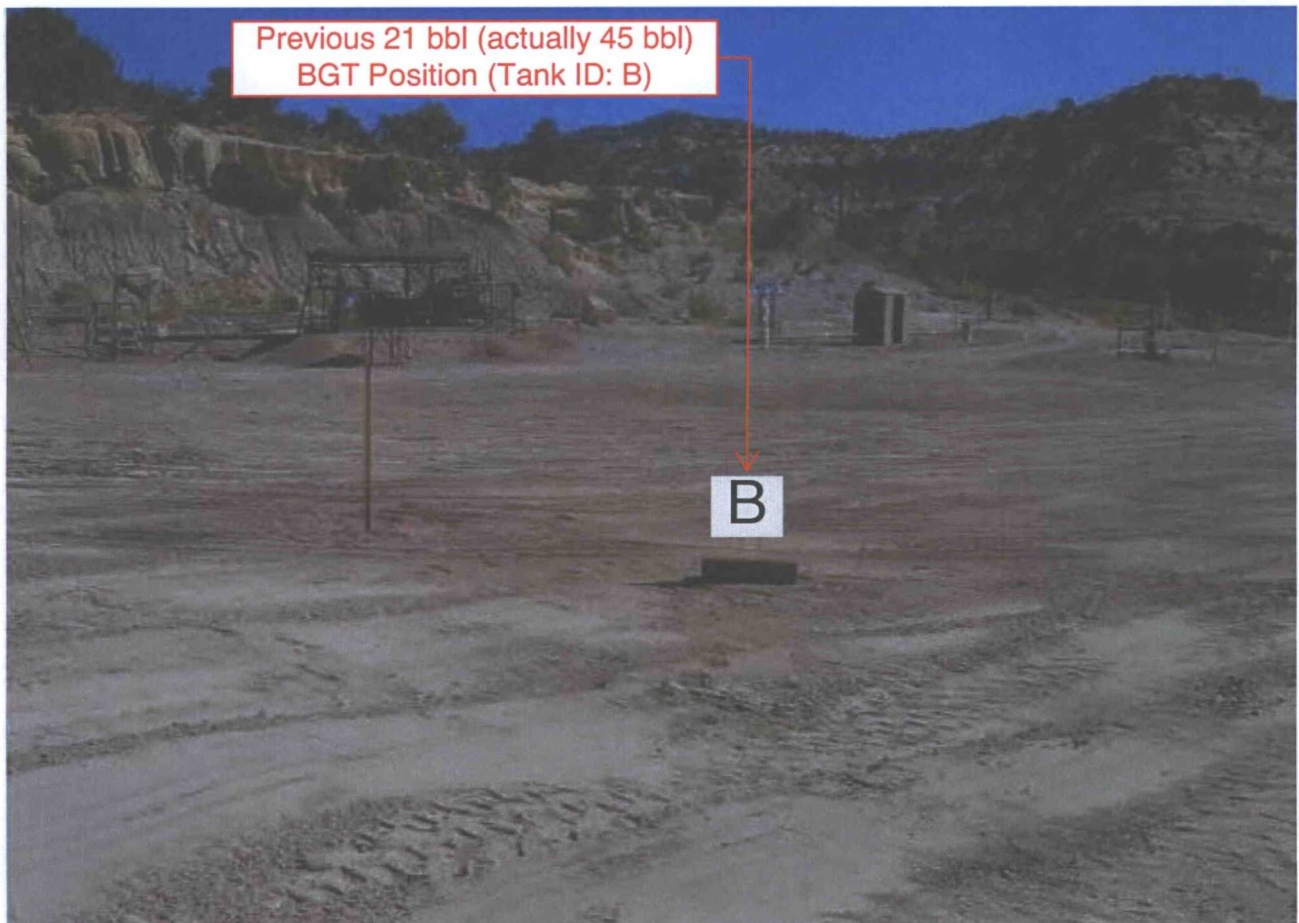
| <input checked="" type="checkbox"/> Site Reclamation (Photo Documentation) |

10. BP shall reclaim the BGT location and all areas associated with the BGT including associated access roads to a safe and stable condition that blends with the surrounding undisturbed area. BP shall substantially restore the impacted surface area to the condition that existed prior to oil and gas operations by placement of the soil cover as provided in Subsection H of 19.15.17.13 NMAC, re-contour the location and associated areas to a contour that approximates the original contour and blends with the surrounding topography and re-vegetate according to Subsection I of 19.15.17.13 NMAC.
