Pit, Below-Grade Tank, or  
Proposed Alternative Method Permit or Closure Plan Application

Facility or well name: Atlantic B LS 004B

**BELOW-GRADE TANK CLOSURE PLAN**

**Atlantic B LS #4B**

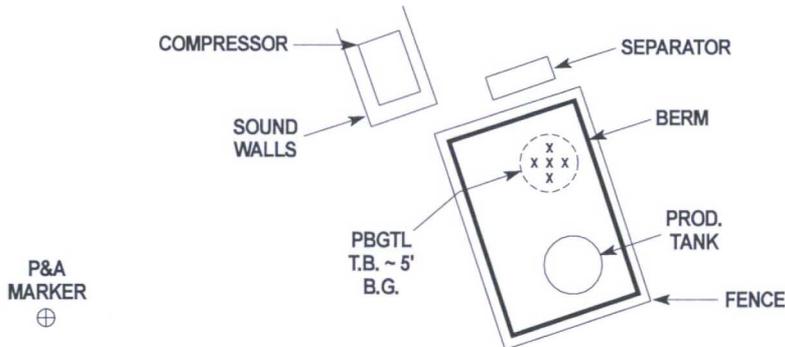
SITE SKETCH BGT Located: off  on site PLOT PLAN circle: **attached**

OVM CALIB. READ. = **100.4** ppm RF=1.00  
OVM CALIB. GAS = **100** ppm  
TIME: **12:30** am/pm DATE: **06/23/17**

**X - S.P.D.**
