Pit, Below-Grade Tank, or  
Proposed Alternative Method Permit or Closure Plan Application

BP AMERICA PRODUCTION COMPANY  
SAN JUAN BASIN, NORTHWEST NEW MEXICO

BELOW-GRADE TANK CLOSURE PLAN

**HUBBARD LS 003**

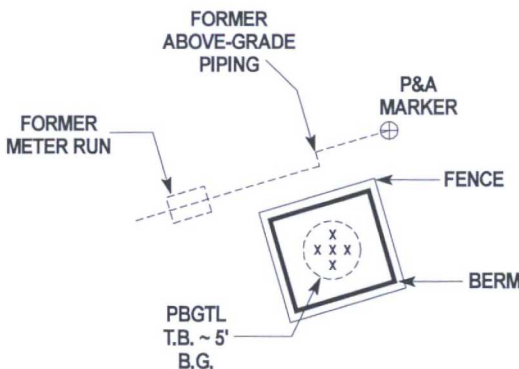
<b>SITE OBSERVATIONS:</b> LOST INTEGRITY OF EQUIPMENT: YES <u>NO</u> EXPLANATION - _____ APPARENT EVIDENCE OF A RELEASE OBSERVED AND/OR OCCURRED: YES <u>NO</u> EXPLANATION: _____ EQUIPMENT SET OVER RECLAIMED AREA: YES <u>NO</u> EXPLANATION - _____ OTHER: <b>GAS WELL RECENTLY PLUGGED &amp; ABANDONED (P&amp;A).</b>		
EXCAVATION DIMENSION ESTIMATION: <b>NA</b> ft. X <b>NA</b> ft. X <b>NA</b> ft. EXCAVATION ESTIMATION (Cubic Yards): <b>NA</b> DEPTH TO GROUNDWATER: <b>&lt;100'</b> NEAREST WATER SOURCE: <b>&gt;1,000'</b> NEAREST SURFACE WATER: <b>&gt;1,000'</b> NMOCD TPH CLOSURE STD: <b>1,000</b> ppm		
<b>SITE SKETCH</b> BGT Located : off <u>on</u> site PLOT PLAN circle: <u>attached</u>

<div style="position: absolute; top: 680px; left: 670px; font-size: 2em;">N</div> <div style="position: absolute; top: 860px; left: 610px; font-weight: bold;">X - S.P.D.</div>		
NOTES: BGT = BELOW-GRADE TANK; E.D. = EXCAVATION DEPRESSION; B.G. = BELOW GRADE; B = BELOW; T.H. = TEST HOLE; ~ = APPROX.; W.H. = WELL HEAD; T.B. = TANK BOTTOM; PBGTL = PREVIOUS BELOW-GRADE TANK LOCATION; SPD = SAMPLE POINT DESIGNATION; R.W. = RETAINING WALL; NA - NOT APPLICABLE OR NOT AVAILABLE; SW - SINGLE WALL; DW - DOUBLE WALL; SB - SINGLE BOTTOM; DB - DOUBLE BOTTOM.		<b>MISCELL. NOTES</b> PO: <b>4300829404</b> REF #: VID: PJ #: Permit date(s): <b>06/14/10</b> OCD Appr. date(s): <b>04/08/16</b> Tank ID: <b>A</b> OVM = Organic Vapor Meter ppm = parts per million BGT Sidewalls Visible: Y / <u>(N)</u> BGT Sidewalls Visible: Y / N BGT Sidewalls Visible: Y / N Magnetic declination: <b>10° E</b>

NOTES: **GOOGLE EARTH IMAGERY DATE: 3/15/2015.**
