Pit, Below-Grade Tank, or
Proposed Alternative Method Permit or Closure Plan Application

BELOW-GRADE TANK CLOSURE PLAN

FLORANCE M 047A

API No. 3004522021

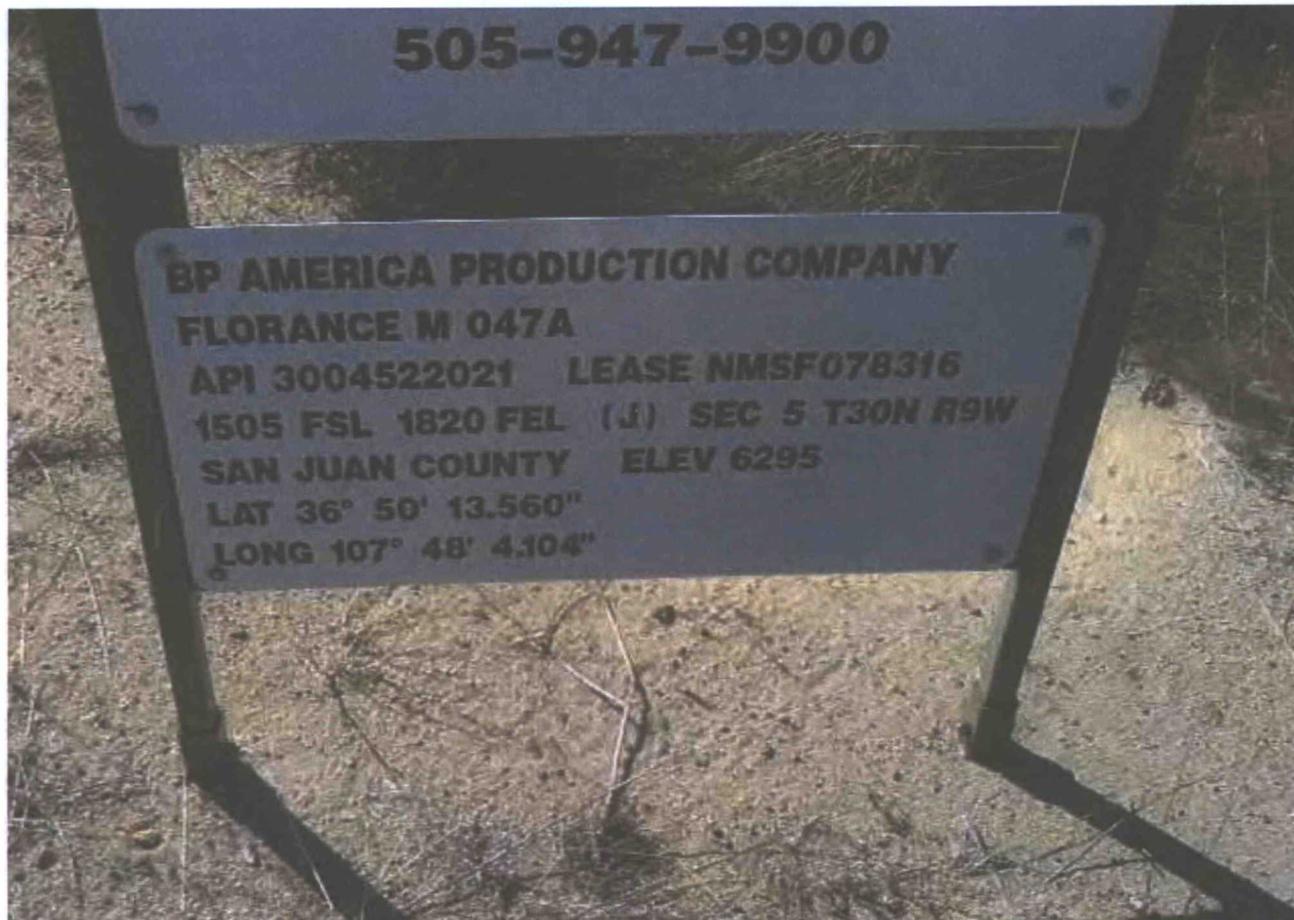
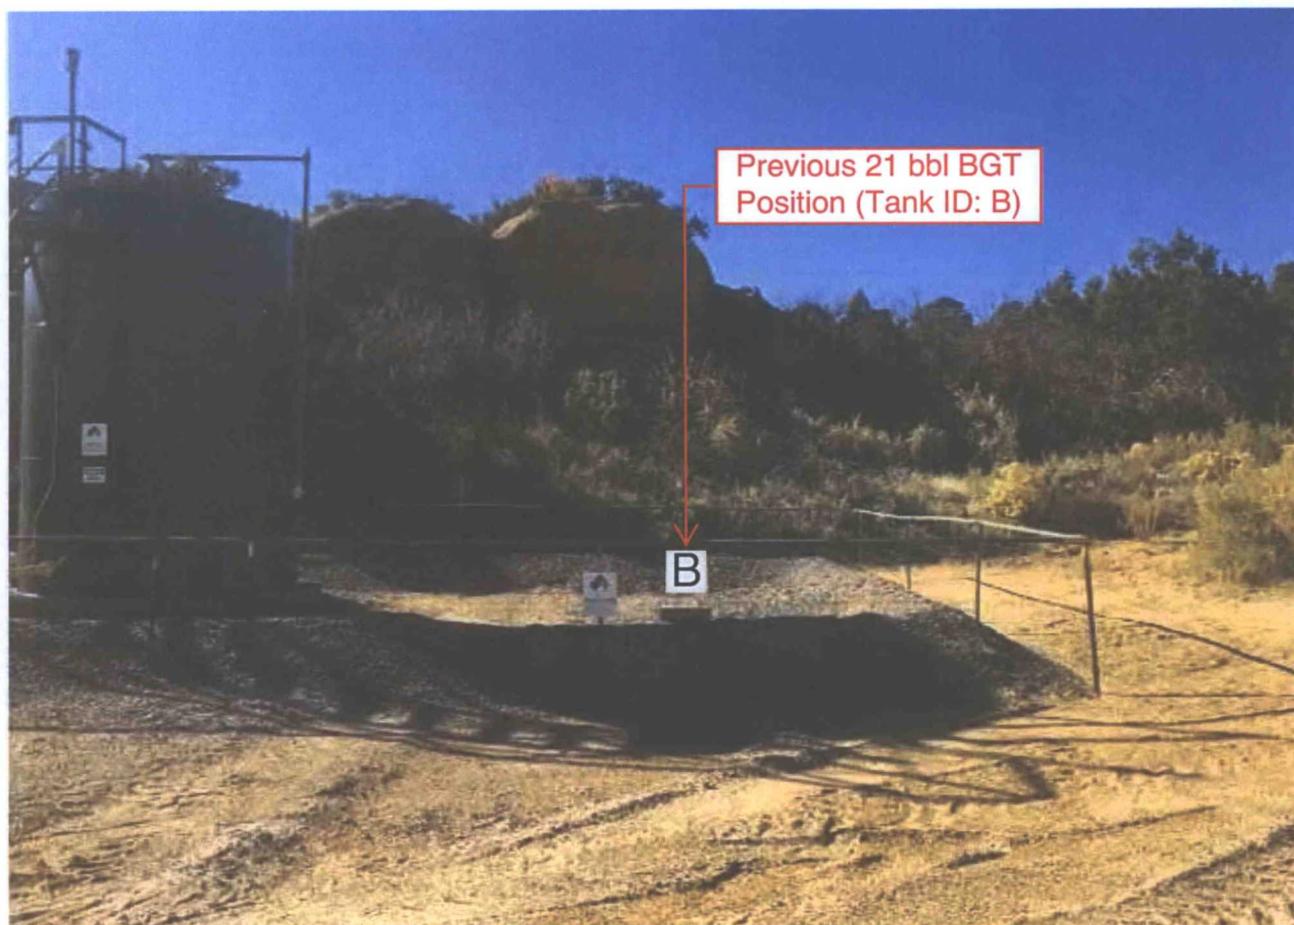
BP did not meet the 60 closure completion requirement due to an error in internal tracking. Closure report on C-144 form is included including photos of reclamation completion.

The area has been backfilled. The area will be reclaimed when the well is plugged and abandoned.
