16174
Pit, Below-Grade Tank, or
Proposed Alternative Method Permit or Closure Plan Application

BP AMERICA PRODUCTION COMPANY
SAN JUAN BASIN, NORTHWEST NEW MEXICO

BELOW-GRADE TANK CLOSURE PLAN

FLORANCE 018R

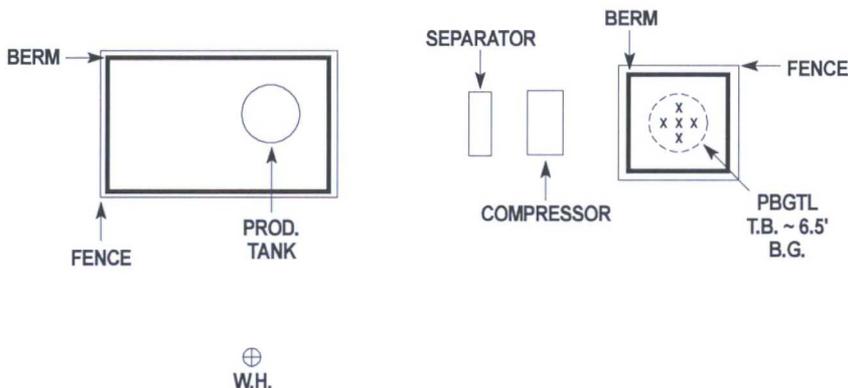
SITE SKETCH	BGT Located: off <input checked="" type="checkbox"/> on site	PLOT PLAN circle: <input checked="" type="checkbox"/> attached	OVM CALIB. READ. = 100.0 ppm RF=1.00
			OVM CALIB. GAS = 100 ppm
			TIME: 2:05 am/pm DATE: 09/25/17

SITE OBSERVATIONS:	LOST INTEGRITY OF EQUIPMENT: YES <input checked="" type="checkbox"/> NO <input type="checkbox"/> EXPLANATION - _____
APPARENT EVIDENCE OF A RELEASE OBSERVED AND/OR OCCURRED: YES <input checked="" type="checkbox"/> NO <input type="checkbox"/> EXPLANATION: _____	EQUIPMENT SET OVER RECLAIMED AREA: <input checked="" type="checkbox"/> YES / <input type="checkbox"/> NO EXPLANATION - 105 BBL SHALLOW LOW PROFILE ABOVE-GRADE TANK TO BE SET ATOP BGT LOCATION.
OTHER: NMOCD OR BLM REPS. NOT PRESENT TO WITNESS CONFIRMATION SAMPLING. BEDROCK - COMPETENT.

DEPTH TO GROUNDWATER: **>100'** NEAREST WATER SOURCE: **>1,000'** NEAREST SURFACE WATER: **>1,000'** NMOCD TPH CLOSURE STD: **5,000** ppm
