On December 8, 2017, crude oil was discovered leaking from a valve at the well tie-in riser for the W Lybrook Unit #720H, located in Section 23, Township 23N, Range 9W, San Juan County, New Mexico. The same day of discovery, the release source was stopped and cleanup initiated.

### 2.0 Release Summary

Well Location: W Lybrook Unit #720H

Agency Notification Date(s): December 8, 2017 Source of Release: failed valve at well tie-in riser

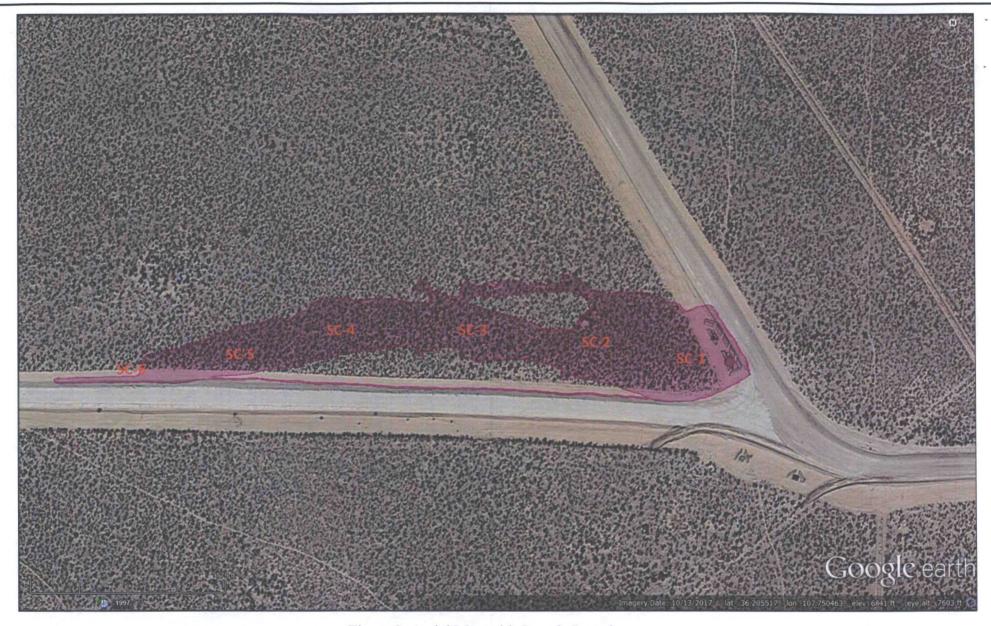
Figure 2. Aerial Map with Sample Locations W Lybrook Unit #720H Well Tie-In Riser Section 23, Township 23N, Range 09W N36.205393, W107.749757 San Juan County, NM

On December 13, 2017, six confirmation soil samples (SC-1 through SC-6) were collected from the excavation. Agencies were notified of the sampling event, but no representatives were present during collection of the confirmation samples. Soil samples composited for laboratory analysis were placed into laboratory supplied glassware, labeled, and shipped on ice to Hall Environmental Analysis Laboratory. Each sample was analyzed for the following:

An additional sample, SC-4R, was collected on December 15, 2017. Mr. A. Adeloye, BLM-FFO, was present during collection of the additional sample. Sample SC-4R was analyzed for MRO and DRO only per USEPA Method 8015M/D.

Final laboratory analytical results for soil confirmation samples (SC-1 through SC-6) reported benzene and BTEX concentrations below the NMOCD RRAL of 10 mg/kg and 50 mg/kg, respectively. All final soil confirmation samples reported TPH concentrations below the NMOCD RRAL of 1,000 mg/kg,
