Pit, Below-Grade Tank, or  
Proposed Alternative Method Permit or Closure Plan Application

BP AMERICA PRODUCTION COMPANY  
SAN JUAN BASIN, NORTHWEST NEW MEXICO

BELOW-GRADE TANK CLOSURE PLAN

TAPP LS 004A

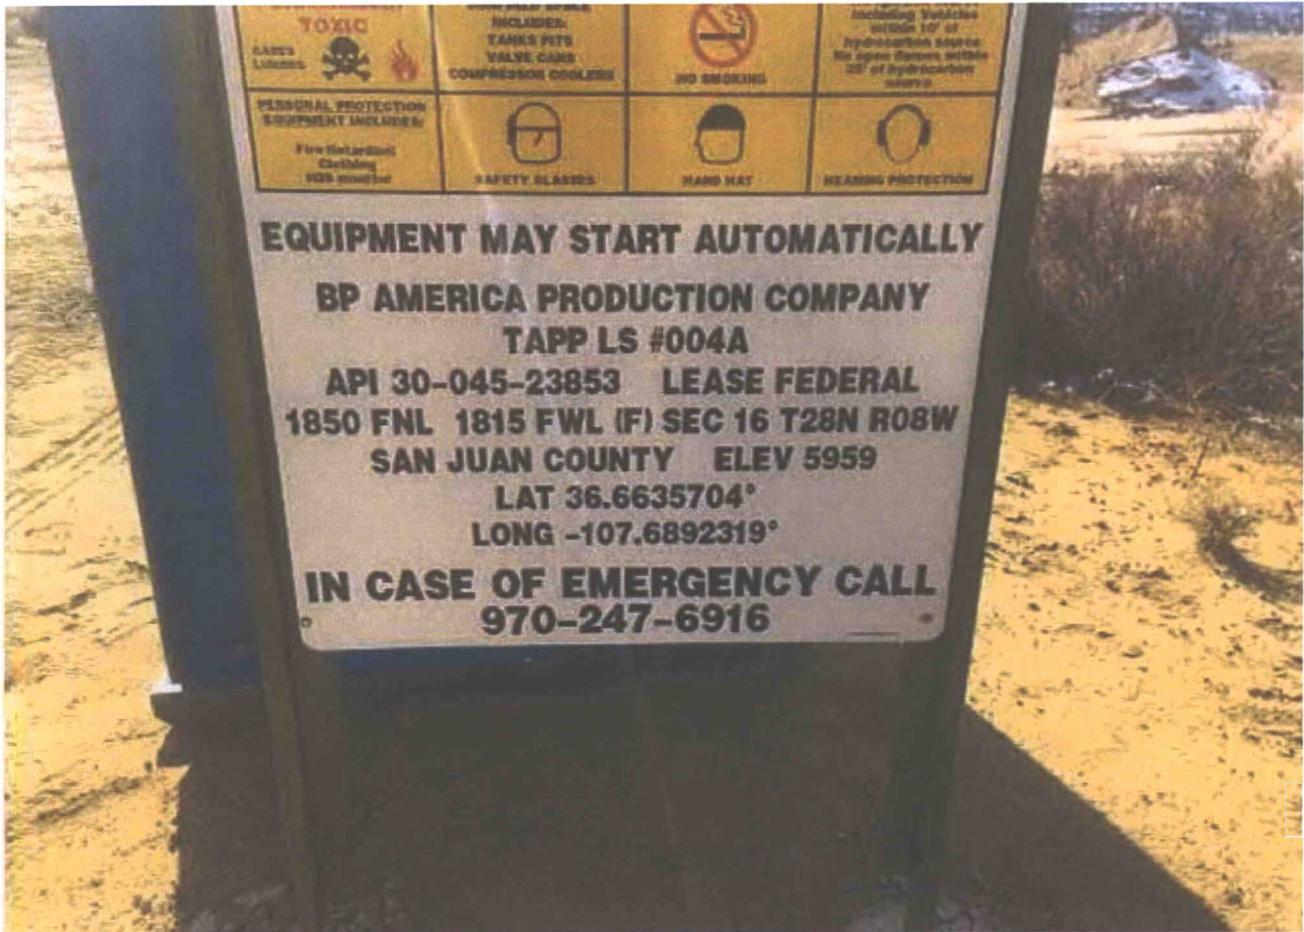
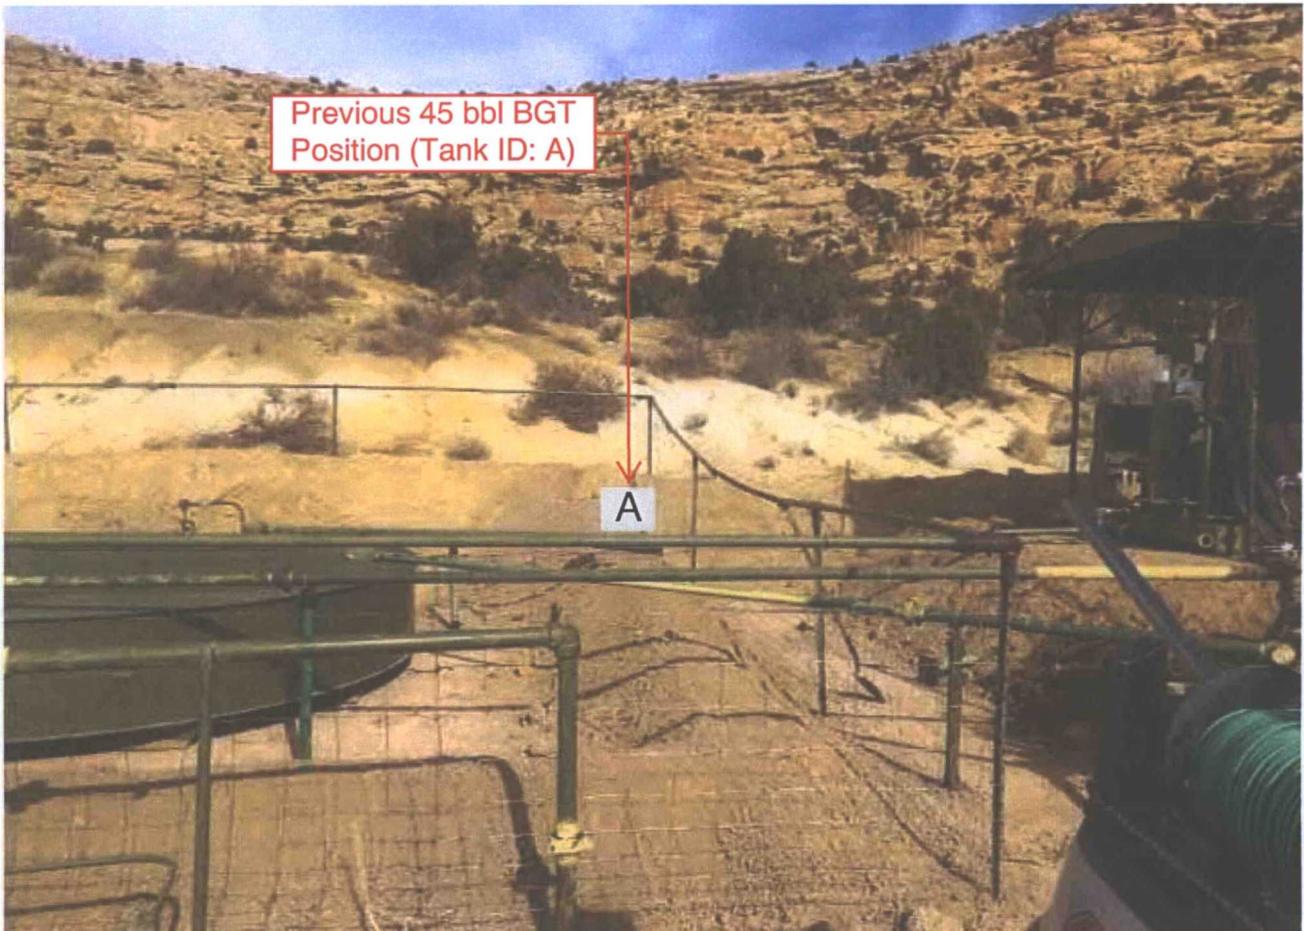
**The area has been backfilled and a 105 BBL shallow low profile above-grade tank set partially atop BGT location. The location will be reclaimed once the well is plugged and abandoned.**

**Closure report on C-144 form is included including photos of reclamation completion.**
