Pit, Below-Grade Tank, or
Proposed Alternative Method Permit or Closure Plan Application

BELOW-GRADE TANK CLOSURE PLAN

WARREN LS 001A

API No. 3004523772

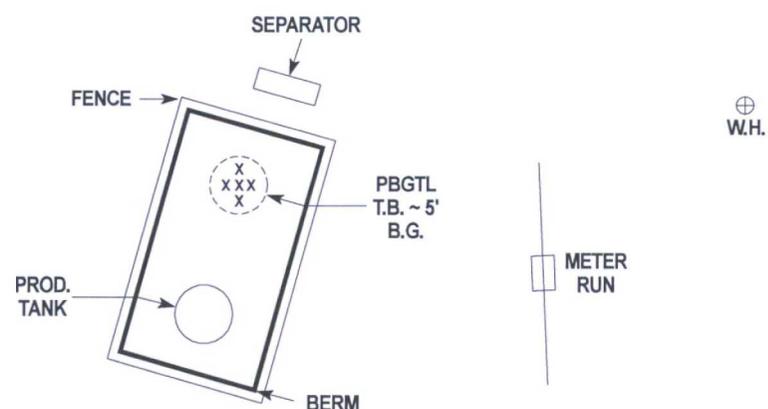
SITE SKETCH BGT Located: off / on site PLOT PLAN circle: attached

SOIL DESCRIPTION: SOIL TYPE: SAND / SILTY SAND / SILT / SILTY CLAY / CLAY / GRAVEL / OTHER _____
SOIL COLOR: **DARK YELLOWISH BROWN** PLASTICITY (CLAYS): NON PLASTIC / SLIGHTLY PLASTIC / COHESIVE / MEDIUM PLASTIC / HIGHLY PLASTIC
COHESION (ALL OTHERS): NON COHESIVE / SLIGHTLY COHESIVE / COHESIVE / HIGHLY COHESIVE DENSITY (COHESIVE CLAYS & SILTS): SOFT / FIRM / STIFF / VERY STIFF / HARD
CONSISTENCY (NON COHESIVE SOILS): LOOSE / FIRM / DENSE / VERY DENSE HC ODOR DETECTED: YES / NO EXPLANATION - _____
MOISTURE: DRY / SLIGHTLY MOIST / MOIST / WET / SATURATED / SUPER SATURATED
SAMPLE TYPE: GRAB / COMPOSITE # OF PTS. **5** ANY AREAS DISPLAYING WETNESS: YES / NO EXPLANATION - _____
DISCOLORATION/STAINING OBSERVED: YES / NO EXPLANATION - _____

SITE OBSERVATIONS: LOST INTEGRITY OF EQUIPMENT: YES / NO EXPLANATION - _____
APPARENT EVIDENCE OF A RELEASE OBSERVED AND/OR OCCURRED: YES / NO EXPLANATION: _____
EQUIPMENT SET OVER RECLAIMED AREA: YES / NO EXPLANATION - **105 BBL SHALLOW LOW PROFILE ABOVE-GRADE TANK TO BE SET ATOP BGT LOCATION.**
OTHER: **NMOC D OR BLM REPS. NOT PRESENT TO WITNESS CONFIRMATION SAMPLING.**

Describe Cause of Problem and Remedial Action Taken.*
Sampling of the soil beneath the BGT was done during removal. Soil analysis resulted for Chlorides, BTEX, and TPH below BGT closure standards. Field reports and laboratory results are attached.
