Pit, Below-Grade Tank, or  
Proposed Alternative Method Permit or Closure Plan Application

BELOW-GRADE TANK CLOSURE PLAN

**TAPP 002**

**API No. 3004523814**

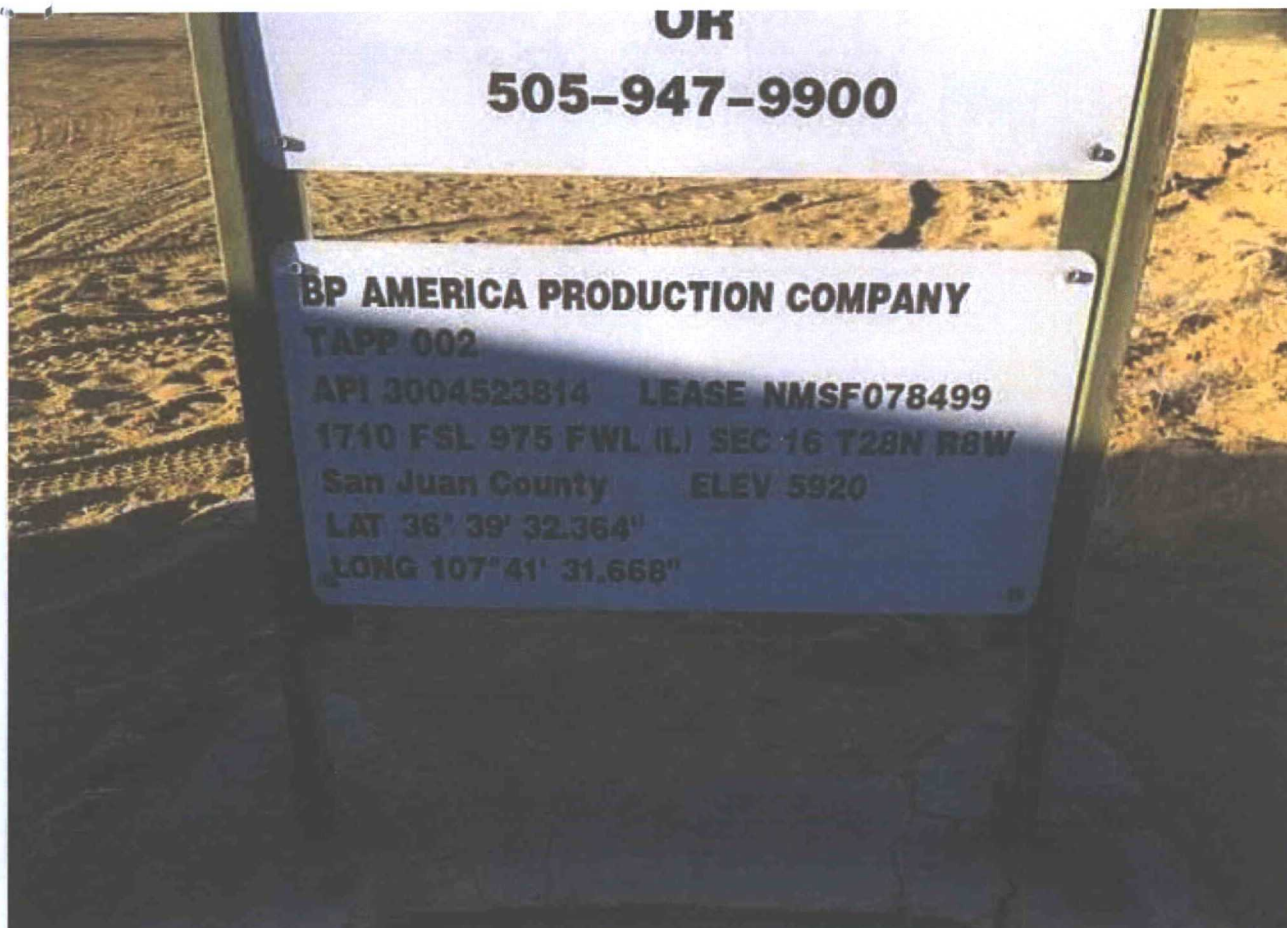
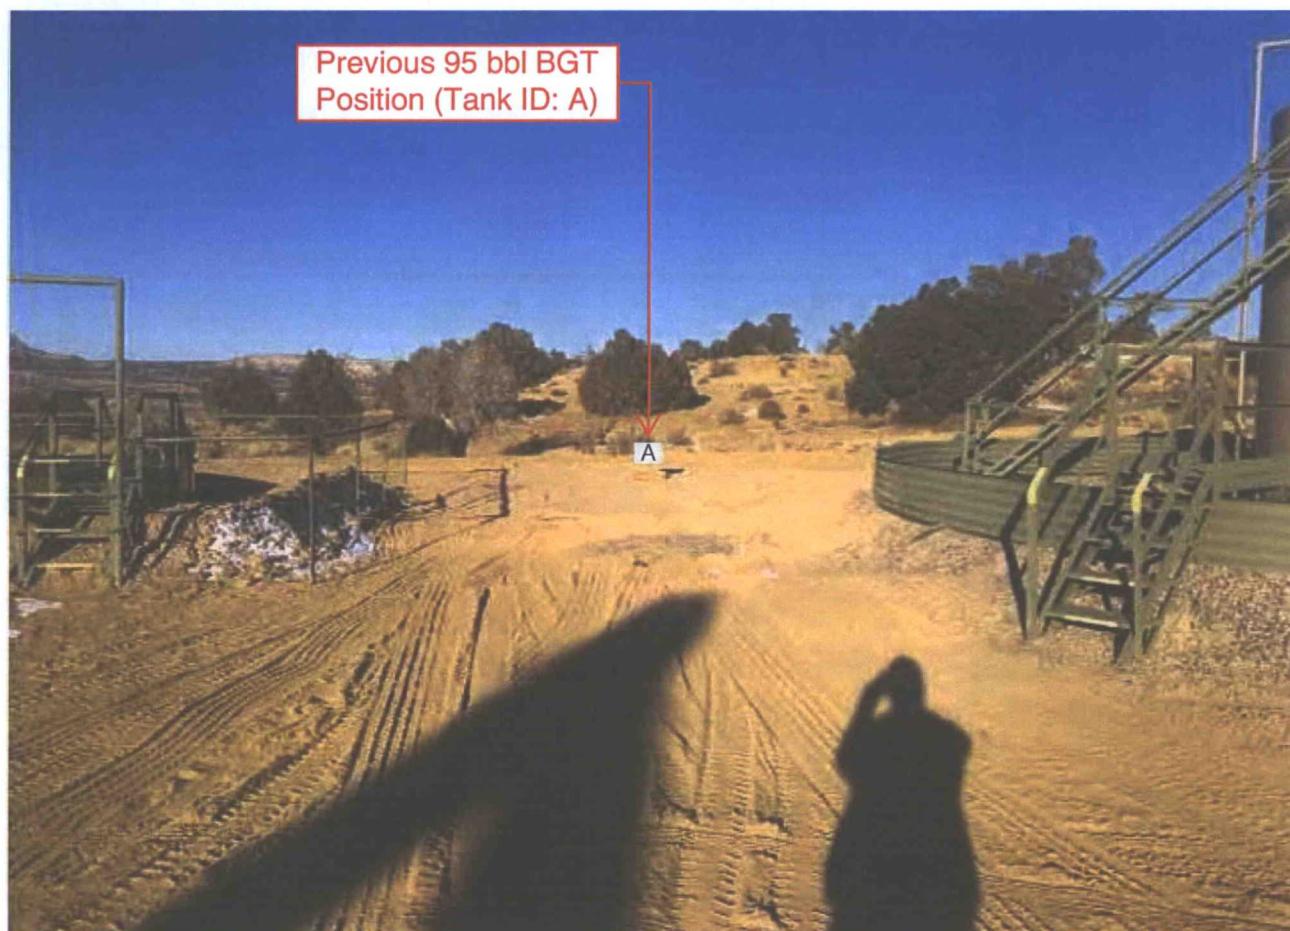
☐ Proof of Closure Notice (surface owner and division)  
☐ Proof of Deed Notice (required for on-site closure for private land only)  
☐ Plot Plan (for on-site closures and temporary pits)  
☒ Confirmation Sampling Analytical Results (if applicable)  
☒ Waste Material Sampling Analytical Results (required for on-site closure)  
☒ Disposal Facility Name and Permit Number  
☒ Soil Backfilling and Cover Installation  
☐ Re-vegetation Application Rates and Seeding Technique  
☒ Site Reclamation (Photo Documentation)

10. BP shall reclaim the BGT location and all areas associated with the BGT including associated access roads to a safe and stable condition that blends with the surrounding undisturbed area. BP shall substantially restore the impacted surface area to the condition that existed prior to oil and gas operations by placement of the soil cover as provided in Subsection H of 19.15.17.13 NMAC, re-contour the location and associated areas to a contour that approximates the original contour and blends with the surrounding topography and re-vegetate according to Subsection I of 19.15.17.13 NMAC.
