### BP AMERICA PRODUCTION COMPANY

#### BELOW-GRADE TANK CLOSURE PLAN

#### W D HEATH A 008

API No. 3004508409

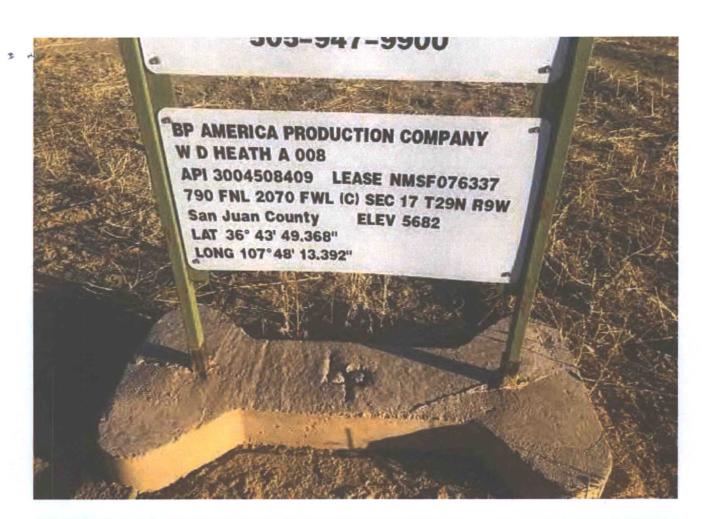
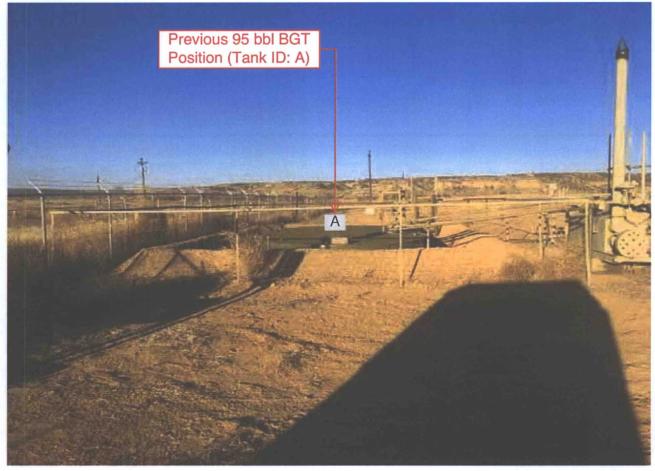
The area has been backfilled and a 105 BBL shallow low profile above-grade tank set atop BGT location. The location will be reclaimed once the well is plugged and abandoned.

BP did not meet the 60 closure completion requirement due to an error in internal tracking. Closure report on C-144 form is included including photos of reclamation completion.
