BP AMERICA PRODUCTION COMPANY
SAN JUAN BASIN, NORTHWEST NEW MEXICO

BELOW-GRADE TANK CLOSURE PLAN

NEIL A 021

API No. 3004527811

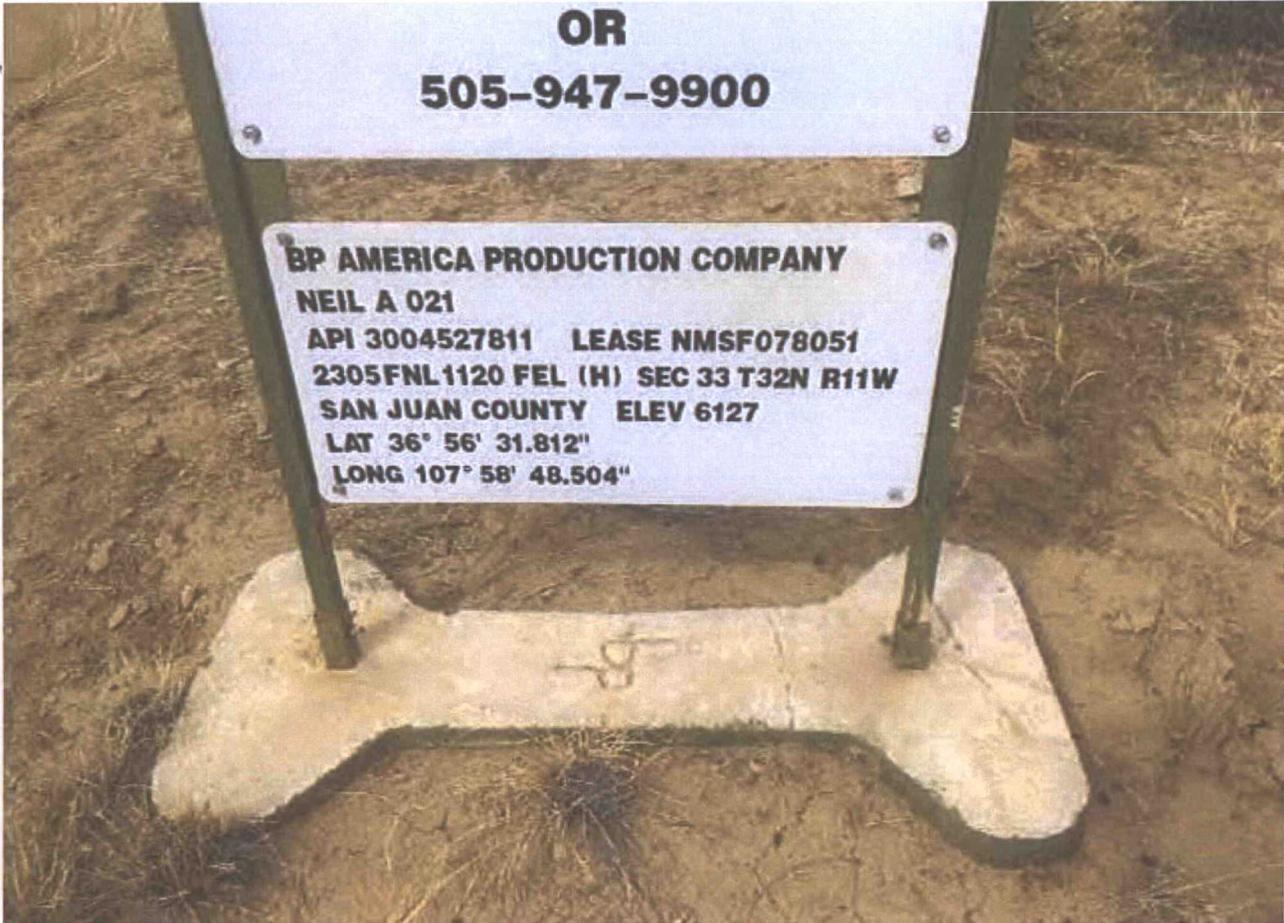
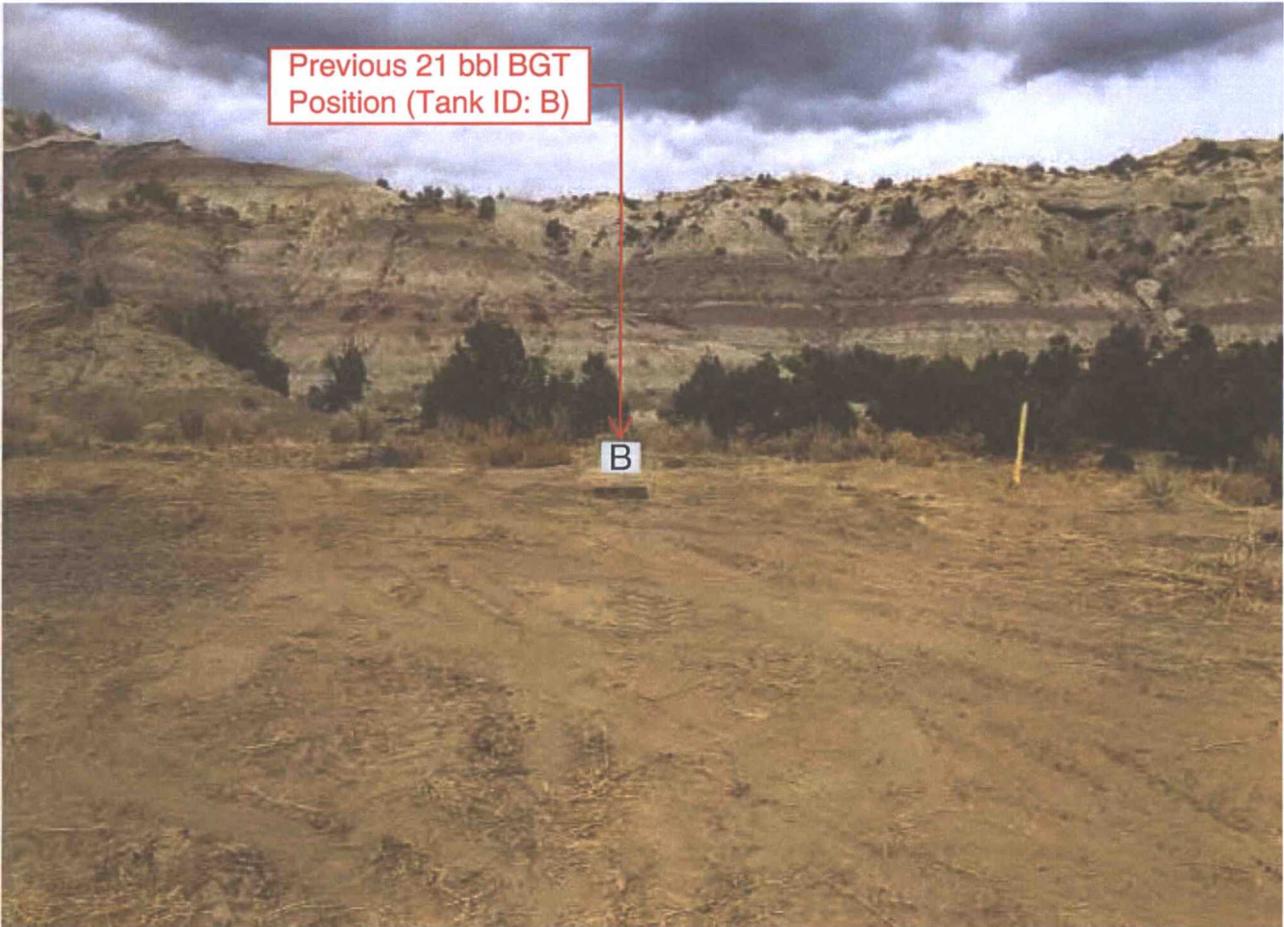
The area has been backfilled and the BGT location's surface condition is clear, but within the site's operational area. The location will be reclaimed once the well is plugged and abandoned.
