# **BP AMERICA PRODUCTION COMPANY**

#### BELOW-GRADE TANK CLOSURE PLAN

#### **ARNAUD A 004**

API No. 3004528682

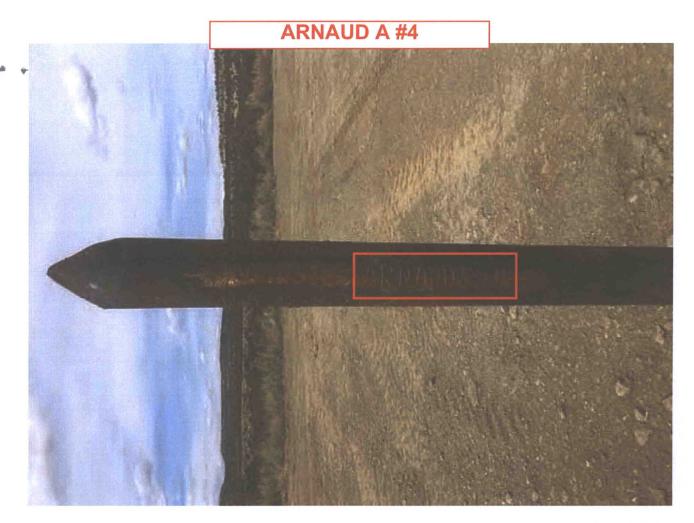
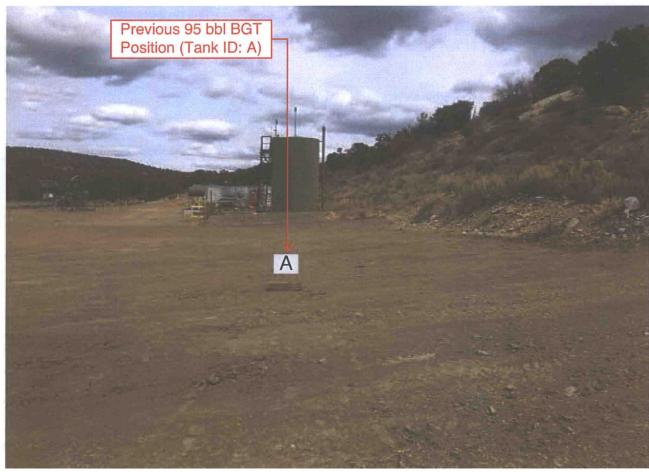
The gas well was recently plugged & abandoned, BGT location's surface condition is clear.

Closure report on C-144 form is included including photos of reclamation completion.
