Pit, Below-Grade Tank, or
Proposed Alternative Method Permit or Closure Plan Application

BELOW-GRADE TANK CLOSURE PLAN

GCU 049

API No. 3004507076

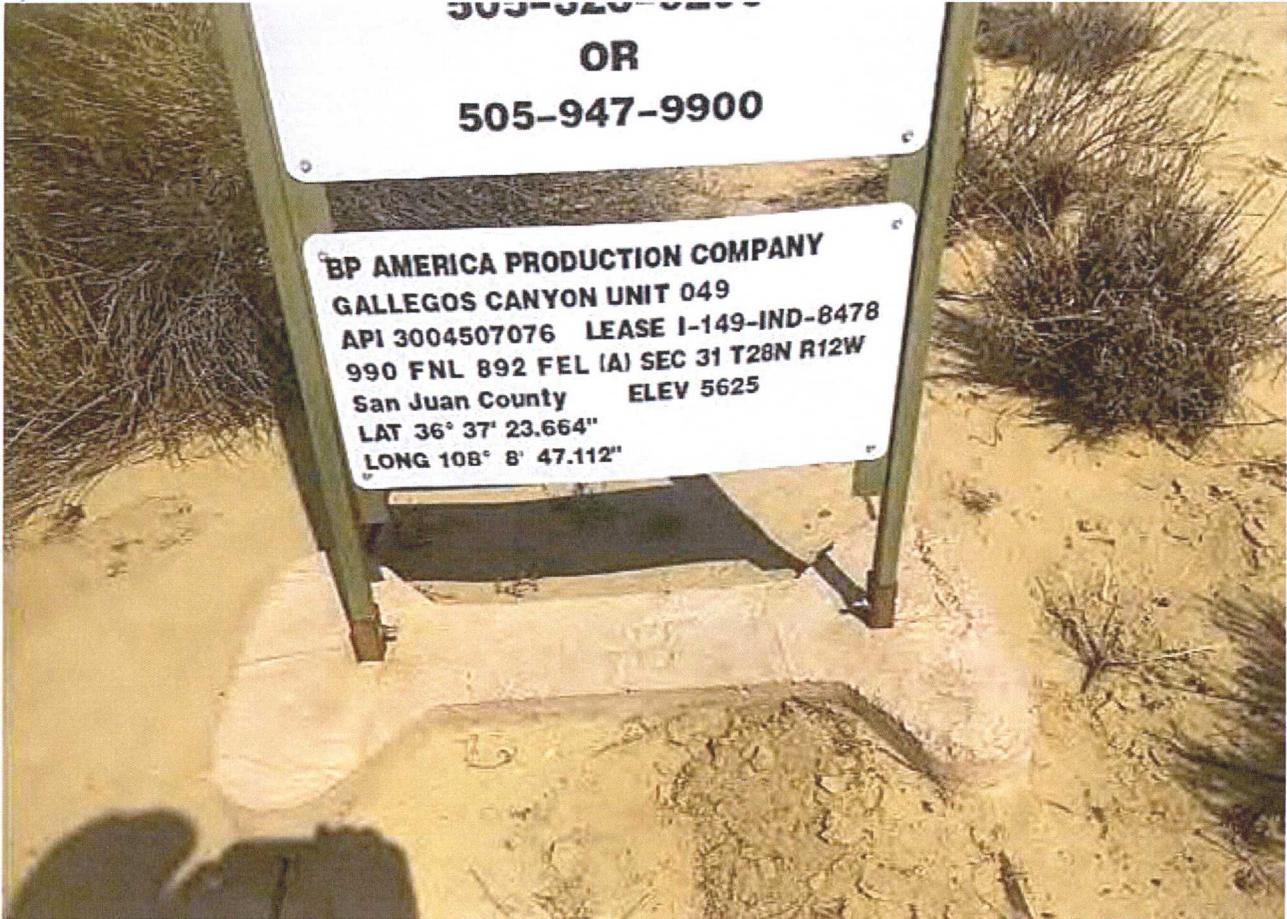
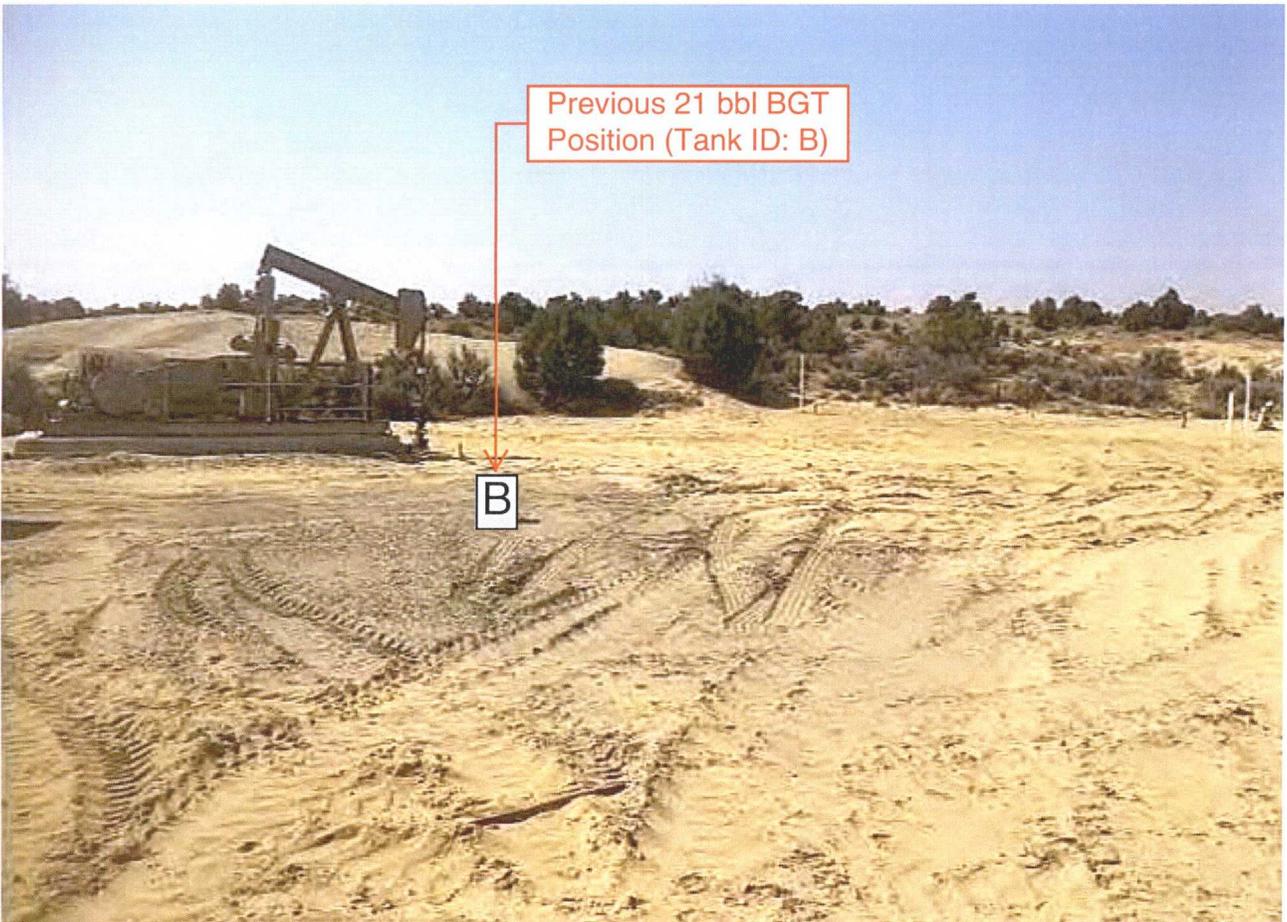
Closure report on C-144 form is included including photos of reclamation completion.
