Pit, Below-Grade Tank, or  
Proposed Alternative Method Permit or Closure Plan Application

1.  
Operator: BP America Production Company OGRID #: 778  
Address: 200 Energy Court, Farmington, NM 87401  
Facility or well name: GCU 198  
API Number: 3004507275 OCD Permit Number: \_\_\_\_\_  
U/L or Qtr/Qtr N Section 20 Township 28N Range 12W County: San Juan  
Center of Proposed Design: Latitude 36.64325 Longitude -108.13757 NAD83  
Surface Owner: ☐ Federal ☐ State ☐ Private ☒ Tribal Trust or Indian Allotment

3.  
☒ Below-grade tank: Subsection I of 19.15.17.11 NMAC TANK A  
Volume: 95 bbl Type of fluid: Produced Water  
Tank Construction material: Steel  
☐ Secondary containment with leak detection ☐ Visible sidewalls, liner, 6-inch lift and automatic overflow shut-off  
☐ Visible sidewalls and liner ☐ Visible sidewalls only ☒ Other Single wall/ Double bottom; sidewalls not visible  
Liner type: Thickness \_\_\_\_\_ mil ☐ HDPE ☐ PVC ☐ Other \_\_\_\_\_

20.  
**Closure Method:**  
 Waste Excavation and Removal ☐ On-Site Closure Method ☐ Alternative Closure Method ☐ Waste Removal (Closed-loop systems only)  
☐ If different from approved plan, please explain.

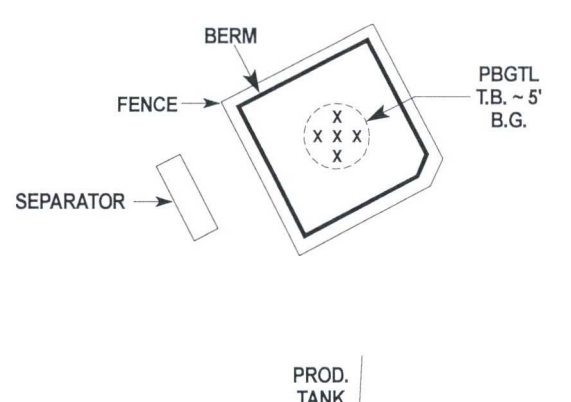
| <b>SOIL DESCRIPTION:</b> SOIL TYPE: <u>SAND</u> <u>SILTY SAND</u> SILT / SILTY CLAY / CLAY <u>GRAVEL</u> <u>OTHER</u> <b>BEDROCK (SANDSTONE)</b><br>SOIL COLOR: <b>MOSTLY DARK YELLOWISH ORANGE</b> PLASTICITY (CLAYS): NON PLASTIC / SLIGHTLY PLASTIC / COHESIVE / MEDIUM PLASTIC / HIGHLY PLASTIC<br>COHESION (ALL OTHERS): <u>NON COHESIVE</u> SLIGHTLY COHESIVE / COHESIVE <u>HIGHLY COHESIVE</u> DENSITY (COHESIVE CLAYS & SILTS): SOFT / FIRM / STIFF / VERY STIFF / HARD<br>CONSISTENCY (NON COHESIVE SOILS): LOOSE <u>FIRM</u> DENSE <u>VERY DENSE</u> HC ODOR DETECTED: <u>YES</u> NO EXPLANATION - <b>MINOR IN DISCOLORED SOILS</b><br>MOISTURE: <u>DRY</u> <u>SLIGHTLY MOIST</u> <u>MOIST</u> WET / SATURATED / SUPER SATURATED<br>SAMPLE TYPE: GRAB <u>COMPOSITE</u> # OF PTS. <b>5</b> ANY AREAS DISPLAYING WETNESS: YES <u>NO</u> EXPLANATION -<br>DISCOLORATION/STAINING OBSERVED: <u>YES</u> NO EXPLANATION - <b>LIGHT GRAY</b> | | |
| <b>SITE OBSERVATIONS:</b> LOST INTEGRITY OF EQUIPMENT: <u>YES</u> NO EXPLANATION - <b>MOST LIKELY AT WEST SIDEWALL &amp; BOTTOM</b><br>APPARENT EVIDENCE OF A RELEASE OBSERVED AND/OR OCCURRED: <u>YES</u> NO EXPLANATION: <b>PHYSICALLY OBSERVED &amp; MINOR HYDROCARBON ODOR</b><br>EQUIPMENT SET OVER RECLAIMED AREA: YES <u>NO</u> EXPLANATION -<br>OTHER: <b>NMOCD OR BLM REPS. NOT PRESENT TO WITNESS CONFIRMATION SAMPLING. GAS WELL TO BE PLUGGED &amp; ABANDONED.</b> | | |
| EXCAVATION DIMENSION ESTIMATION: _____ ft. X _____ ft. X _____ ft. EXCAVATION ESTIMATION (Cubic Yards): _____<br>DEPTH TO GROUNDWATER: <b>&lt;100'</b> NEAREST WATER SOURCE: <b>&gt;1,000'</b> NEAREST SURFACE WATER: <b>&lt;1,000'</b> NMOCD TPH CLOSURE STD: <b>100</b> ppm | | |

| Describe Cause of Problem and Remedial Action Taken.*<br>Sampling of the soil beneath the BGT was done during removal. Soil analysis resulted for Chlorides, BTEX, and TPH below BGT closure standards, except TPH. The release will be addressed following the spill and release guidelines. Field reports and laboratory results are attached. | | |
