Pit, Below-Grade Tank, or
Proposed Alternative Method Permit or Closure Plan Application

BELOW-GRADE TANK CLOSURE PLAN

GCU 210

API No. 3004511648

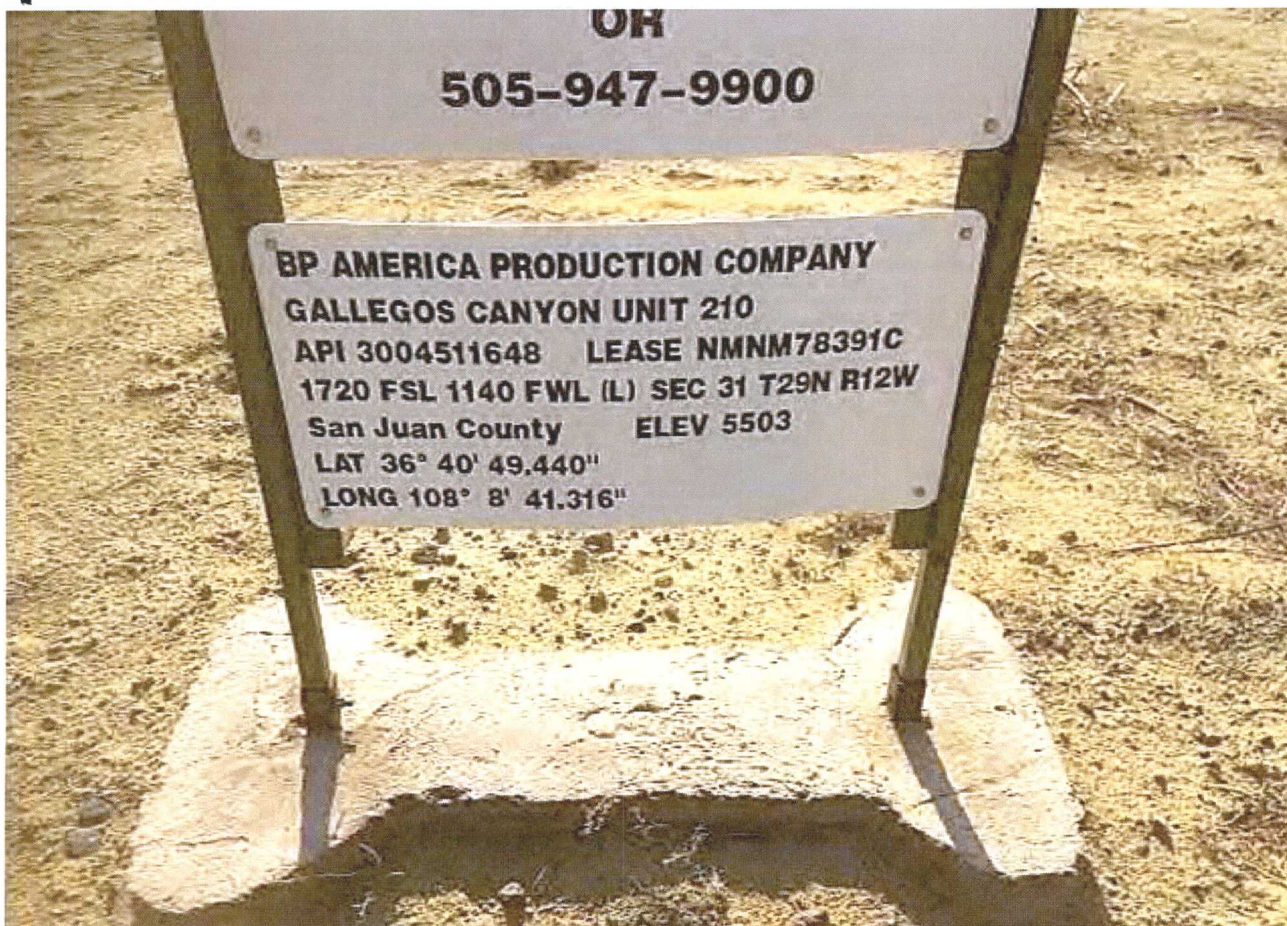
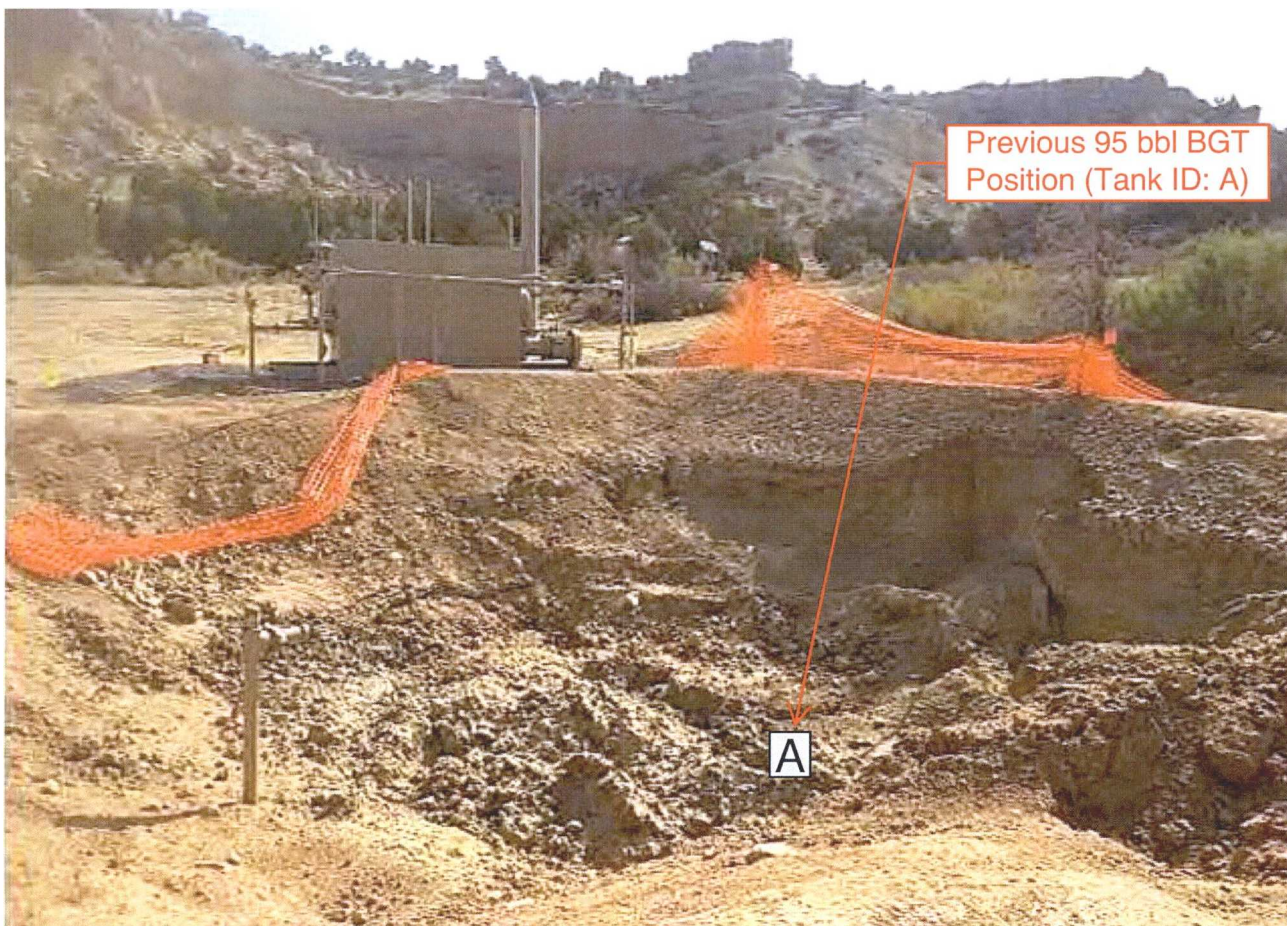
Closure report on C-144 form is included including photos of reclamation completion.
