Pit, Below-Grade Tank, or  
Proposed Alternative Method Permit or Closure Plan Application

BELOW-GRADE TANK CLOSURE PLAN

**BARRETT LS 002A (A)**

**API No. 3004522486**

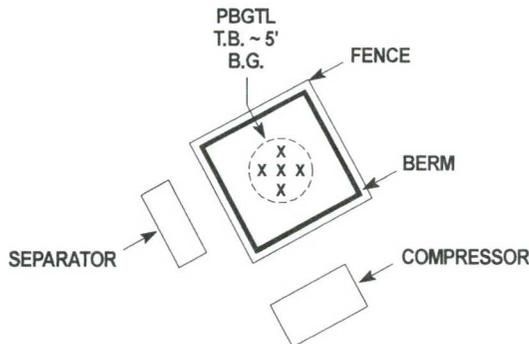
SITE SKETCH	BGT Located: off <input checked="" type="checkbox"/> on site	PLOT PLAN circle: <b>attached</b>
		OVM CALIB. READ. = <b>NA</b> ppm RF=1.00
		OVM CALIB. GAS = <b>NA</b> ppm
		TIME: <b>NA</b> am/pm DATE: <b>NA</b>

SITE OBSERVATIONS:	LOST INTEGRITY OF EQUIPMENT: YES <input checked="" type="checkbox"/> NO <input type="checkbox"/> EXPLANATION - _____	
APPARENT EVIDENCE OF A RELEASE OBSERVED AND/OR OCCURRED: YES <input checked="" type="checkbox"/> NO <input type="checkbox"/> EXPLANATION: _____		
EQUIPMENT SET OVER RECLAIMED AREA: YES <input checked="" type="checkbox"/> NO <input type="checkbox"/> EXPLANATION - _____		
OTHER: <b>NMOCED REP. PRESENT TO WITNESS CONFIRMATION SAMPLING.</b>

DEPTH TO GROUNDWATER: **>100'** NEAREST WATER SOURCE: **>1,000'** NEAREST SURFACE WATER: **300' < X < 1,000'** NMOCED TPH CLOSURE STD: **2,500** ppm

**X - S.P.D.**
