Release Notification and Corrective Action

Name of Company Hilcorp Energy Company	Contact Lindsay Dumas
Address 1111 Travis St. Houston, TX 77002	Telephone No. (281)794-9159
Facility Name: San Juan 28-6 #148N	Facility Type: Gas

Describe Area Affected and Cleanup Action Taken.*
The corroded tank sits on a liner, 4 samples approximately 1' down were taken on 1/22/18. Pictures are attached. Samples were submitted for BTEX 8021, TPH to include DRO-GRO-MRO 8015, and chlorides. All analytical results are below NMOCD action levels, no further remediation required.

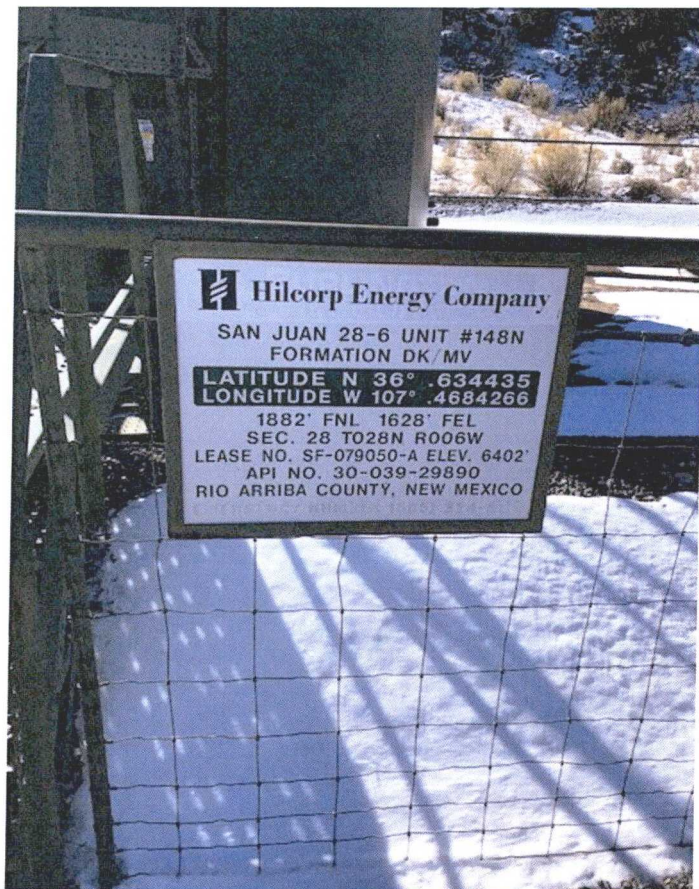
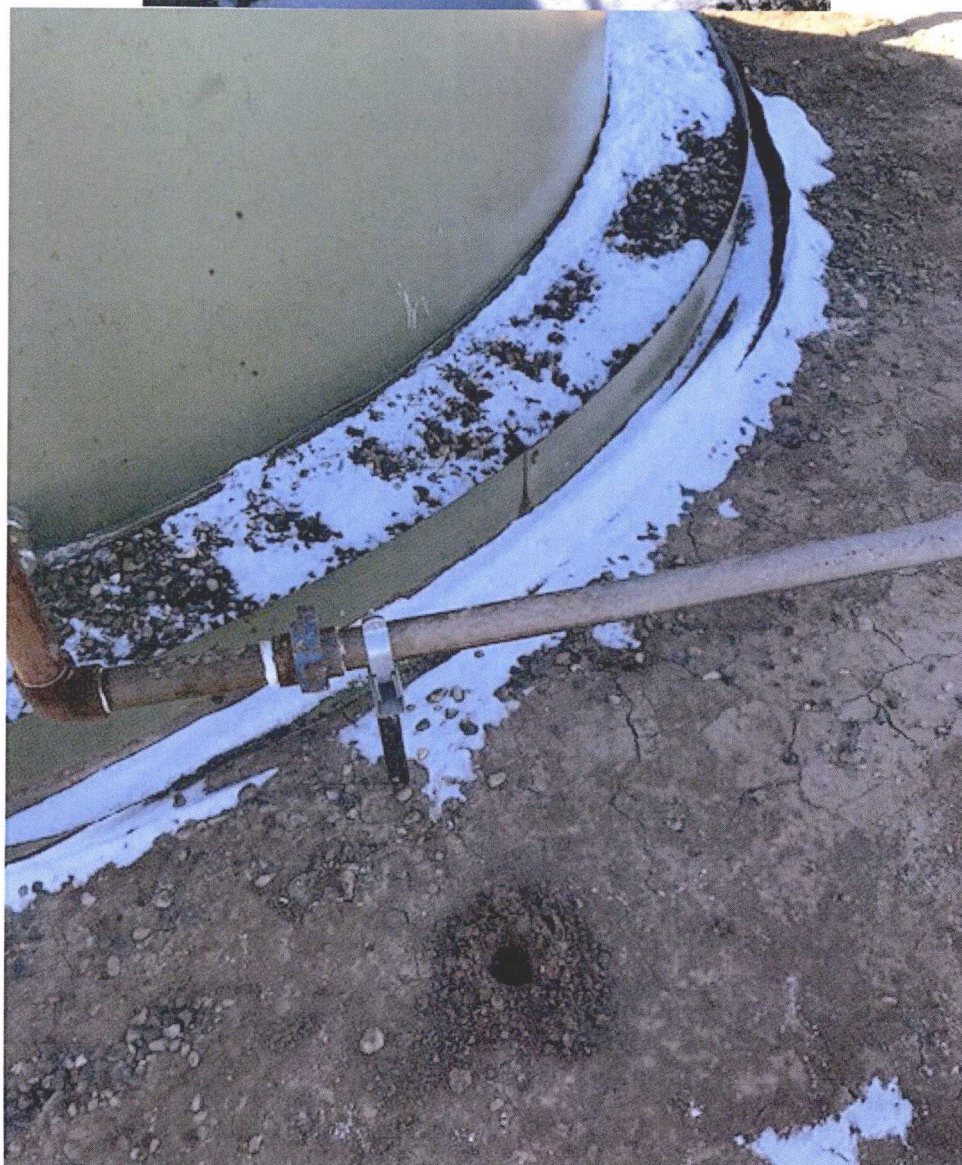
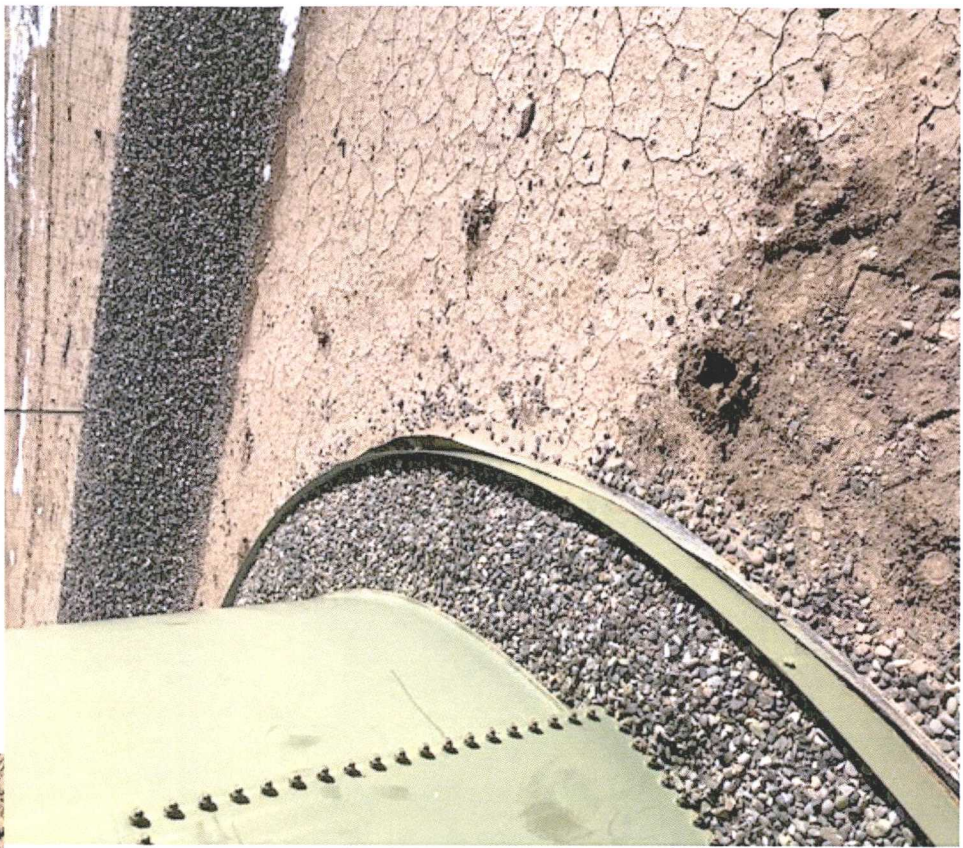
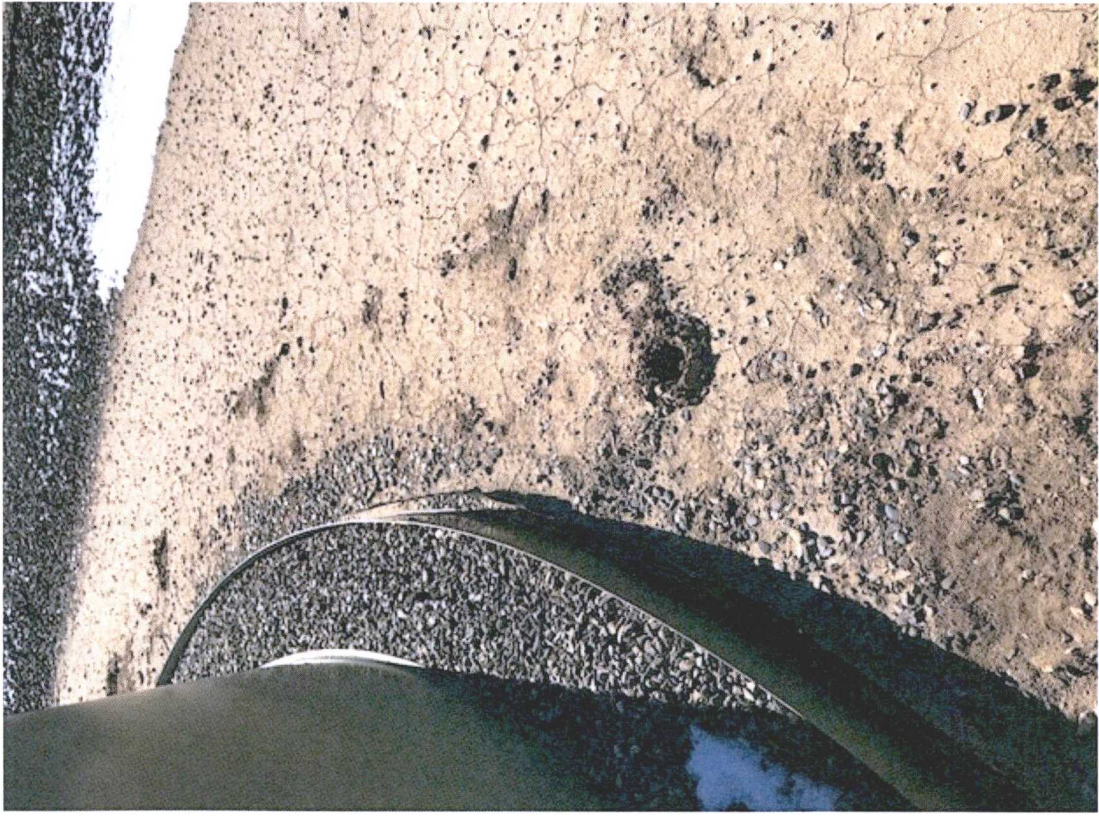
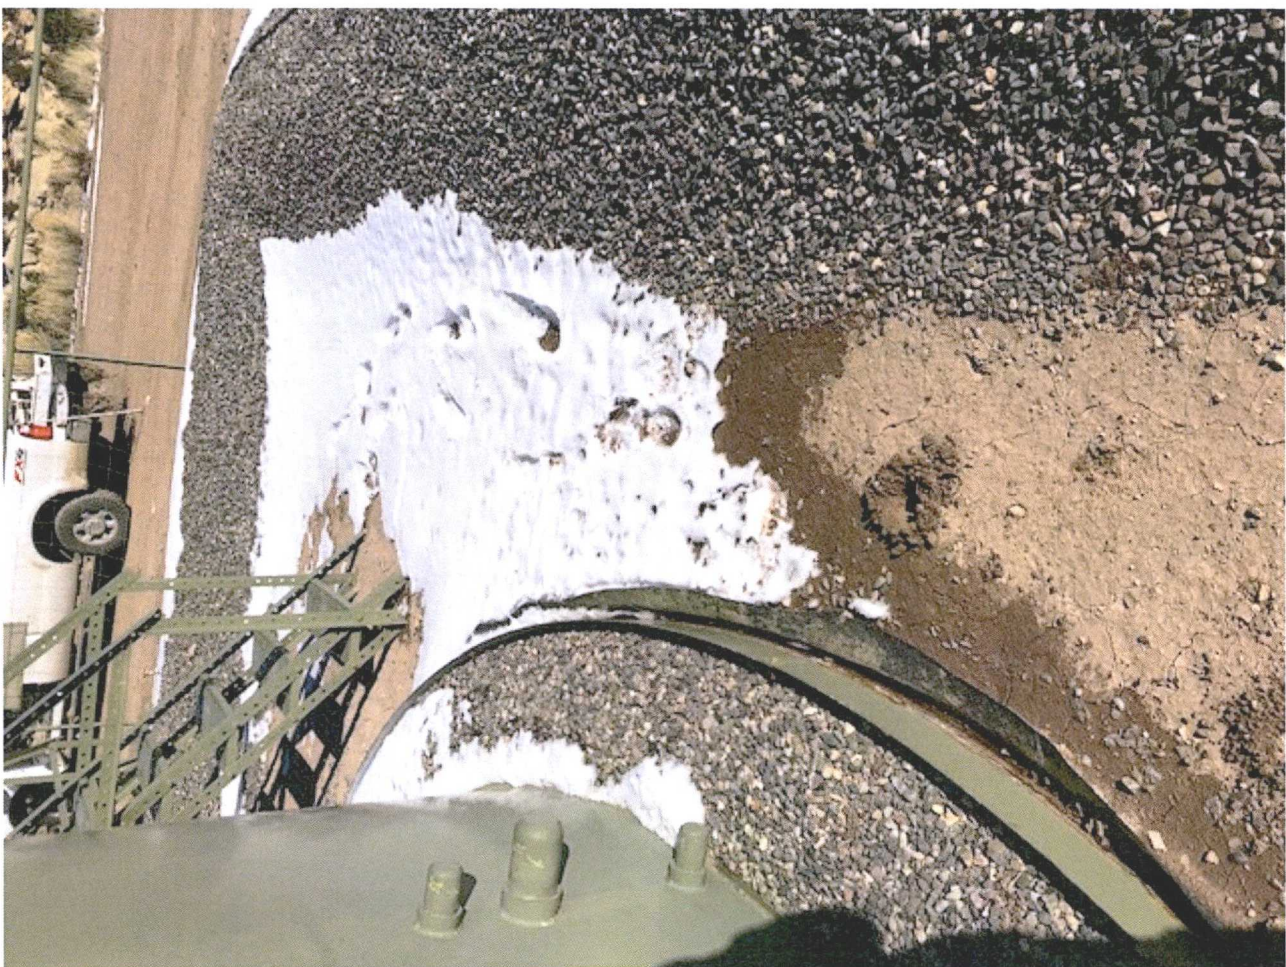
Describe Cause of Problem and Remedial Action Taken.*
The release as a result of corrosion on the bottom of the production tank. There was no standing product to recover.
