Pit, Closed-Loop System, Below-Grade Tank, or Proposed Alternative Method Permit or Closure Plan Application

1.
Operator: BP AMERICA PRODUCTION COMPANY OGRID #: 778
Address: 200 Energy Court, Farmington, NM 87401
Facility or well name: PRITCHARD C 001
API Number: 3004528622 OCD Permit Number: _____
U/L or Qtr/Qtr G Section 34.0 Township 31.0N Range 09W County: San Juan County
Center of Proposed Design: Latitude 36.857956 Longitude -107.763950 NAD: 1927 1983
Surface Owner: Federal State Private Tribal Trust or Indian Allotment

Release Notification

Site Name HEATH GAS COM N 001	Site Type Natural Gas Well
Date Release Discovered	API# <i>(if applicable)</i> 30-045-28622

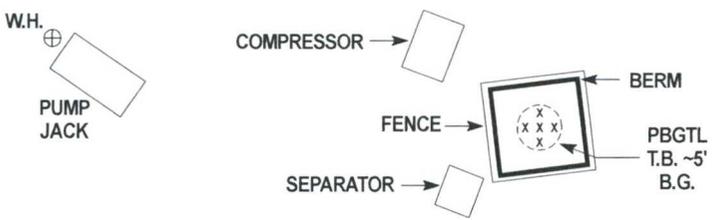
SITE SKETCH	BGT Located: off <input checked="" type="checkbox"/> on site	PLOT PLAN circle: attached	OVM CALIB. READ. = NA ppm RF=1.00 OVM CALIB. GAS = NA ppm TIME: NA am/pm DATE: NA
-------------	--	-----------------------------------	---

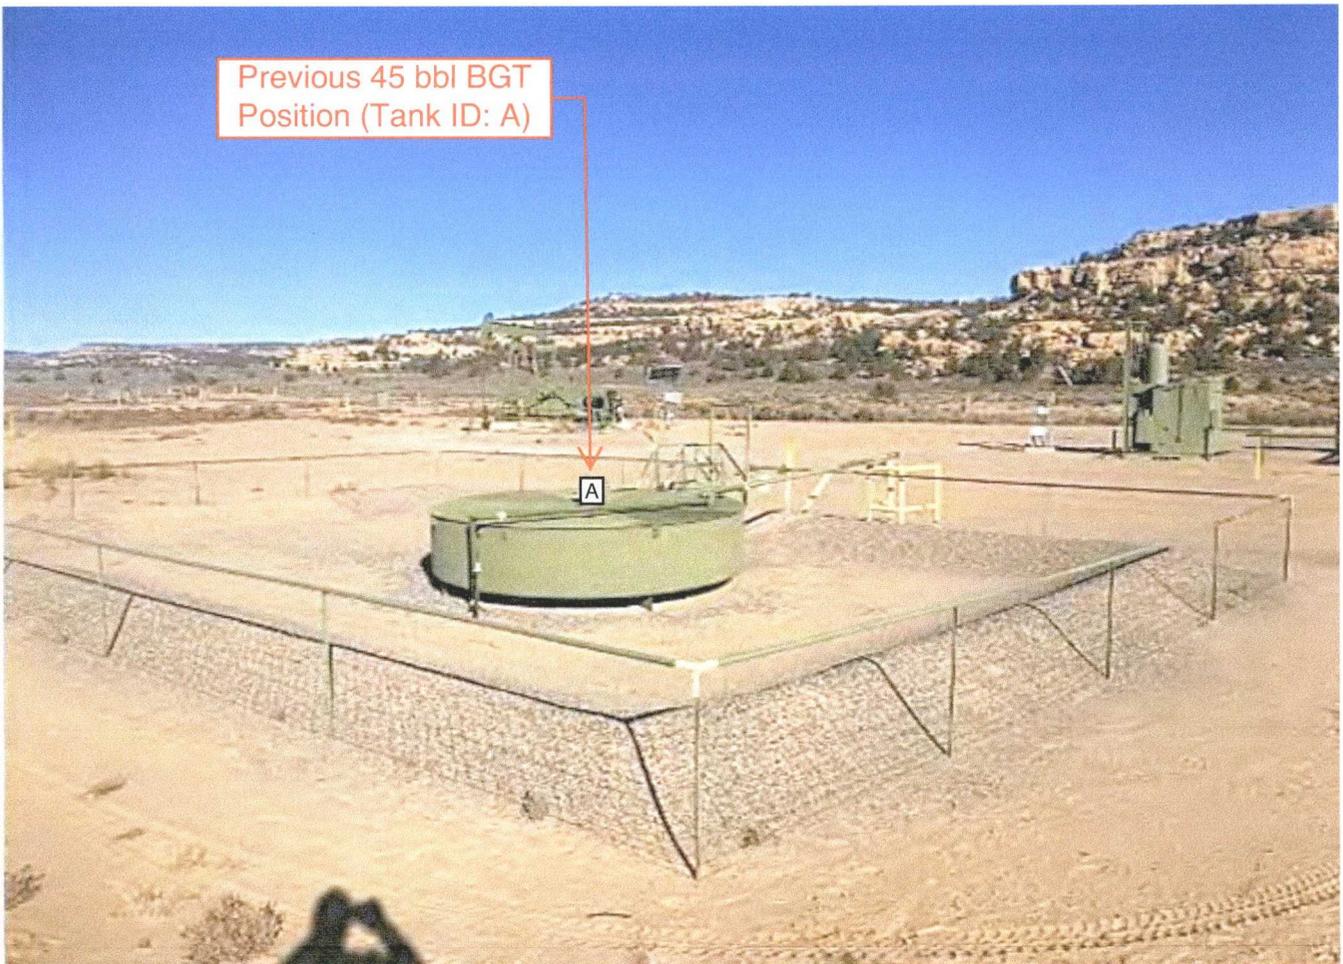
- e. site reclamation, photo documentation.**Closure report on C-144 form is included & contains a photo of the reclamation completion.**
16. BP shall certify that all information in the report and attachments is accurate, truthful, and compliant with all applicable closure requirements and conditions specified in the approved closure plan.
Certification section of C-144 has been completed.
