Location Schematic:  
Remediation

Annie Fed. #1

API #: 30-039-23043

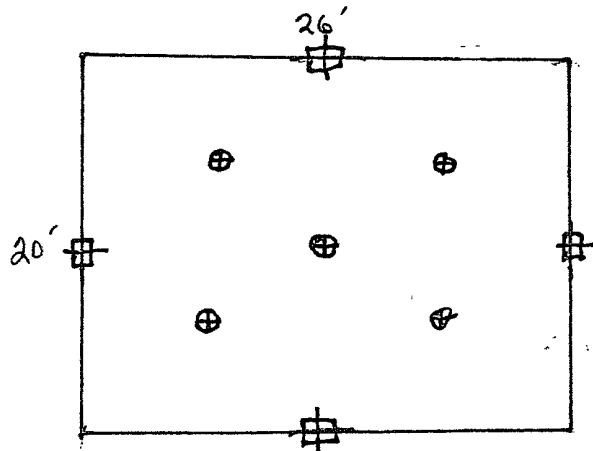
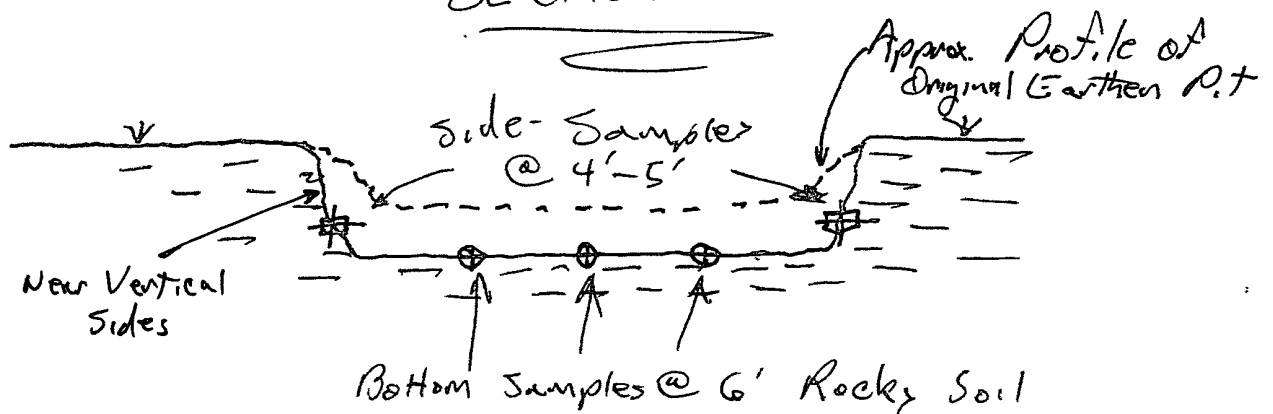
PLAN VIEW:

⊕ : Approx. Sampling Points: Bottom Composite Sample:  
(5-Spot Pattern)

⊞ : Approx. Sampling Points: Side Composite Sample:  
(4-Spot Pattern)

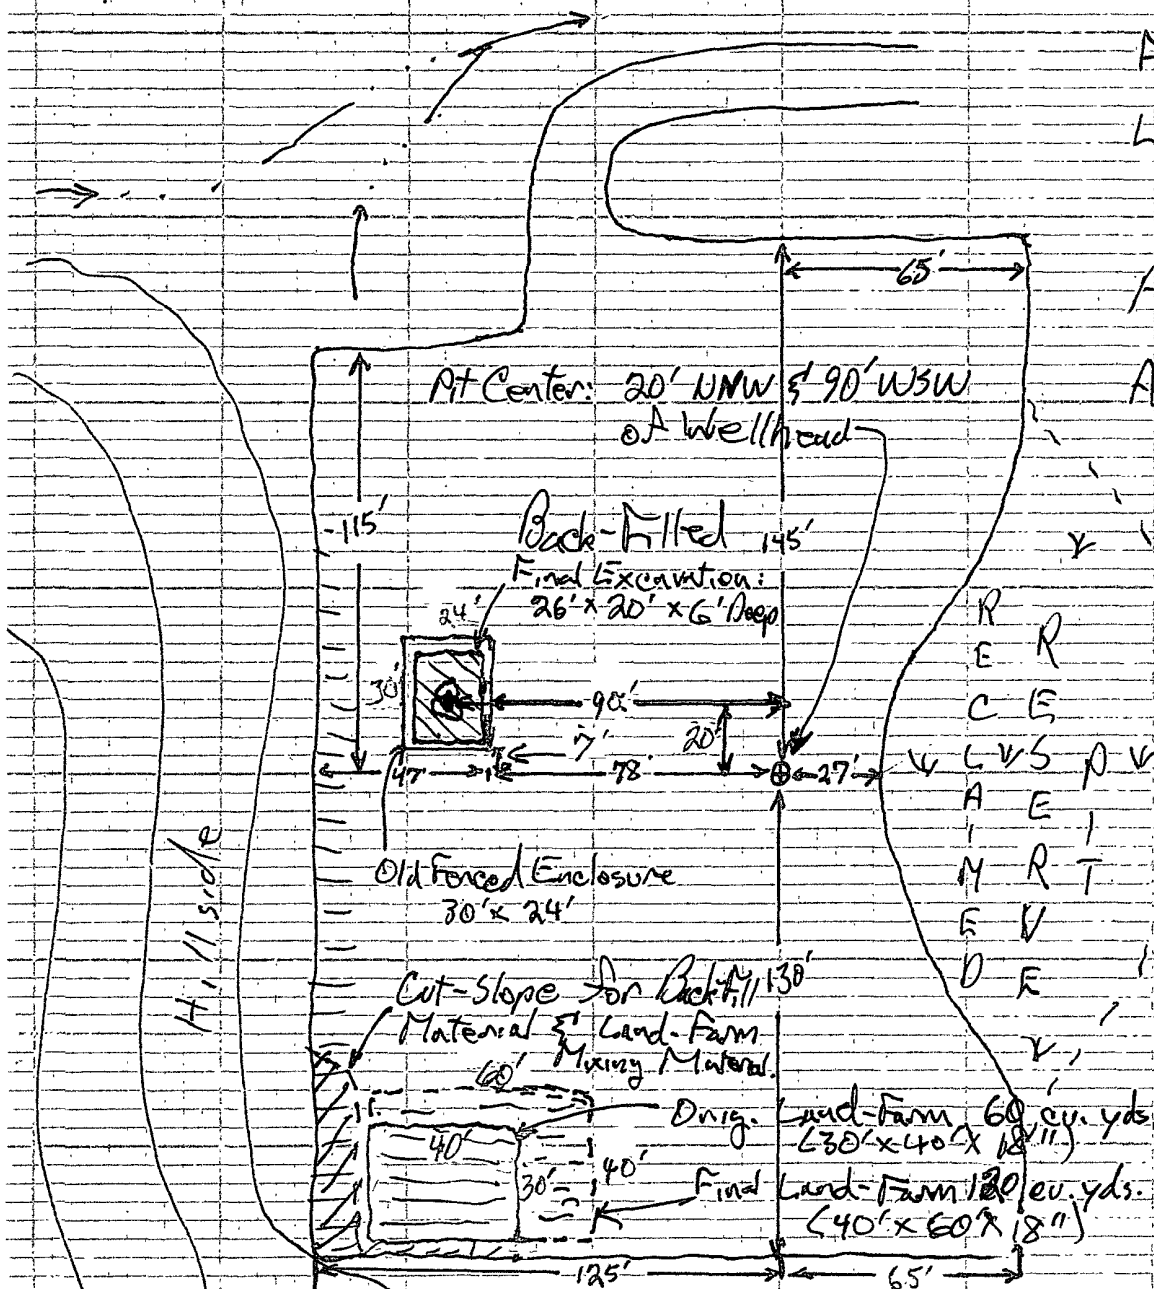
FIGURE 2:

Longitudinal  
Location  
Azimuth  
N. 25° W.

1. Remove Free Fluid & Excavate P.T. Muck & Rocky Soil. Getting very rocky @ Bottom. Tested Bottom & Sides & Excavation (Final) did meet Site Remediation Standards (TPH < 1000 PPM & BTEX < 50 PPM). Some staining still evident on bottom. Leave open to air 1/2 mos. to ventilate & then, place 150# Hi-N<sub>2</sub> Fertilizer in bottom & Back-Fill w/ Clean-Fill from Cut-Slope in SW Corner of Location.

2. Land-Farm & Mix Excavated Material w/ Only Dist. H Battery & Wellhead Areas. Mix-In 100# Hi-N<sub>2</sub> Fertilizer & Till in Oct. 2004 & again in Jan. 2005. Mix-In 60 cu. yds. Clean Fill & 100# Hi-N<sub>2</sub> Fertilizer & Re-Till in Late May 2005. Final Test met Site Standards on 6/15/2005.  
Use Remediated Material to Build & Expand Oil Battery Berm & Water Table Barr.
