CASING REPAIR EVALUATION OR TEMPORARY ABANDONMENT OR PLUG AND ABANDONMENT PROCEDURE

San Juan 28-7 Unit #37

Blanco Pictured Cliffs 1190' FSL & 1700' FEL, Section 6, T27N, R7W Rio Arriba County, New Mexico Lat: N 36° 35' 55.6" / Long: W 107° 36' 41.4" / API 30-039-07172

Current

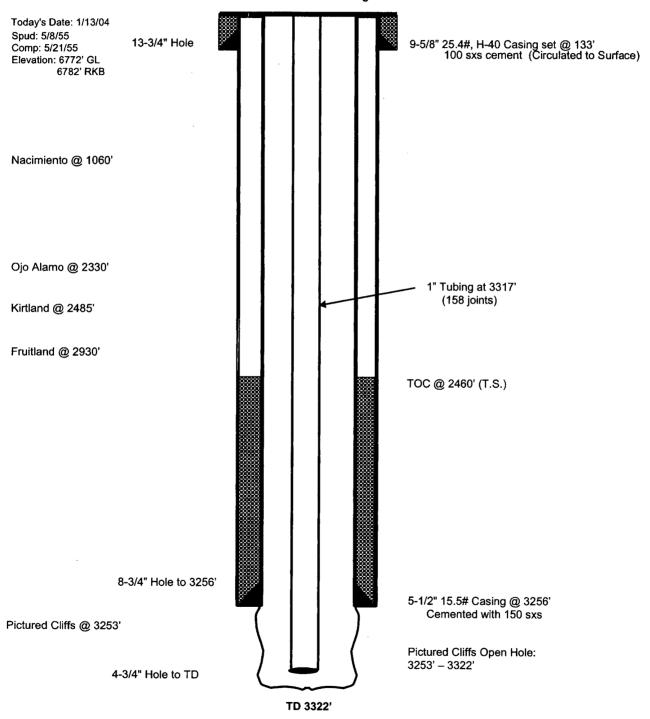
San Juan 28-7 Unit #37

Blanco Pictured Cliffs
SE, Section 6, T-27-N, R-7-W, Rio Arriba County, NM
API #30-039-07172

Lat: N 36°35' 55.572" / Long: W 107 ° 36' 41.4"

ConocoPhillips proposed to plug and abandon this well as per submittal 15060. We are requesting to rescind that approval. We would like to evaluate this well for temporary abandonment of the PC. If the temporary abandonment is found not to be economically feasible we would like to plug the well while on location for the TA. Work will be performed as per the attached TA/P&A procedure. Also attached is a current wellbore schematic and a proposed plugged wellbore schematic.

- Well currently is not capable of producing. Parted 1" tubing or a casing failure may exist and has caused the Pictured Cliffs zone to log off. The following procedure has various options to: 1) determine the condition of the 1" tubing; 2) determine the condition of the 5-1/2" casing; and 3) then test the Pictured Cliffs zone production capabilities. It is anticipated to remove the 1" tubing and use a workstring to test the casing and production capability. Then we would repair the casing if economically justified; or repair the casing without testing, or to temporarily abandon the well if the well is not capable of economic production.
