PIT REMEDIATION AND CLOSURE REPORT

Operator: ConocoPhillips Company Telephone: (505) 599-3400

Facility Or: Gallegos #3 API #: 30-045-21290

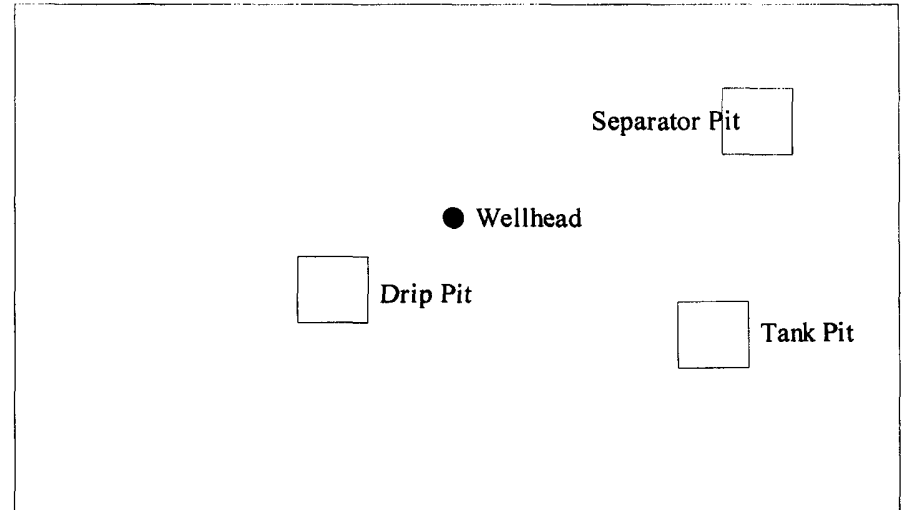
Gallegos #3
 Not to Scale

Reference: wellhead **Footage:** 110'
Direction: N or (S) 70 **Degrees** (E) or W
Initial size: 15' x 15' x 1' = 225ft³
Final Size: 15' x 15' x 1' = 225ft³
Total Cubic Yards: 0 yd³

Gallegos Canyon borders location to the west.
 Pit #1: shale or weathered sandstone at 1' (sample collected)
 Pit #2: sampled at 3' below pit bottom
 Pit #3: sampled at 3' below pit bottom
