PIT REMEDIATION AND CLOSURE REPORT

Facility or Well Name: Axi Apache H-13

Location: Unit: 12 Sec. 31 T. 24 N R. 5 W County Rio Arriba

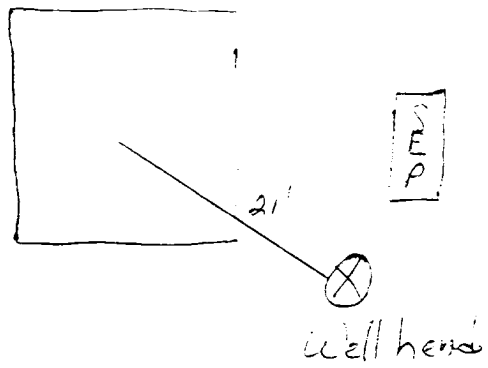
Axi Apple H-13
Sec. 31 T24N R5W
Bayless

Pit Location: Pit dimensions: length 17 width 13 depth 9

(Attach diagram) Reference: wellhead ☒ other ☐

Footage from reference: 20'

Direction from reference: 60 Degrees East North
West of South

Removed contaminated soil from all four side walls of pit to get a below 100 ppm head space reading. Pit bottom was solid sand stone rock

Sample Location North, East, South and West side walls

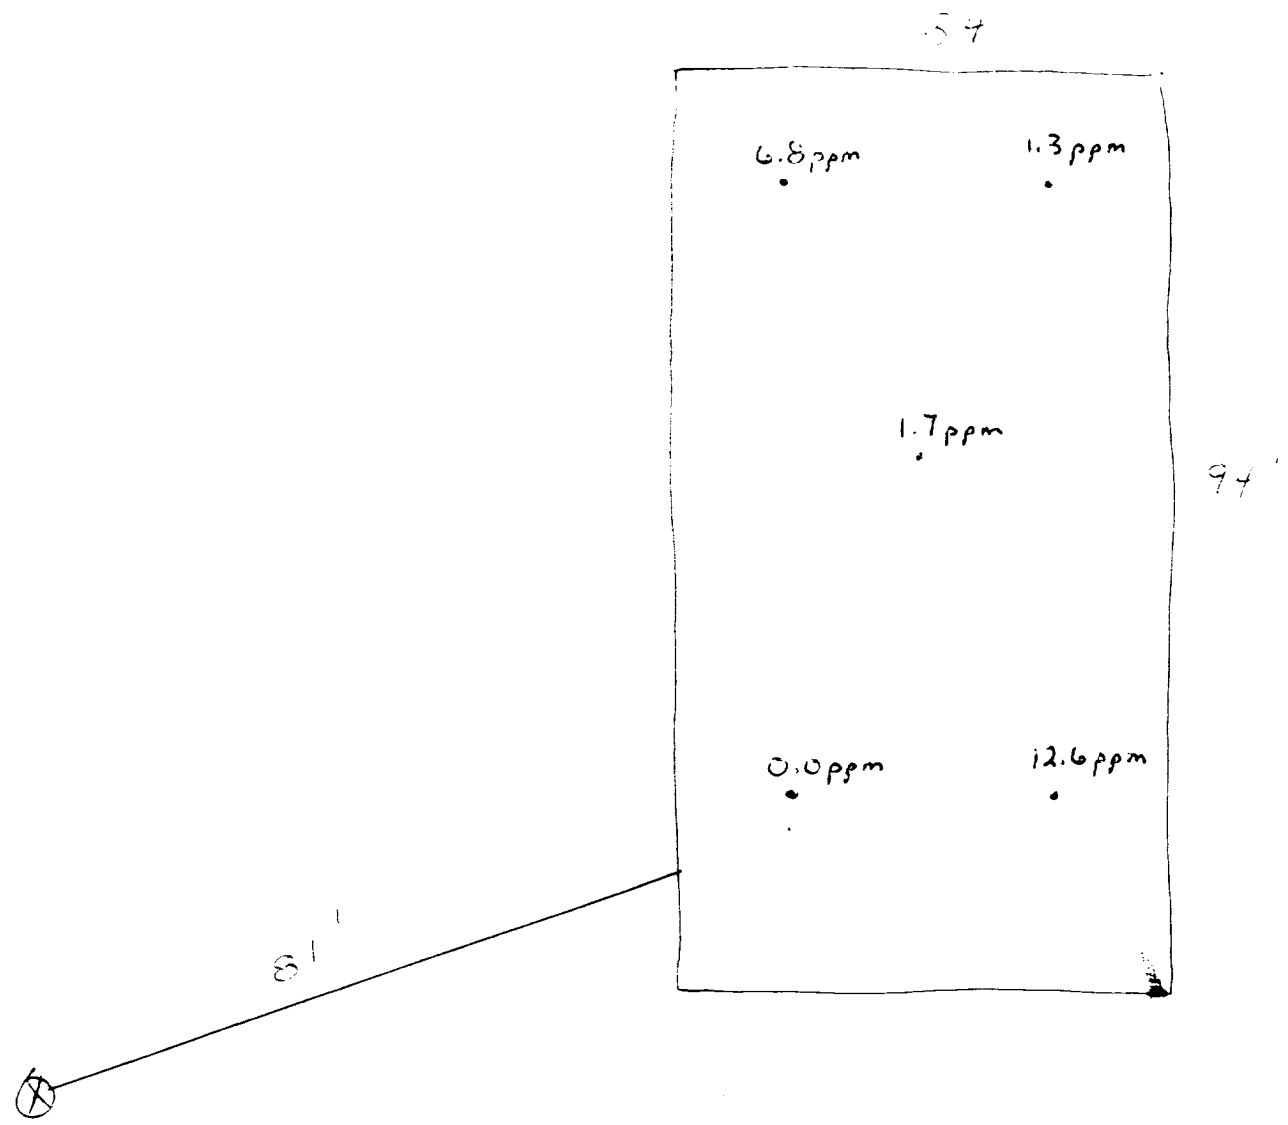
Land Farm

Axi Apache H-13
Sec 31 T24N R5W
Payless
