### FIELD PIT SITE ASSESSMENT FORM

# FILL PIT REMEDIATION/CLOSURE FORM

Project Name/Number: PIT CLOSURE 24324

#### PIT CLOSURE PROJECT - Soil Samples Inside the GWV Zone

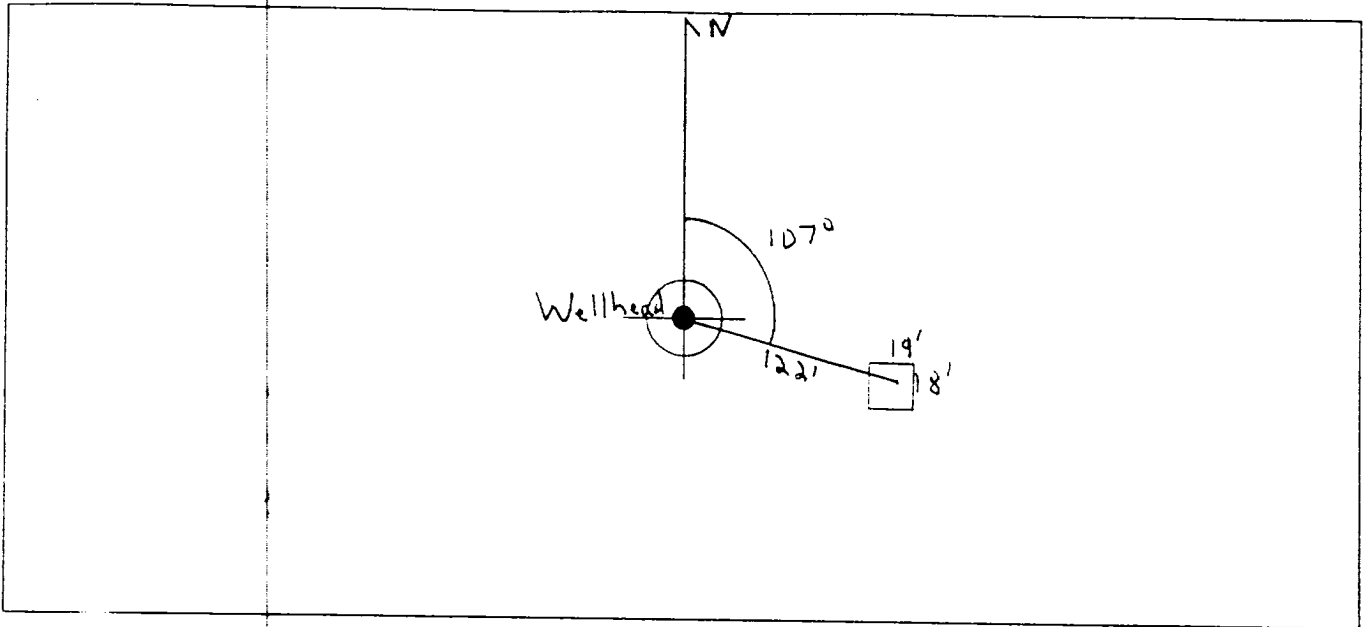
## ORIGINAL PIT LOCATION

Original Pit : a) Degrees from North 107° Footage from Wellhead 122'  
b) Length : 19' Width : 18' Depth : 3'

| REMARKS | <p>Remarks : <u>Redline Book - Inside</u> <u>Vulnerable Zone Topo - Inside</u><br/> <u>1 pit. Will close. Pit dry</u></p> <p><u>DIG + HAUL</u></p> |
