## PIT REMEDIATION AND CLOSURE REPORT

| Facility Or: | San Juan 28-7 #72 | | |
| Location: | Unit or Qtr/Qtr Sec | Unit L | Sec 35 T 28N R 7W County Rio Arriba |

Lease Name: San Juan 28-7 #72 PC/MV Dual

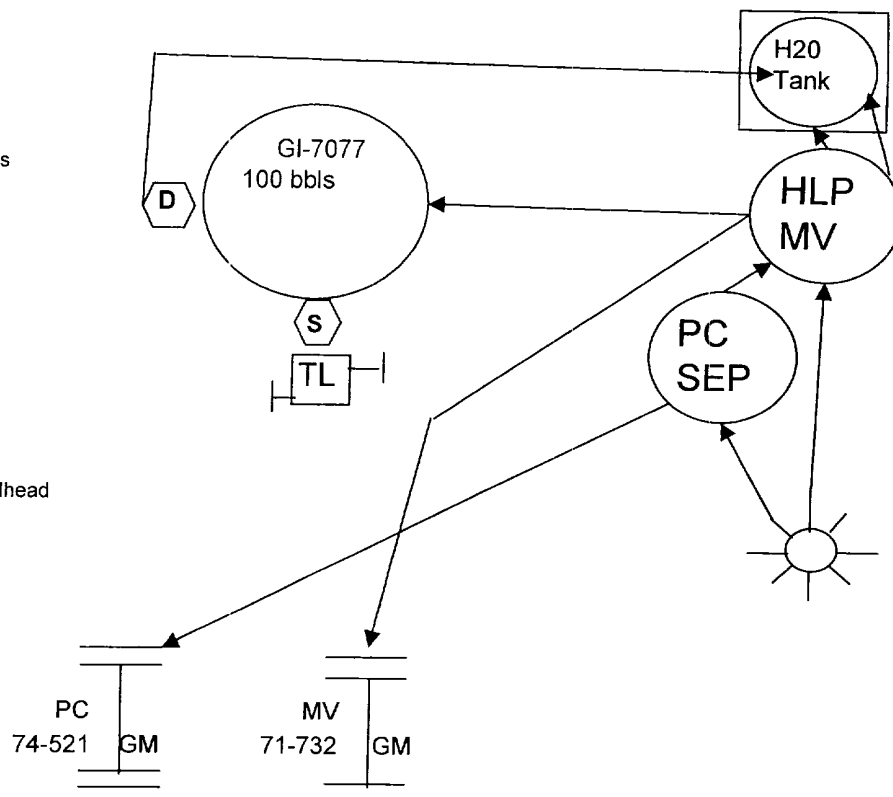
Site Security  
(Indicate North)

Old oil tank drain tank pit - 155' & 110 degrees  
from wellhead.

Old vent tank pit - 200' & 90 degrees from wellhead
